ASCE 41 versus TEASPA*:

Comparison of Seismic Evaluation Results of RC Frame Buildings Damaged during 2016 Meinong Earthquake, Taiwan

Jiun-Wei Lai, Insung Kim , Garrett Hagen, Kirk Johnston, Daniel
Zepeda, Shyh-Jiann Hwang

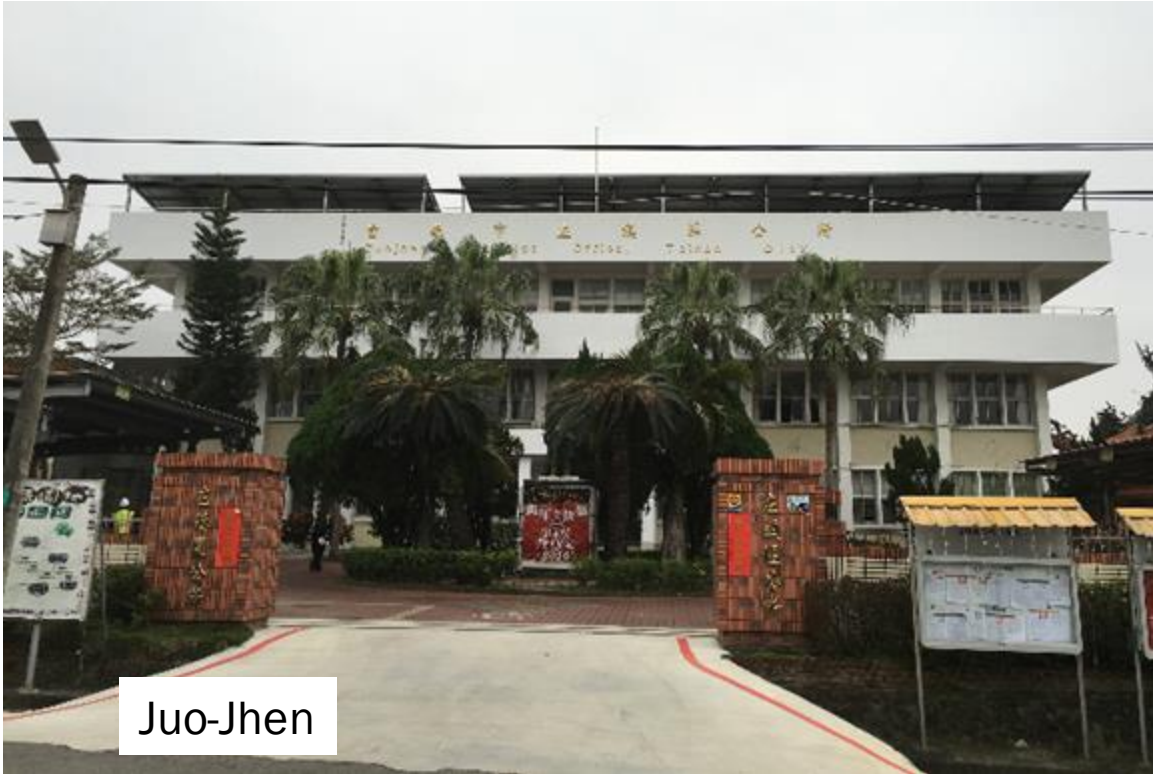
District Office Name	Year of Construction /Modification Phase(s)	Building Dimension (Long. × Trans.)	Nominal Material Properties	Observed Structural Performance Level per ASCE 41	Status in 2018
Juo-Jhen	1974/ 1984/ 1998	108.3 ft × 57.4 ft	$f'_c = 3,000$ psi (RC) $f_y = 40$ ksi (Reinforcement)	Between Life Safety (LS) and Collapse Prevention (CP)	Retrofitted
Shan-Shang*	1984	108.3 ft × 57.4 ft		Between LS and CP	Demolished
Guei-Ren	1974/ 1988/ 2012**	131.2 ft × 57.4 ft		Immediate Occupancy (IO)	In Use

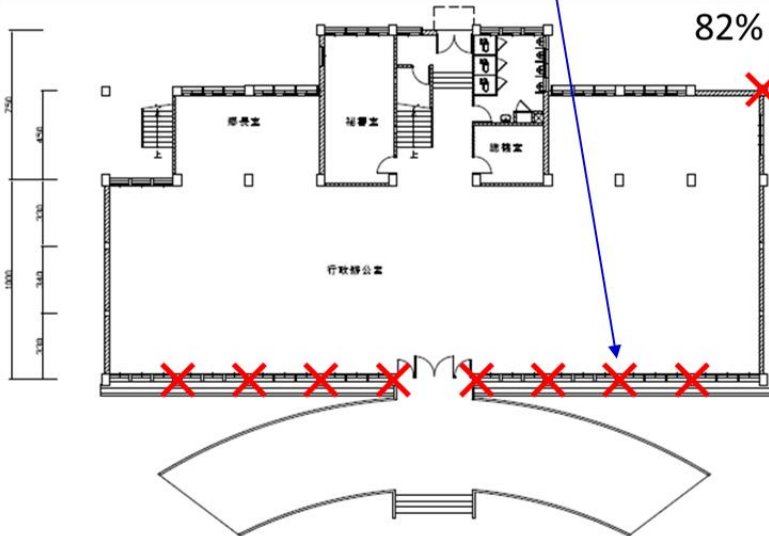
Observed Column Damage during Meinong Earthquake

Column Evaluation Results vs Actual Damage Observed (Jho-Jhen District Office)

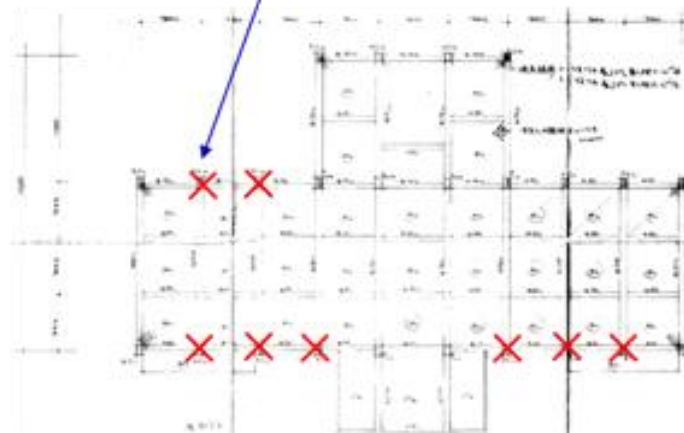
Observed Column Damage during Meinong Earthquake

Column Evaluation Results vs Actual Damage Observed (Shan-Shang District Office)

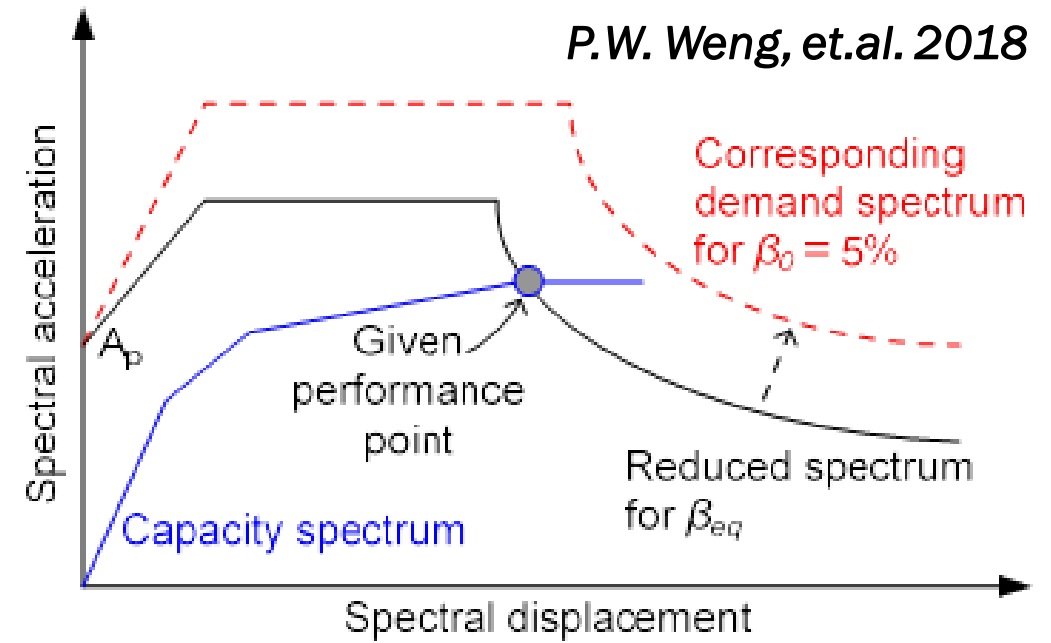
Shan-Shang District Office Building	X direction
Base Shear (tonf)	462
Roof Displacement (cm)	4.05
Seismic Capacity A_p (g)	0.26
Ground Motion Record A_{EQ} (g)	0.40
Capacity-Demand Ratio (CDR)	0.66 (DCR= 1.52)

Retrofit required
