Seismic Performance of Repaired Lightly Reinforced Concrete Walls

Christopher Motter, Aaron Clauson, James Petch,
Matias Hube, Richard Henry, Kenneth Elwood

October 17, 2018

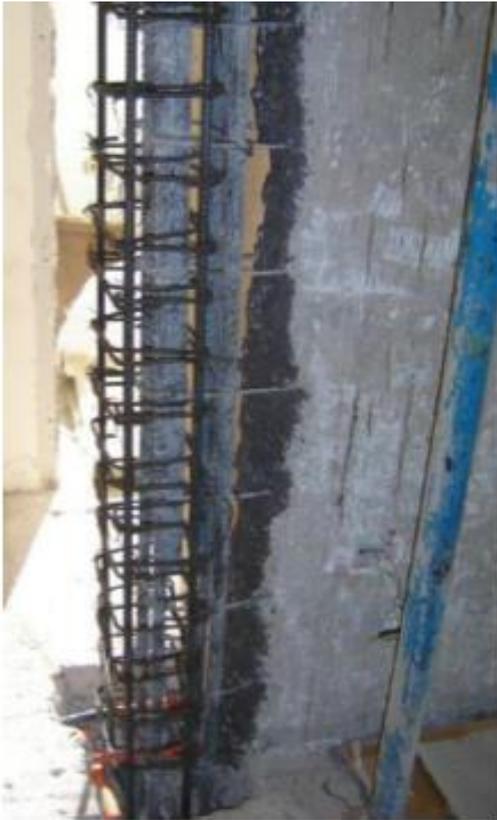
Repair of RC wall in 11-story building in Vina del Mar after Maule, Chile (2010) Earthquake (photo courtesy of Jorge Carvallo)

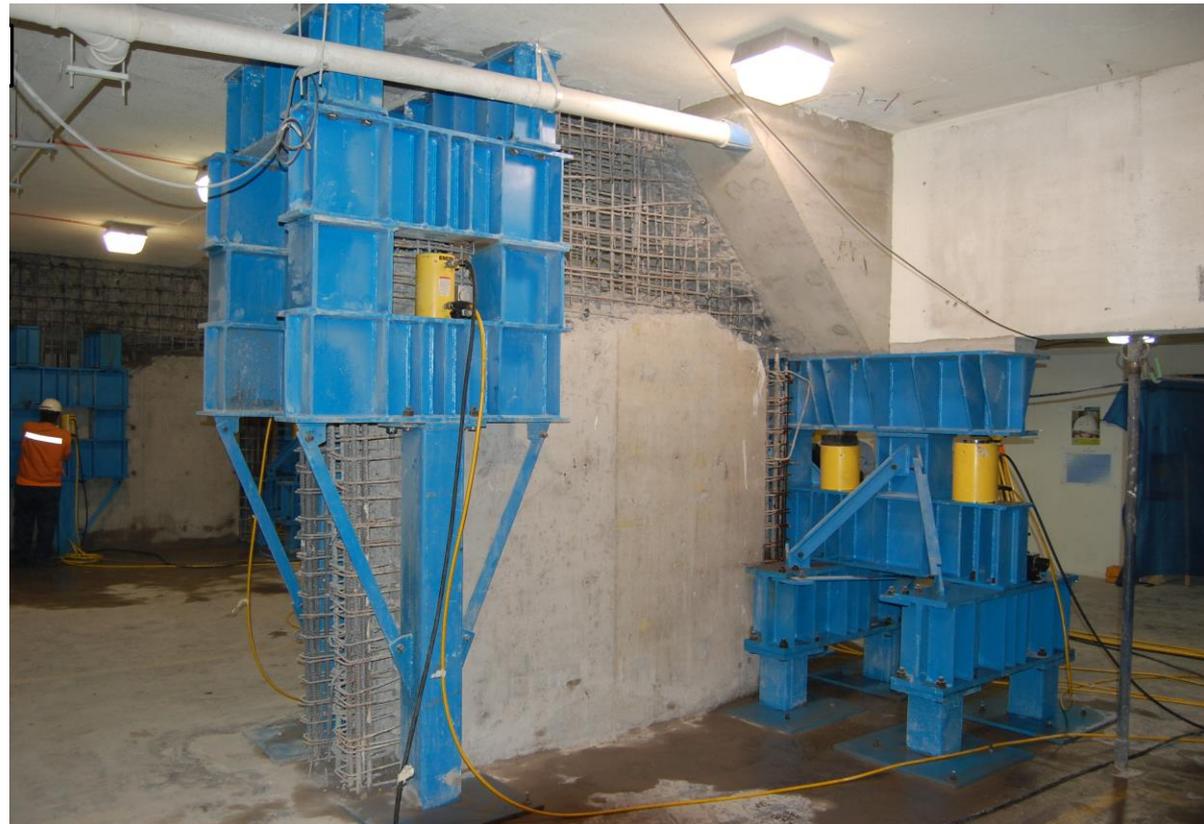
Repair of RC wall in 18-story building in Santiago after Maule, Chile (2010) Earthquake (Sherstobitoff et al, 2012)

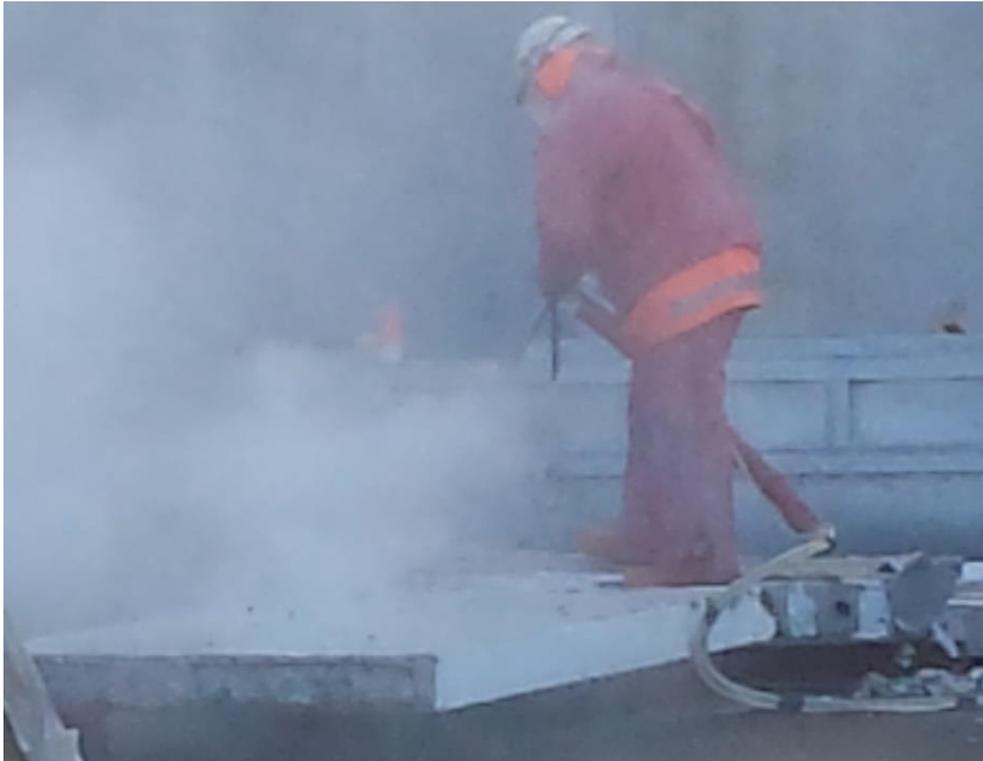
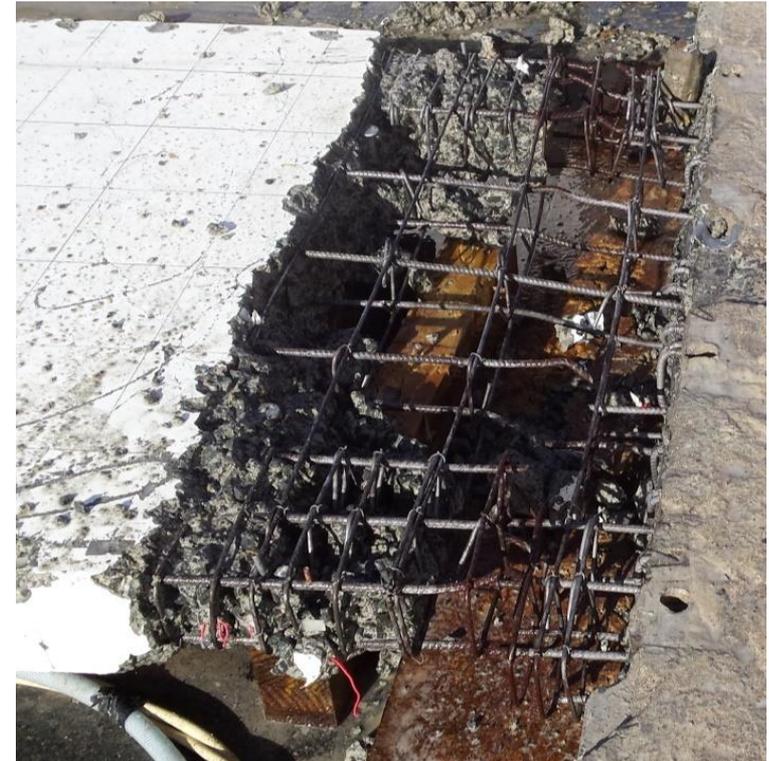
Removal of Concrete
(Hydro-demolition)

- M5-R
 - Replace all concrete and steel over ~ plastic hinge region (hydro-demolition)
 - No crack Injection above repair, as cracks deemed too small

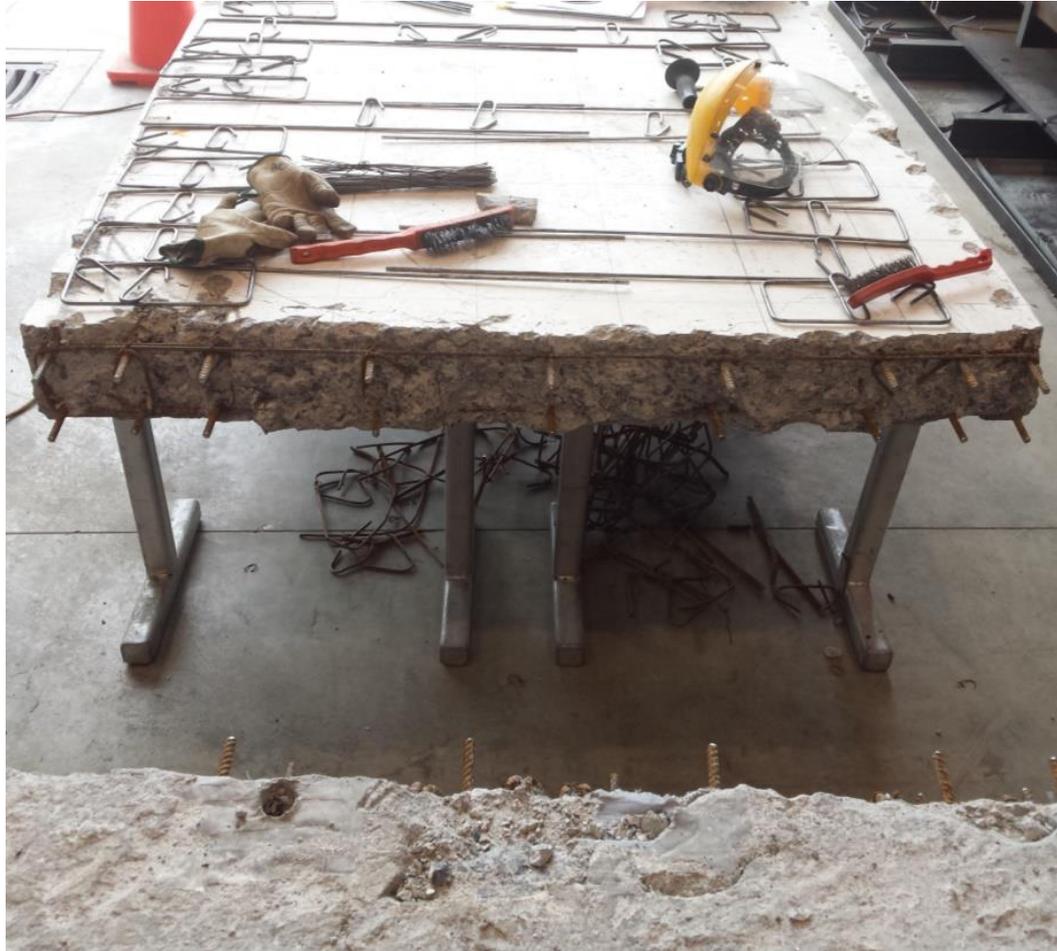
Removal of Existing Reinforcement

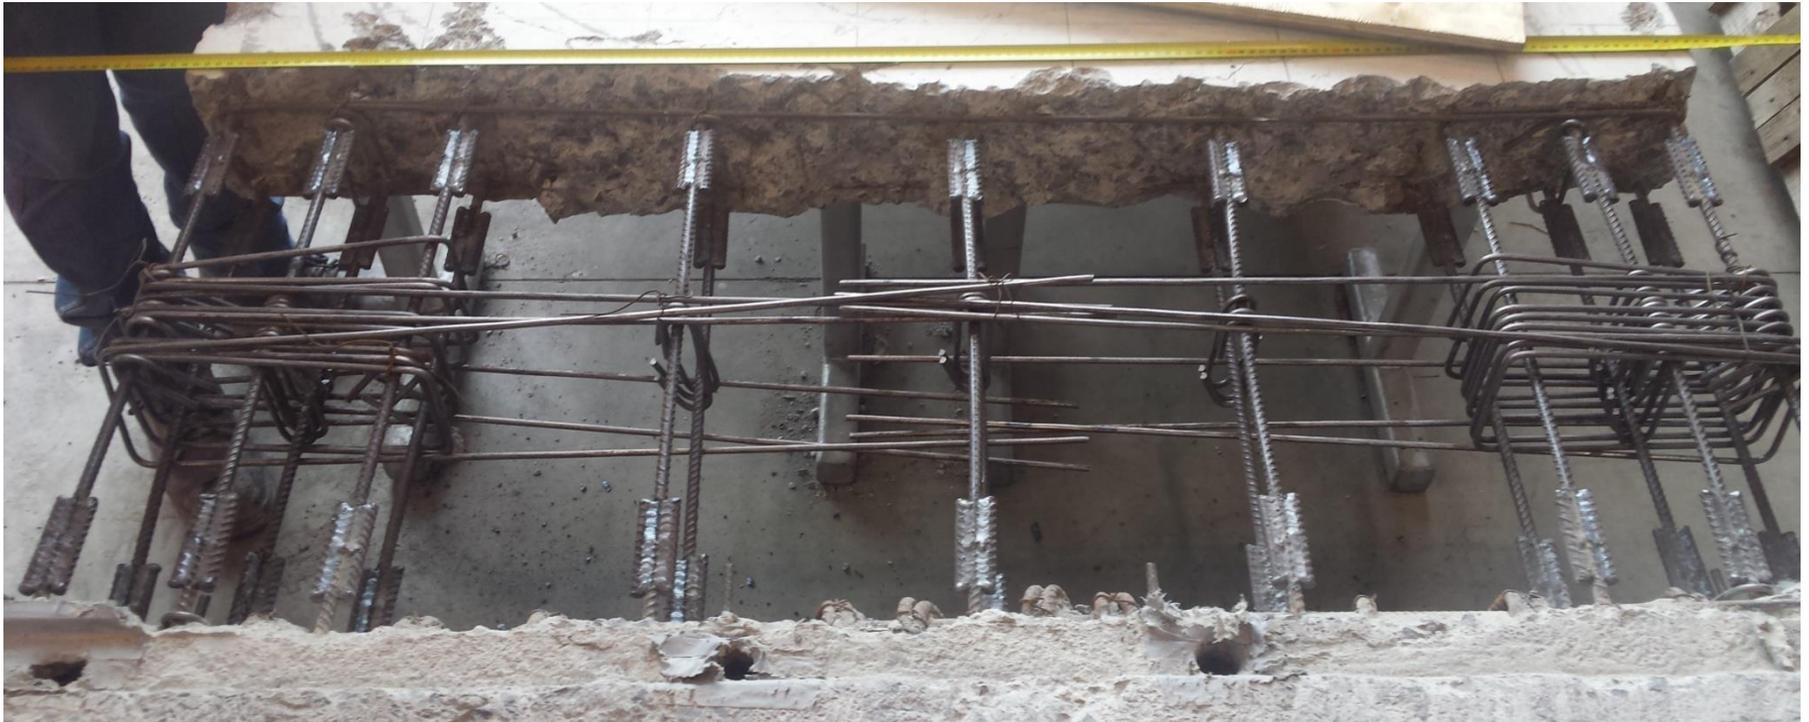
Reinstatement of New Reinforcement

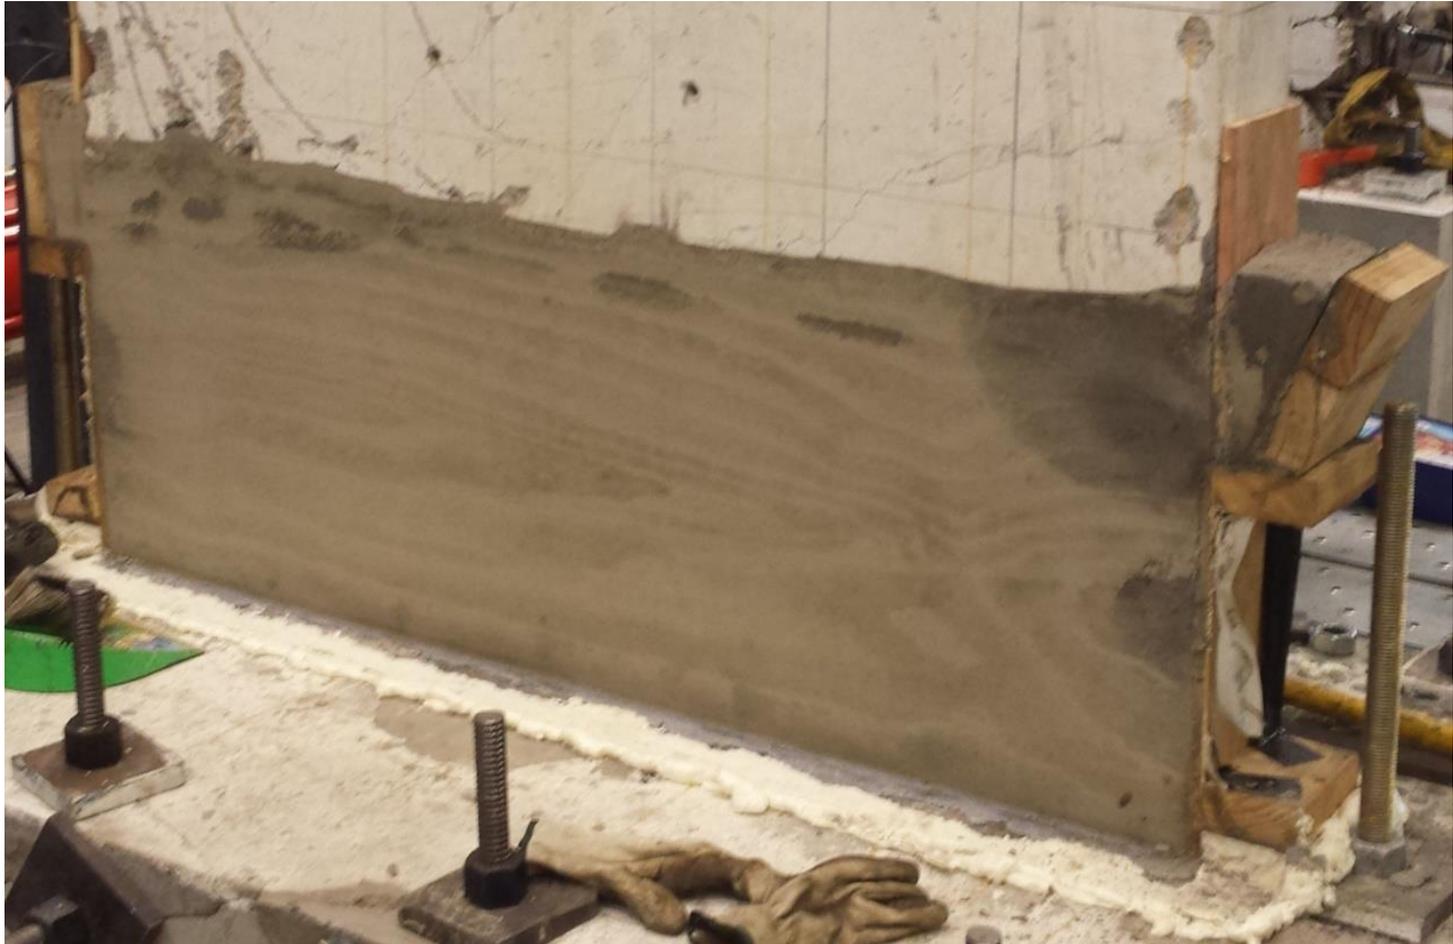
Reinstatement of New Mortar
(repair mortar – tested at 35-MPa on test day)

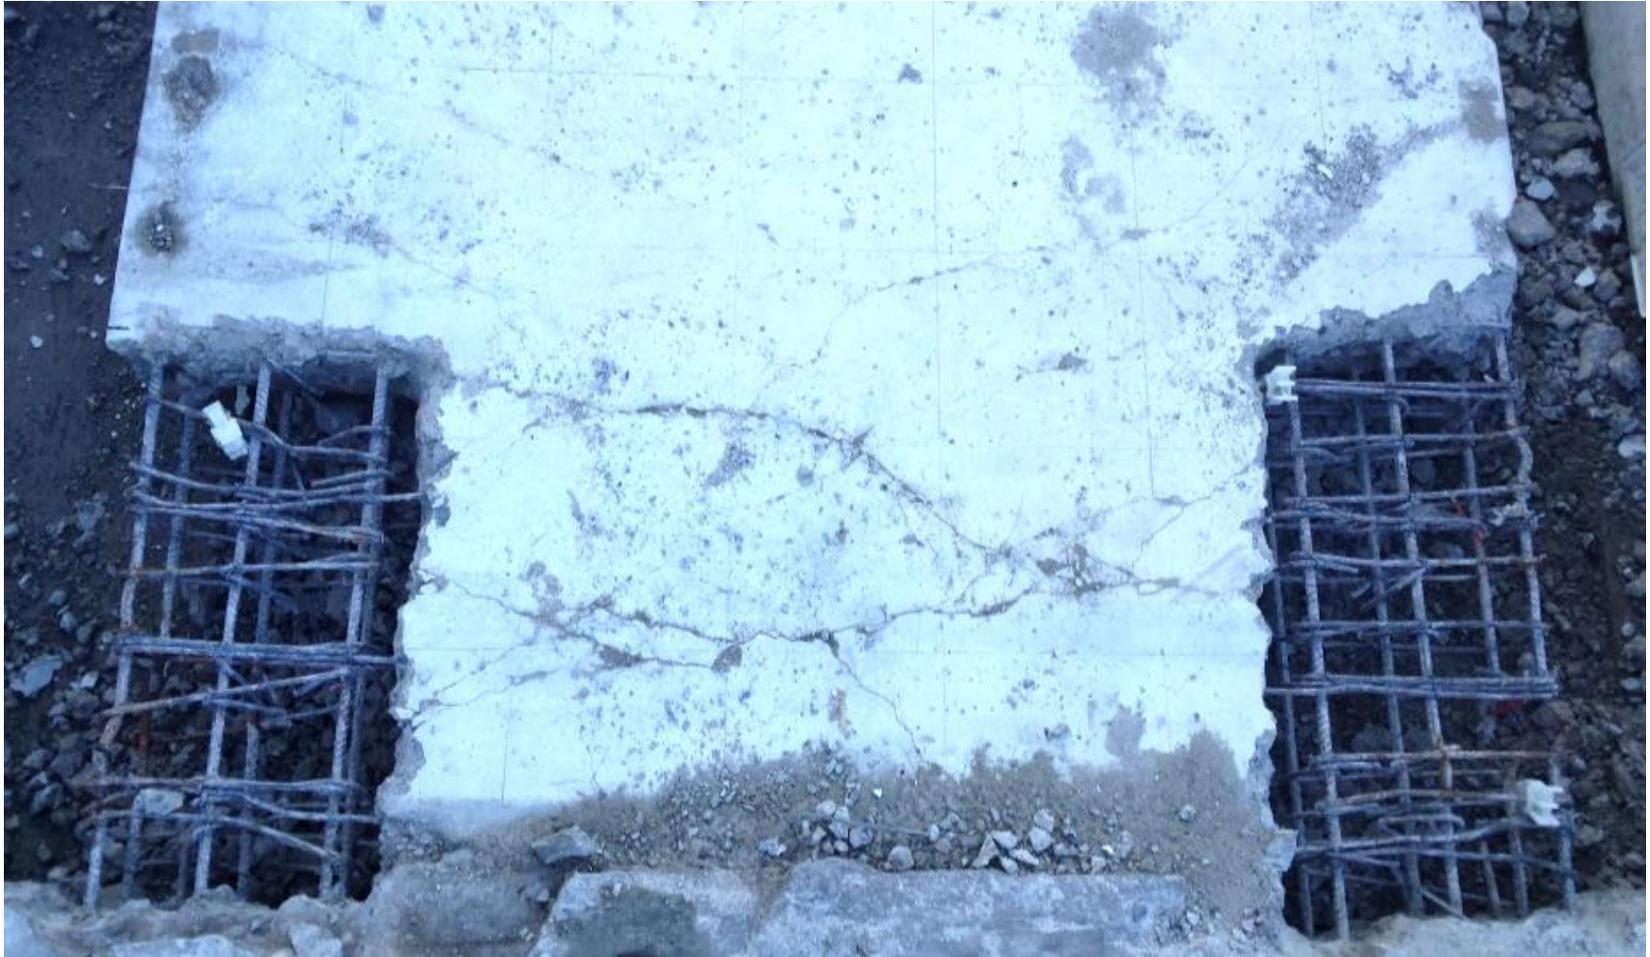
Removal of Concrete
(Jackhammer)

- M6-R
 - Replace all concrete and steel over ~ plastic hinge region only at wall end regions (jackhammer)
 - Crack injection at remaining locations

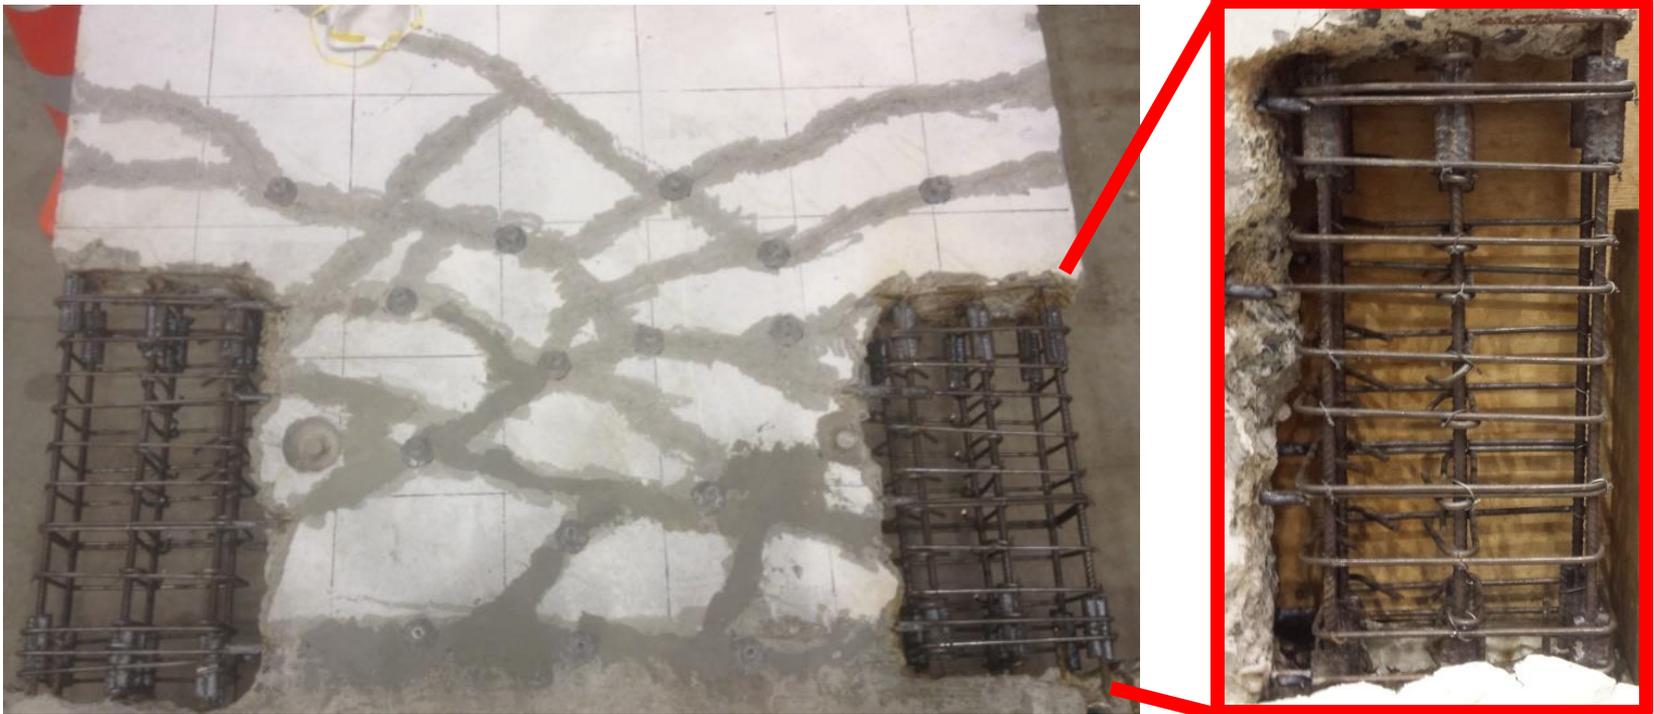
Reinstatement of reinforcement &
Preparation for crack injection

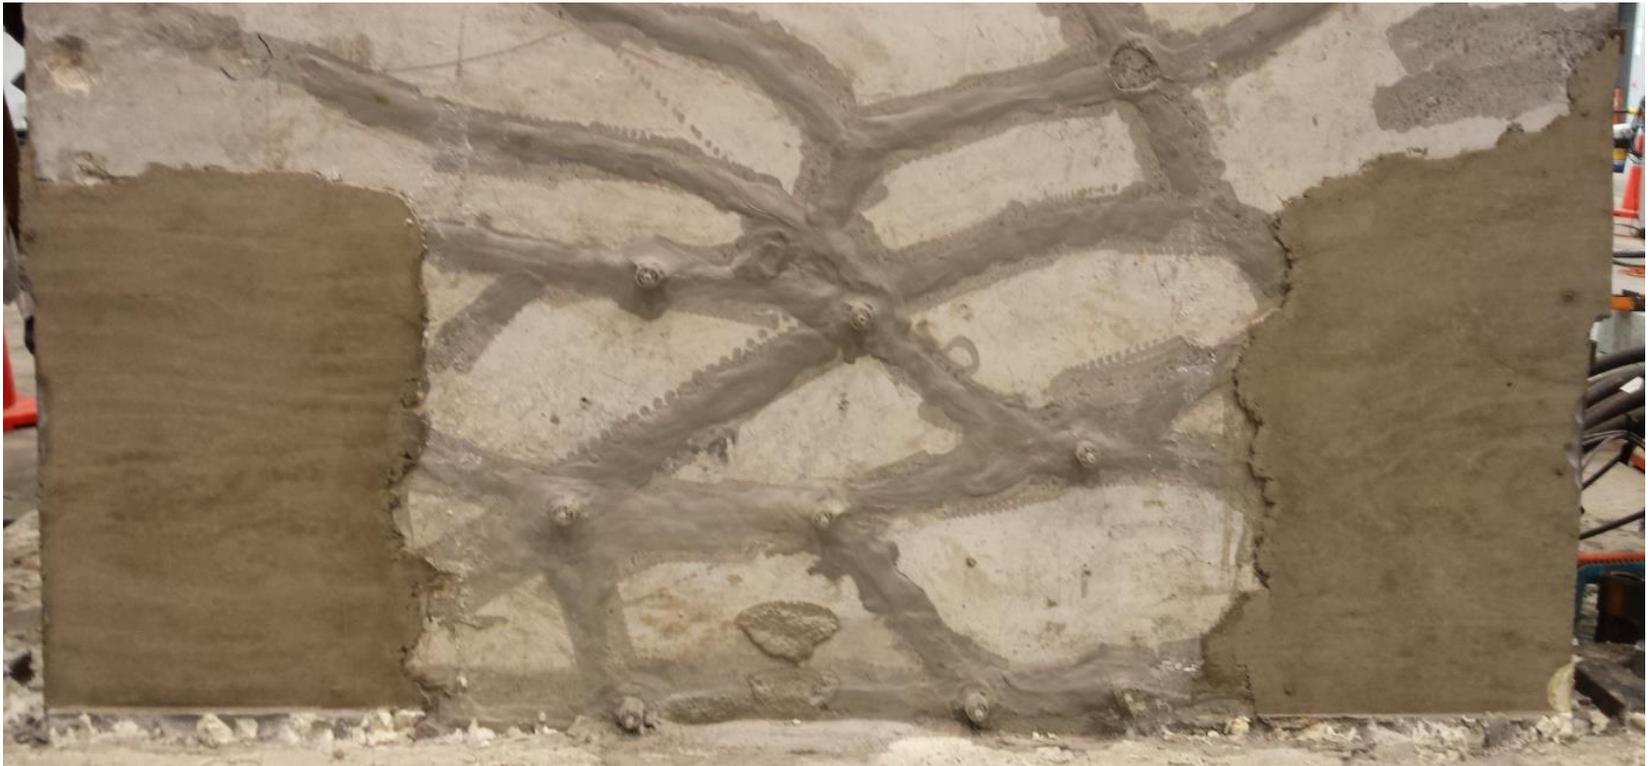
Reinstatement of New Mortar
(Sika Monotop repair mortar – tested at 32-MPa on test day)
&
Preparation for crack injection

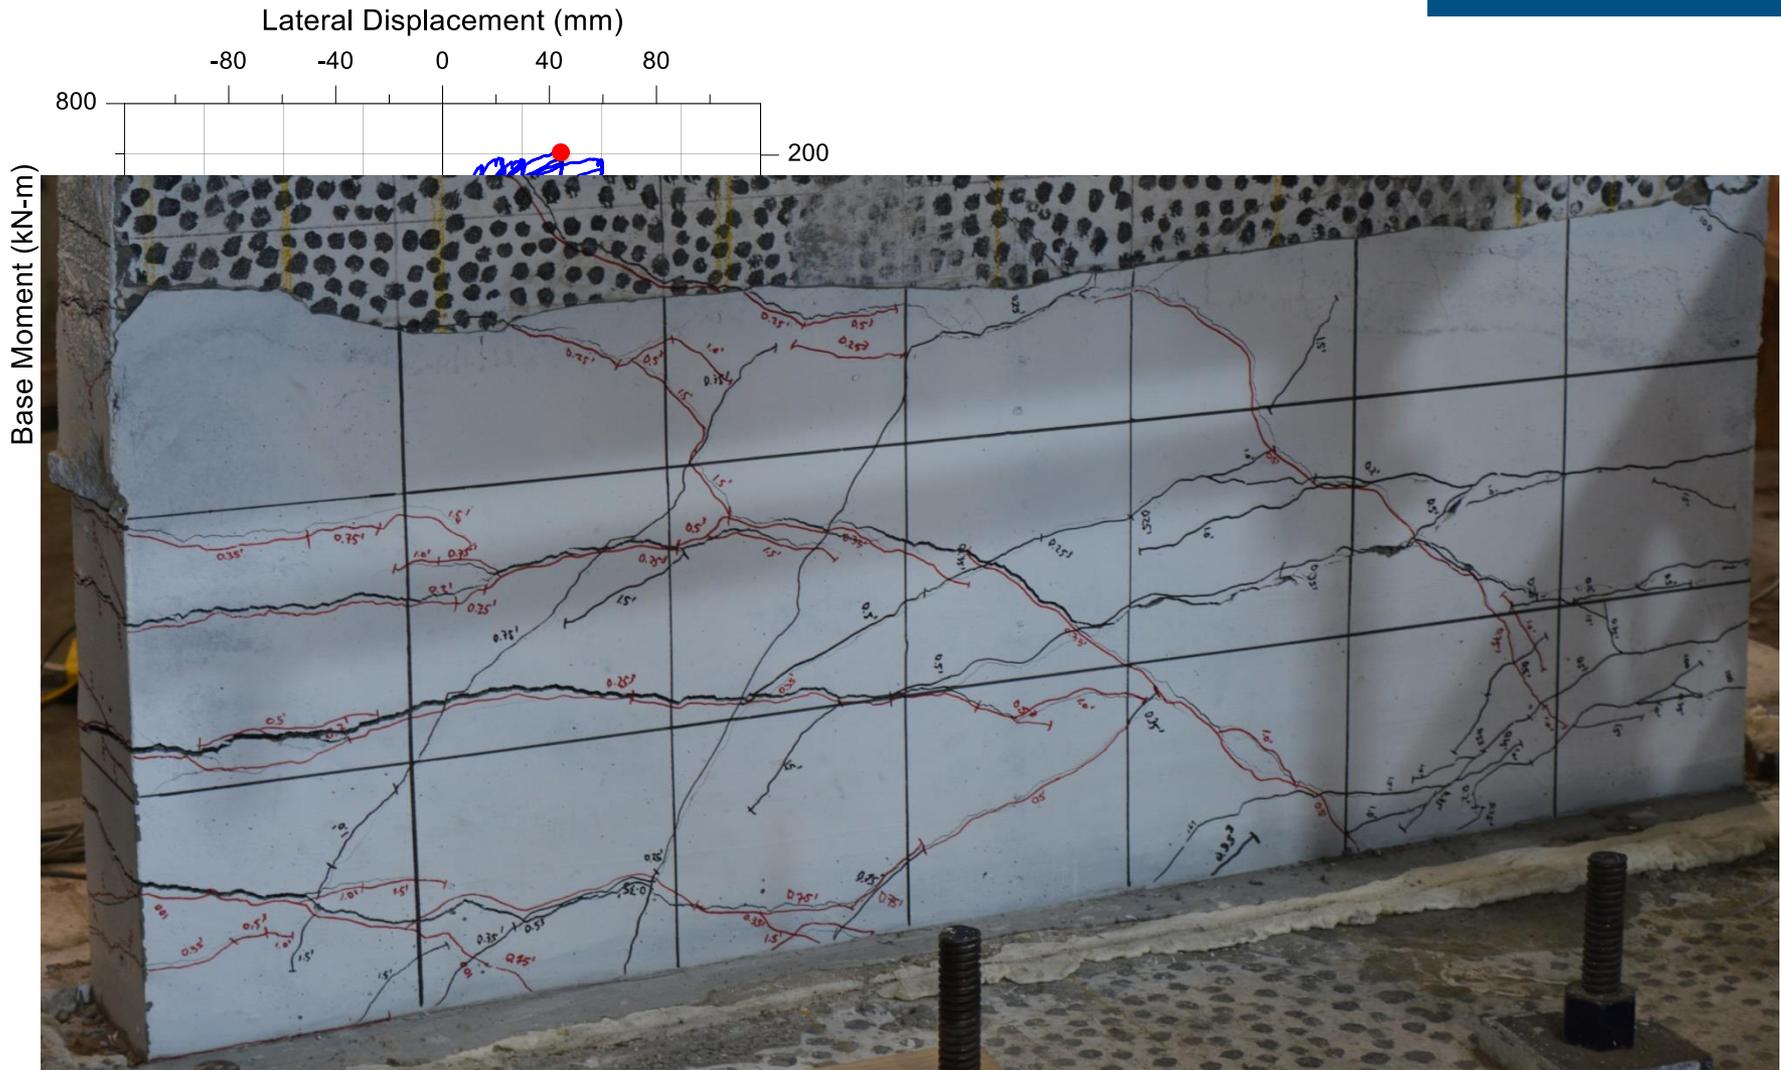
Damage: 1.5% drift, 1st cycle

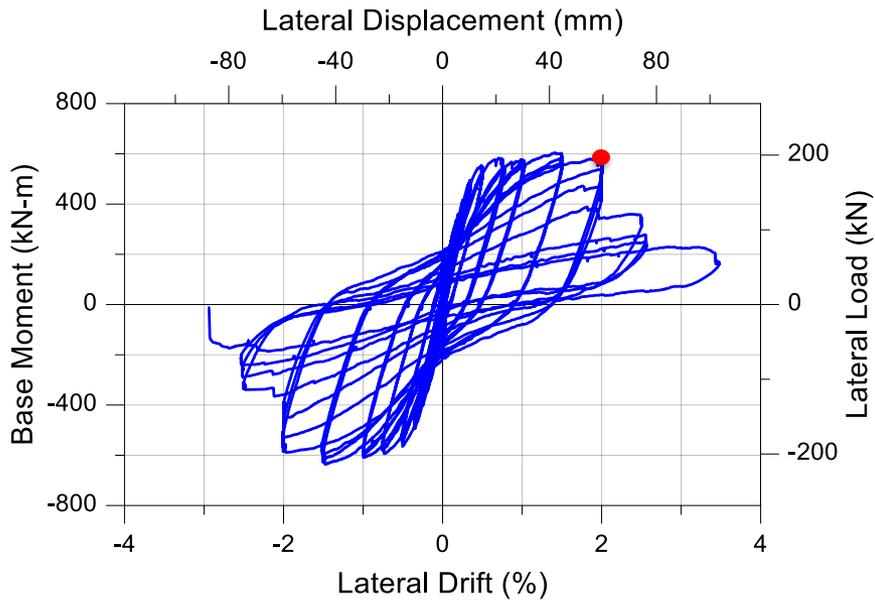
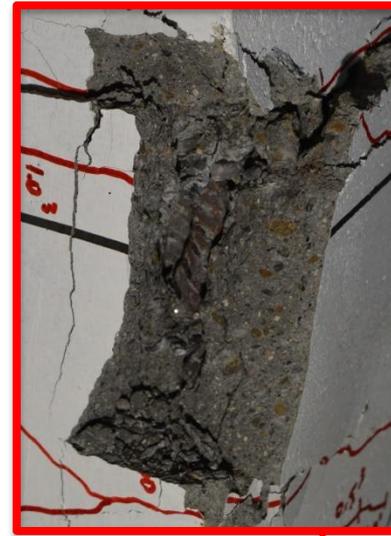
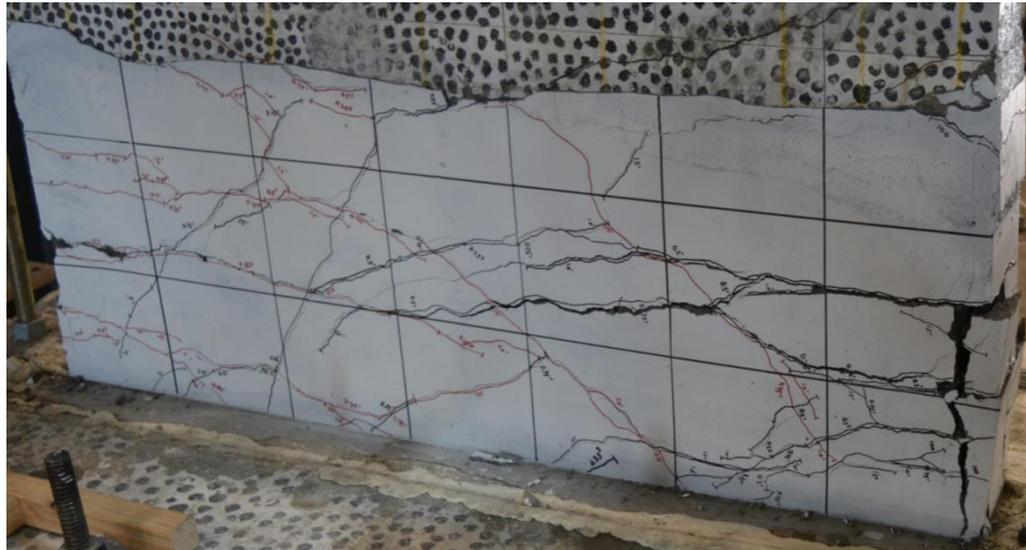
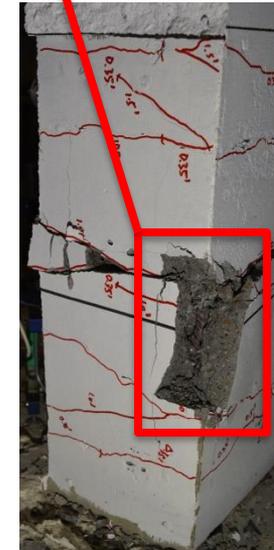
Damage: 2% drift, 1st cycle positive

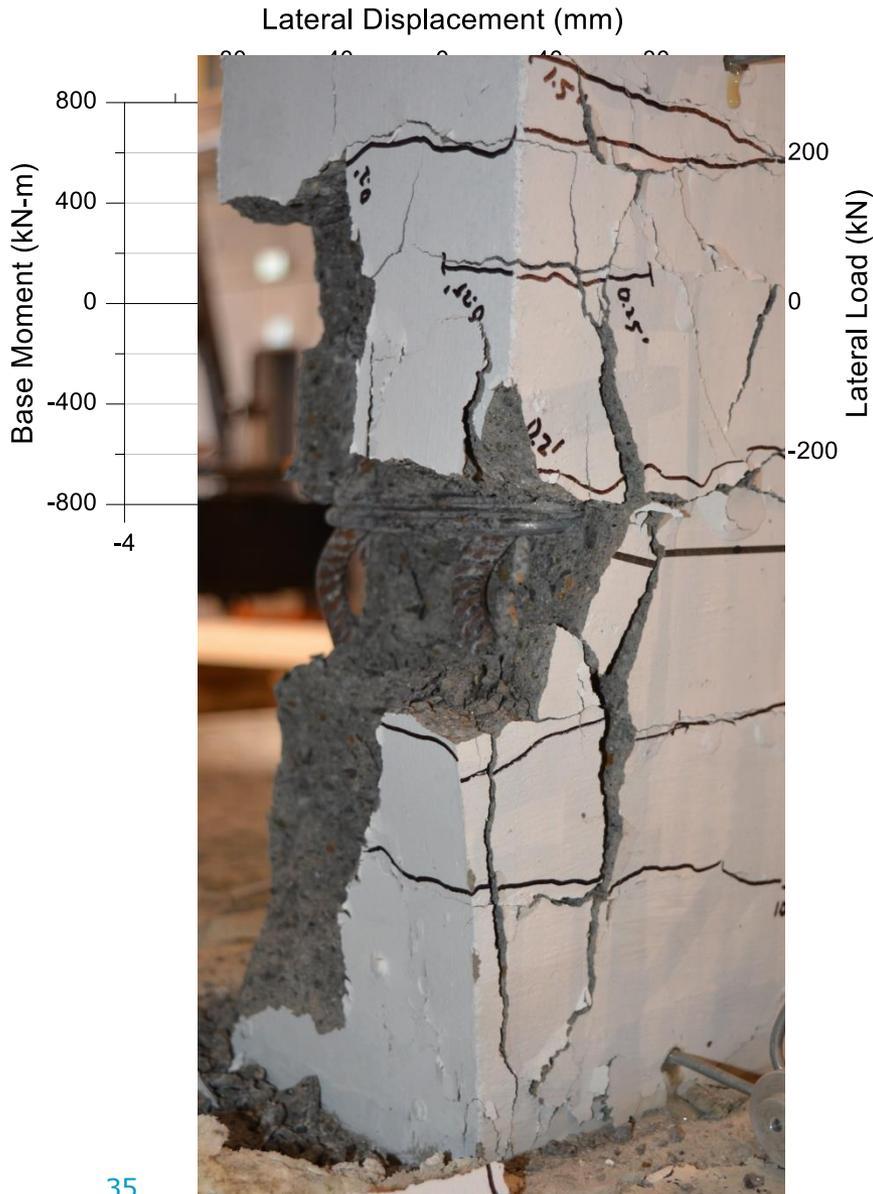
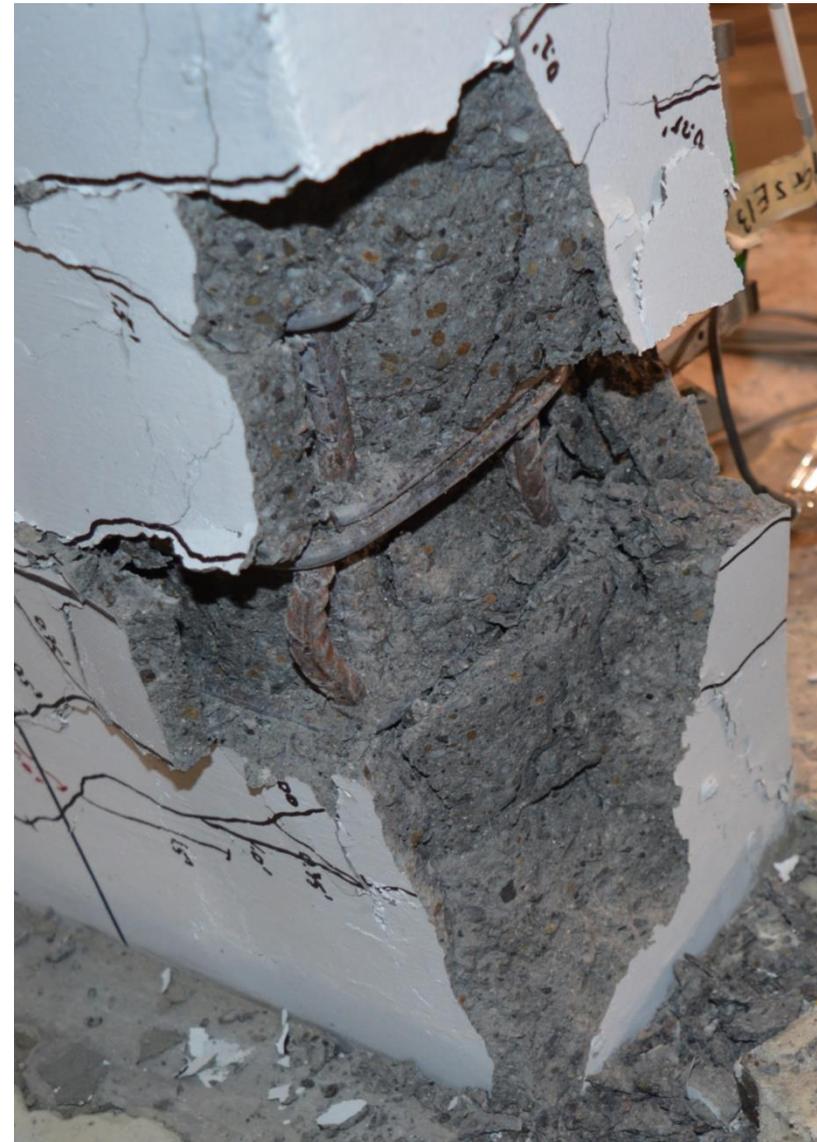
Damage: 2% drift, 1st cycle negative

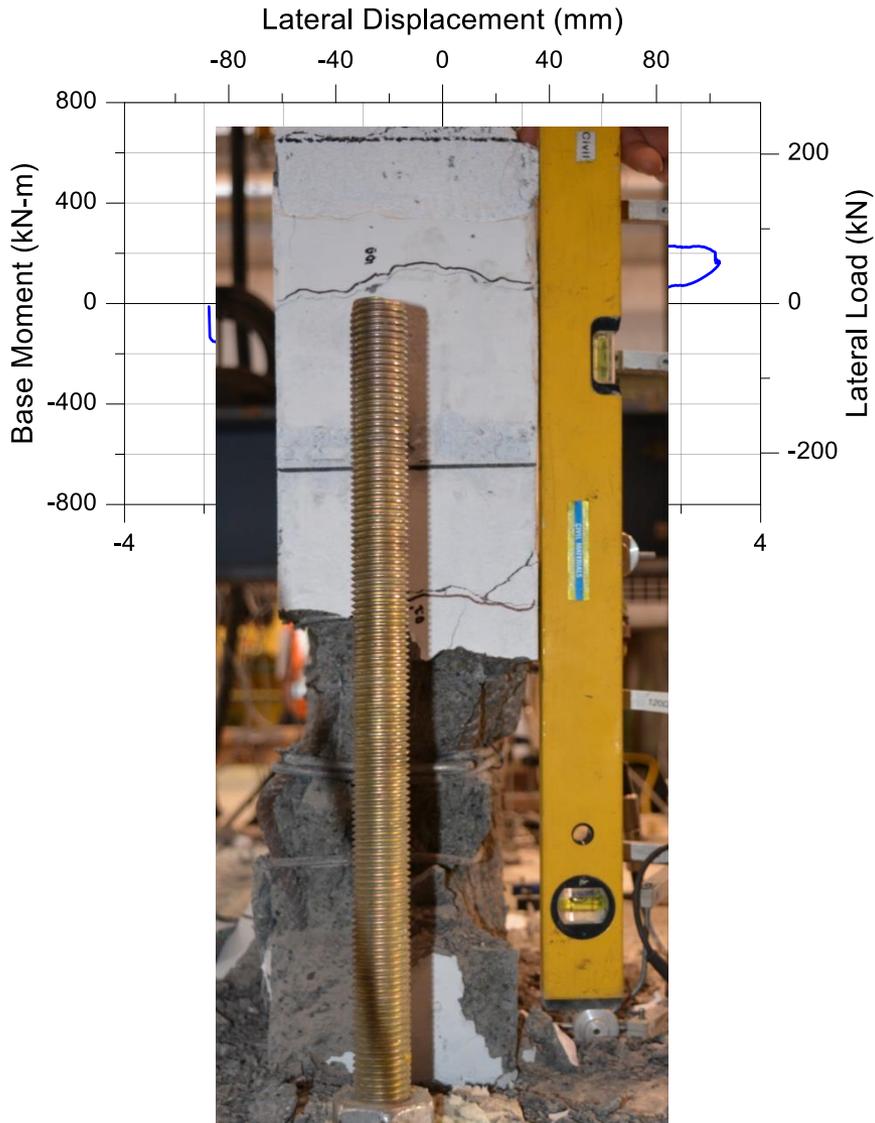
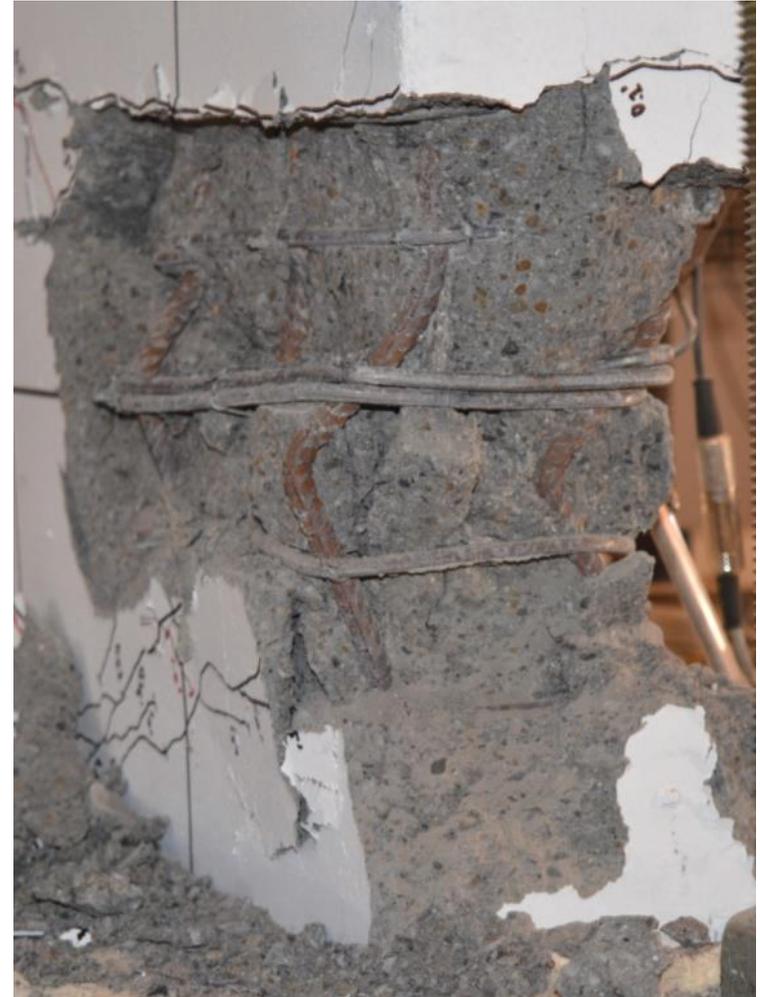
Damage: 2% drift, 3rd cycle negative

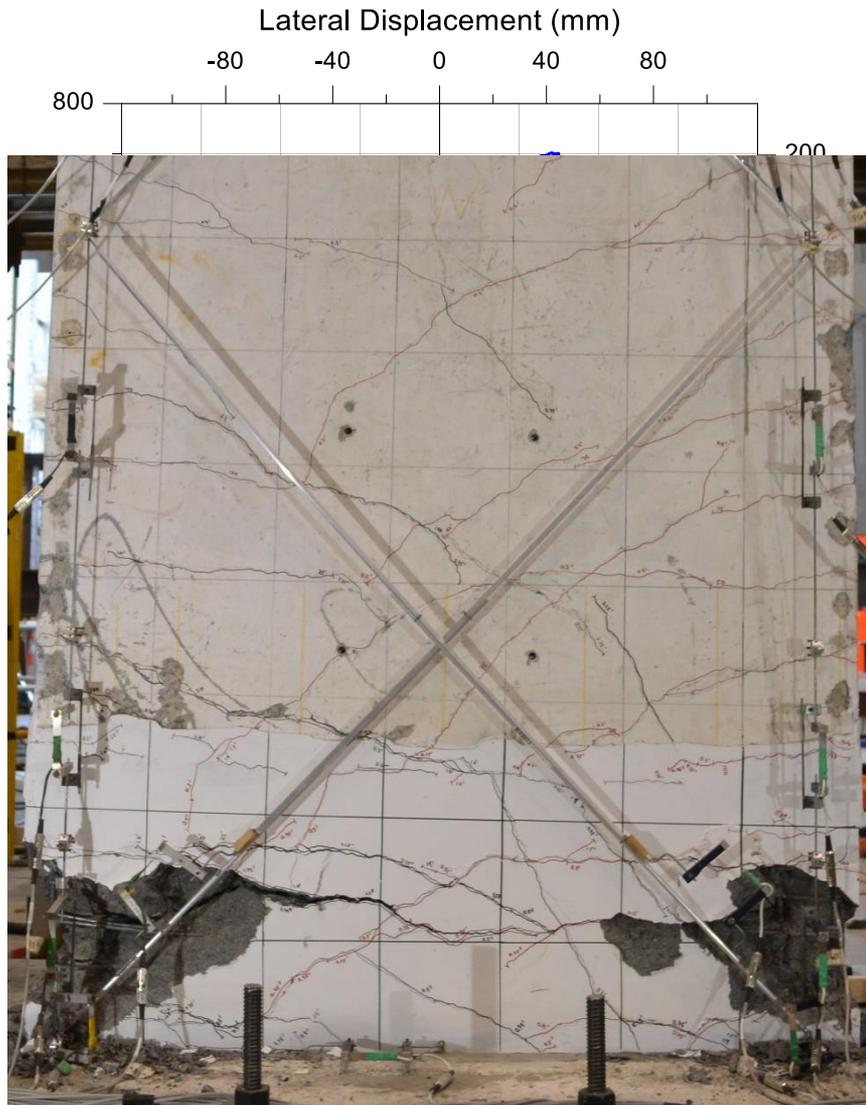
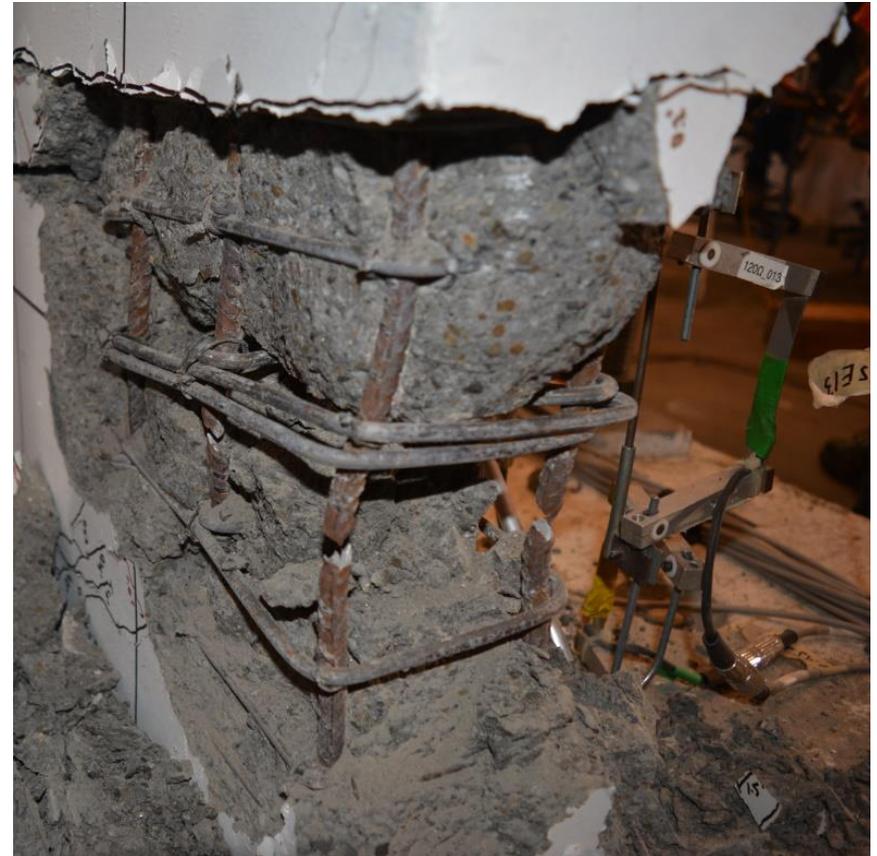
Damage: 2.5% drift, 1st cycle positive

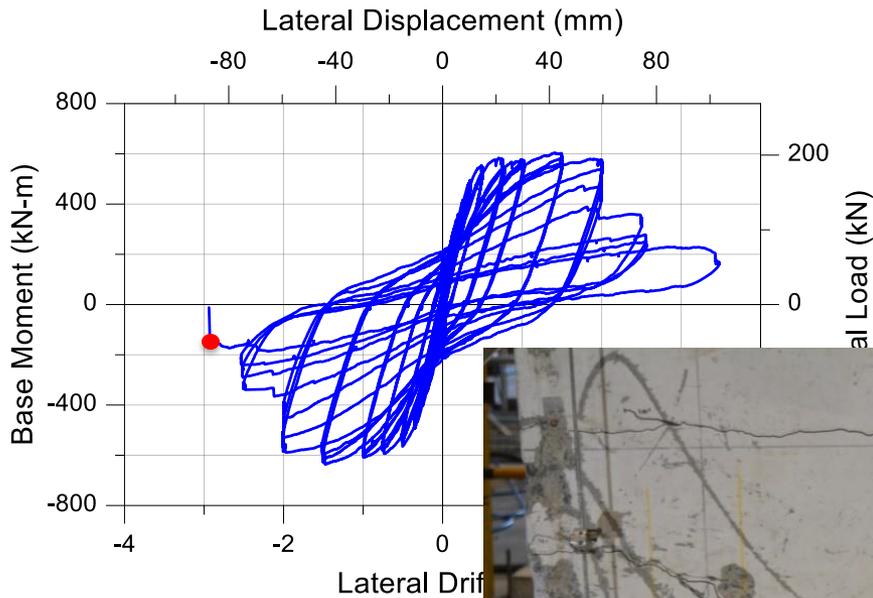
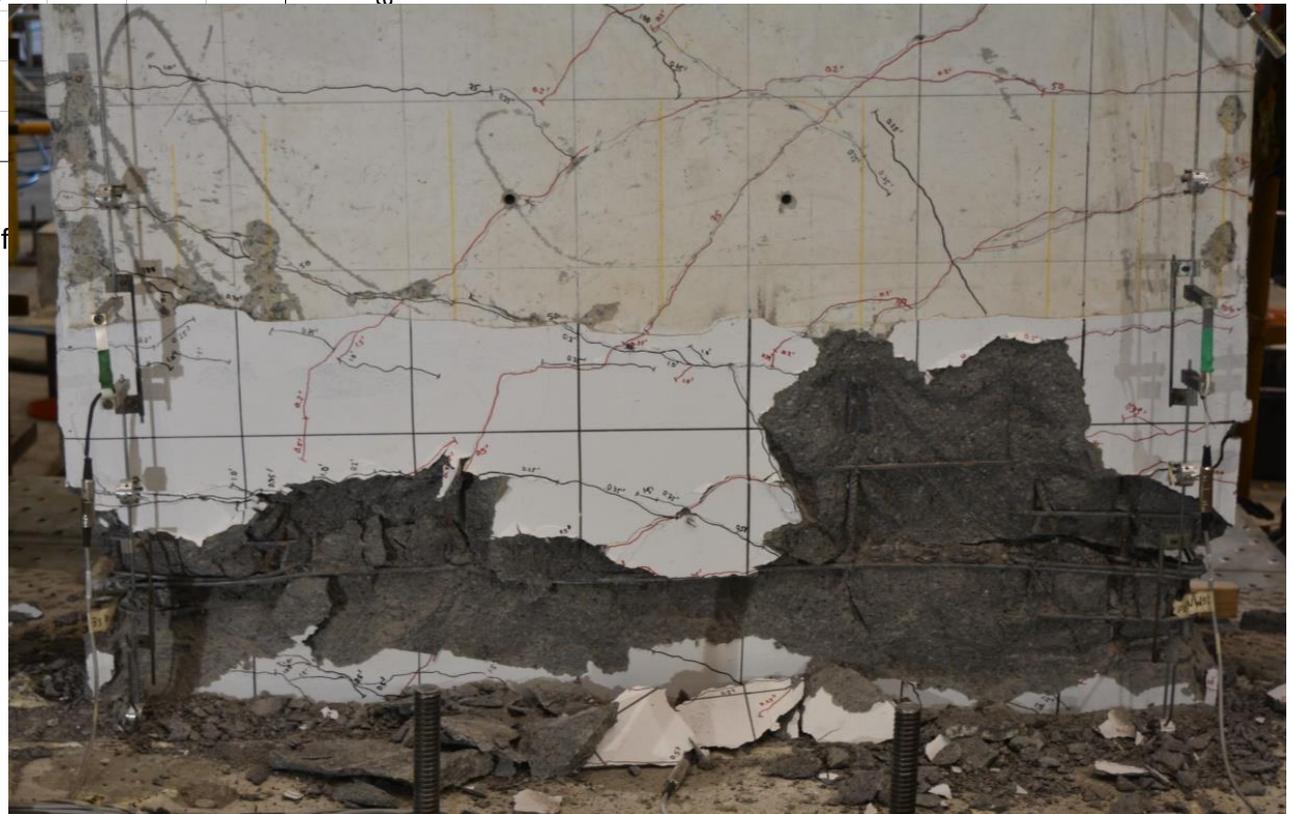
Damage: going to 3.5% drift, 1st cycle neg.
