Presentation at ACI 2016 Fall Conference

**Owner Participation
in
Innovative Engineering Solutions**

Structural Investigation of Dome at the Cathedral of St. John the Devine

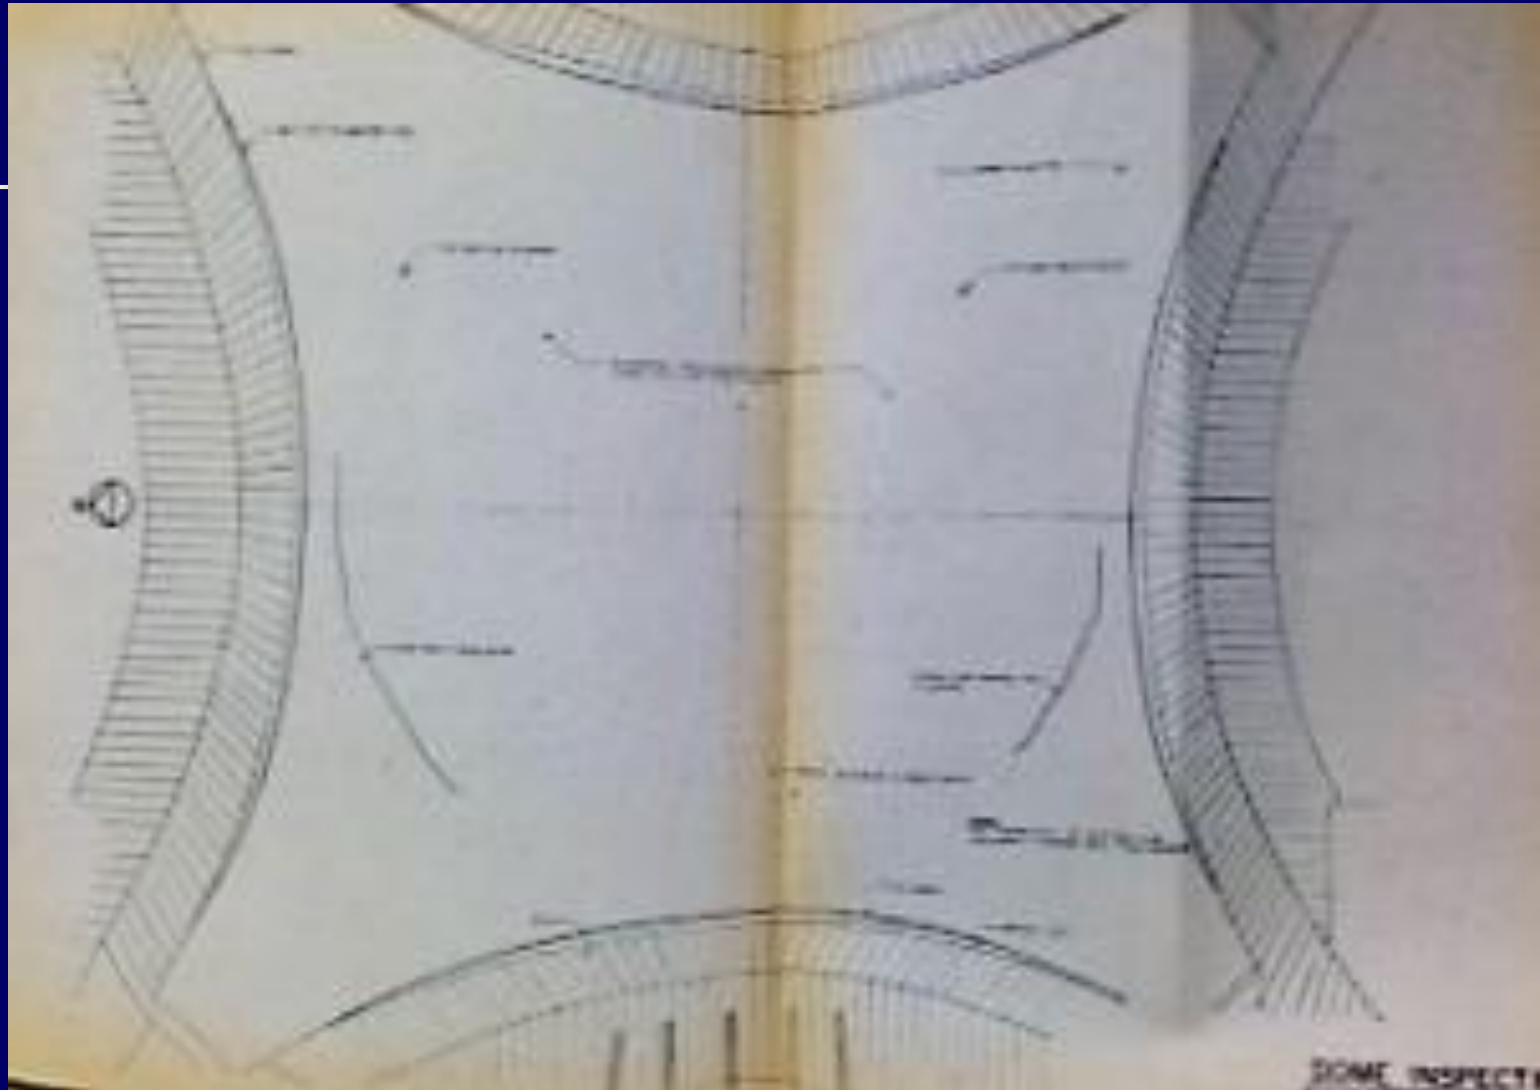
Dome Inspection – Ceiling Plan

In 1969, pieces of mortar and tile dropped to the floor of the crossing. This evidence of apparent structural distress and previous history of cracking led to concern regarding the integrity of the dome.

- Though no sign of imminent failure of the dome, the effects of temperature variations and the moisture intrusions over the years have caused distress and will progressively worsen.
- If periodic temperature variations are eliminated, the structural adequacy of the dome can be assured for many years. This can be accomplished by providing thermal insulation on the exterior surface of the dome and new roofing.
- Provide netting at underside of dome to prevent danger of large pieces of mortar or tile falling to the floor.
- The repair recommendations included removal of existing roofing, inspection and repair of the dome outer surface, providing insulation over the entire dome outer surface and installing membrane waterproofing and providing scaffolding at the underside of the dome to repair the dome underside and arches and to install the netting.

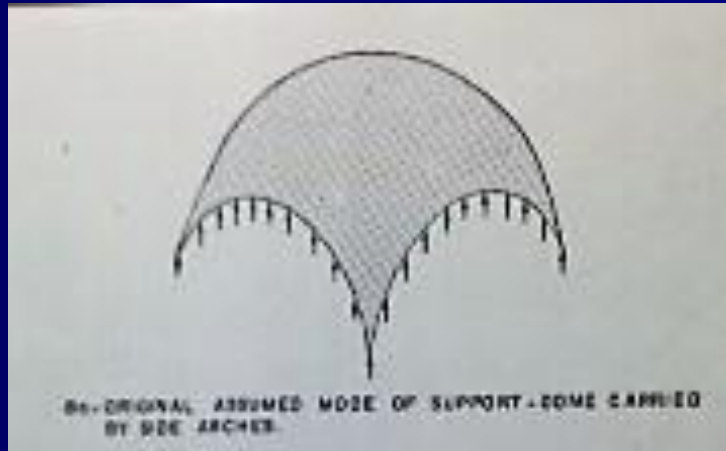
Original Assumed mode of Support
dome carried by side arches

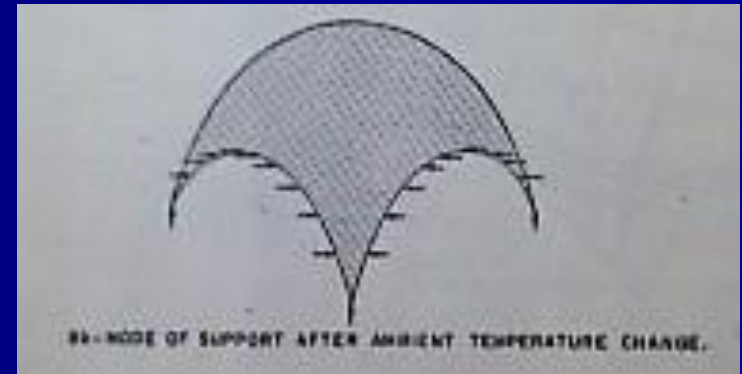
Mode of support after ambient
temp. change

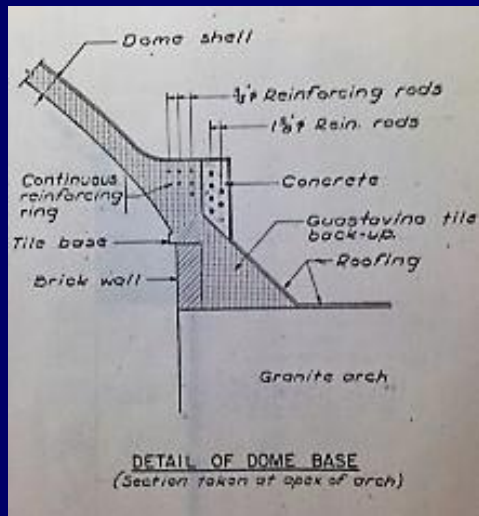
Addition of a Continuous Reinforcing Ring in 1937

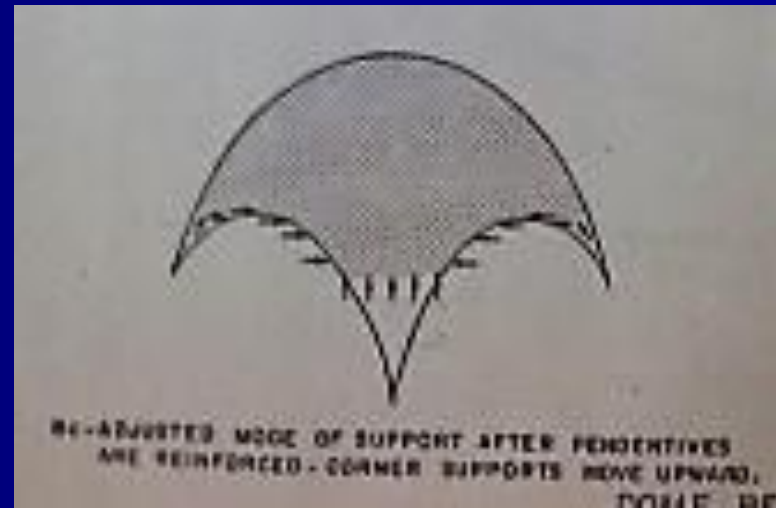
Adjusted mode of support after pendetives are reinforced – corner supports move upwards
