Quality Control of Silica Fume Bridge Decks

Quality Control of Silica Fume Concrete Bridge Decks

KOSCIUSZKO BRIDGE

Brooklyn – Queens Expressway, Brooklyn, NY

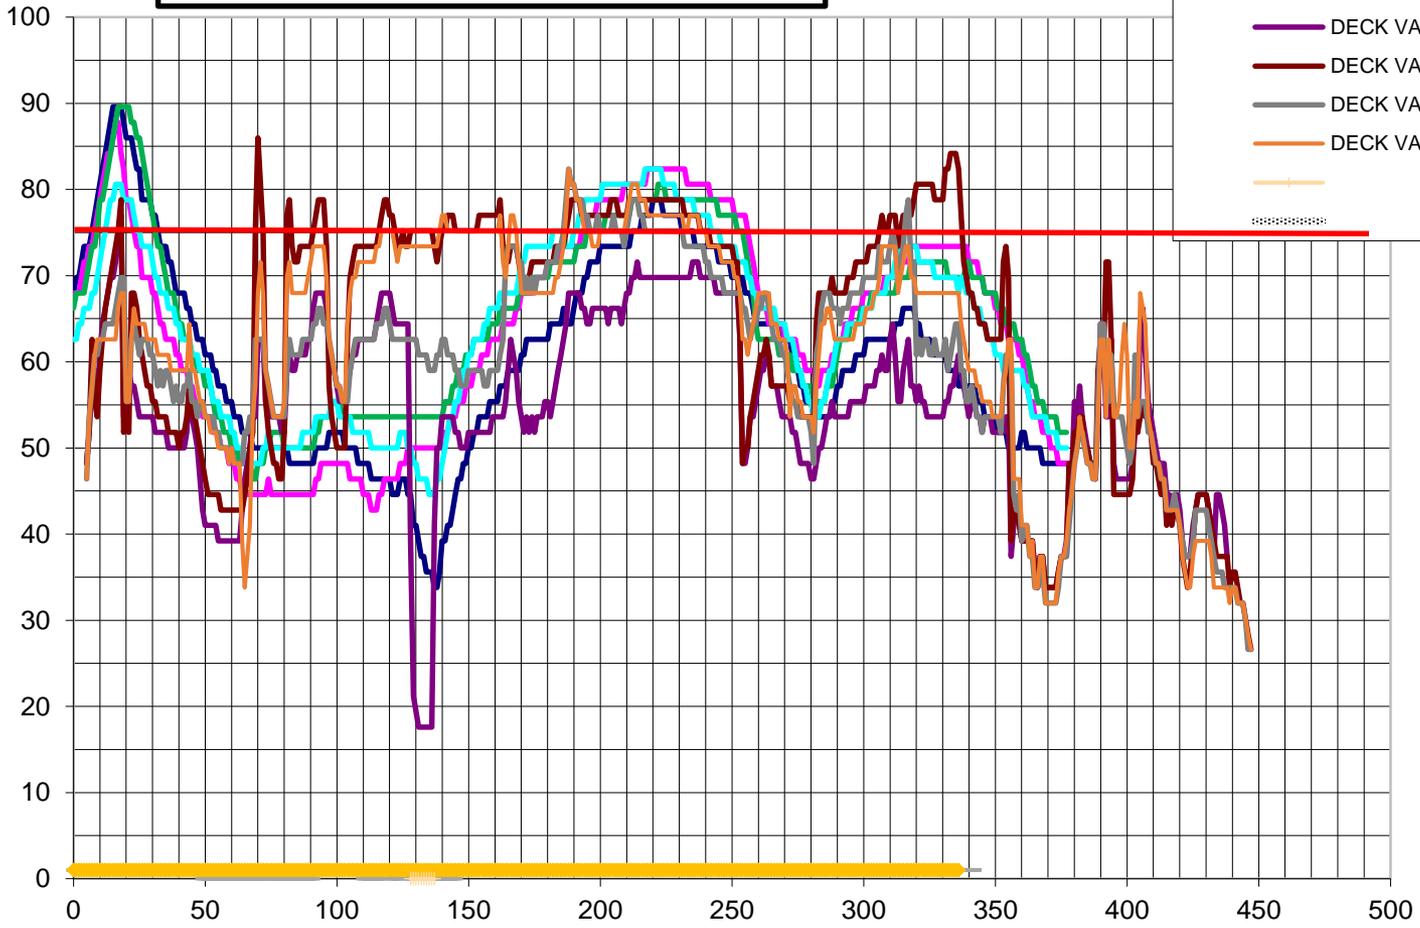
Varick Temperature Data

Logger Temperatures for K BRIDGE 1
Max Delta Temp: 57.6 °F @ 126 Hrs
Min Temp: 17.6 °F @ 125.52 Hrs, Max Temp: 89.6 °F @ 14.83 Hrs
Logger Start Date: 12/30/2015 2:41:37 PM
Last Download Date: 1/18/2016 11:29:15 AM

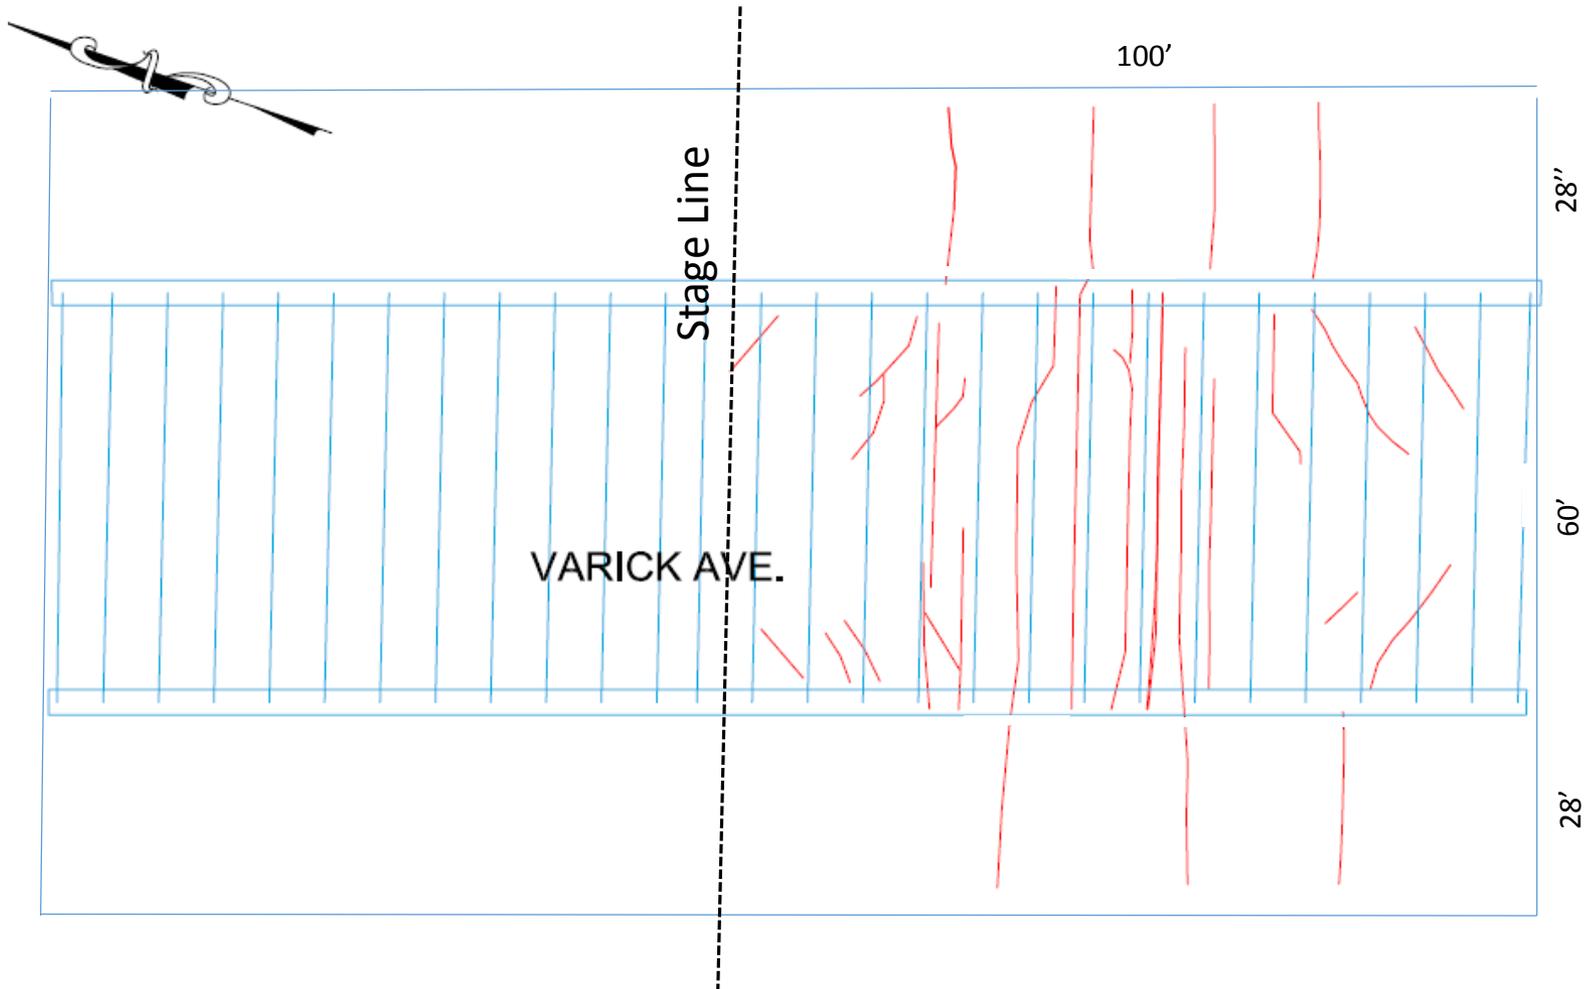
Varick Ave – The Result

- Used one Bidwell to travel the 100' transversely
- Winter conditions
 - glycol hoses top
 - burners underside -
 - avg. cure temp 75F at 18 hour mark
- Scrimped on water - mix too stiff – surface overworked
- Late in applying burlap cure – followed with blankets

- Restraint - steel stringers w/studs, deck dowels to abutments, no exp. Jnts -
- Does not act like a microsilica overlay
- Scrimping on water - great self desiccation, harder finishing, overworking the surface, longer time to place covers.
- Late in placing cure covers
- High curing temperatures –self desiccation and thermal shrinkage

- Removed SIP deck in spots on deck bottom to see if thru cracked
- Map out cracks to determine pattern
- Determine crack widths – greater than 0.007” to be sealed
- Seal cracks with MMA
- Finish with silane – two coats

- Seal all cracks over .007”
- Call in some experts
- Have someone at the plant for batching and moistures
- Add all the water
- Fog and set curing covers quickly
- Minimize placement temperatures
- Optimize Bidwell adjustment to minimize of overworking the surface
- For wide decks - use two Bidwell carriages on one truss to boost paving speed.

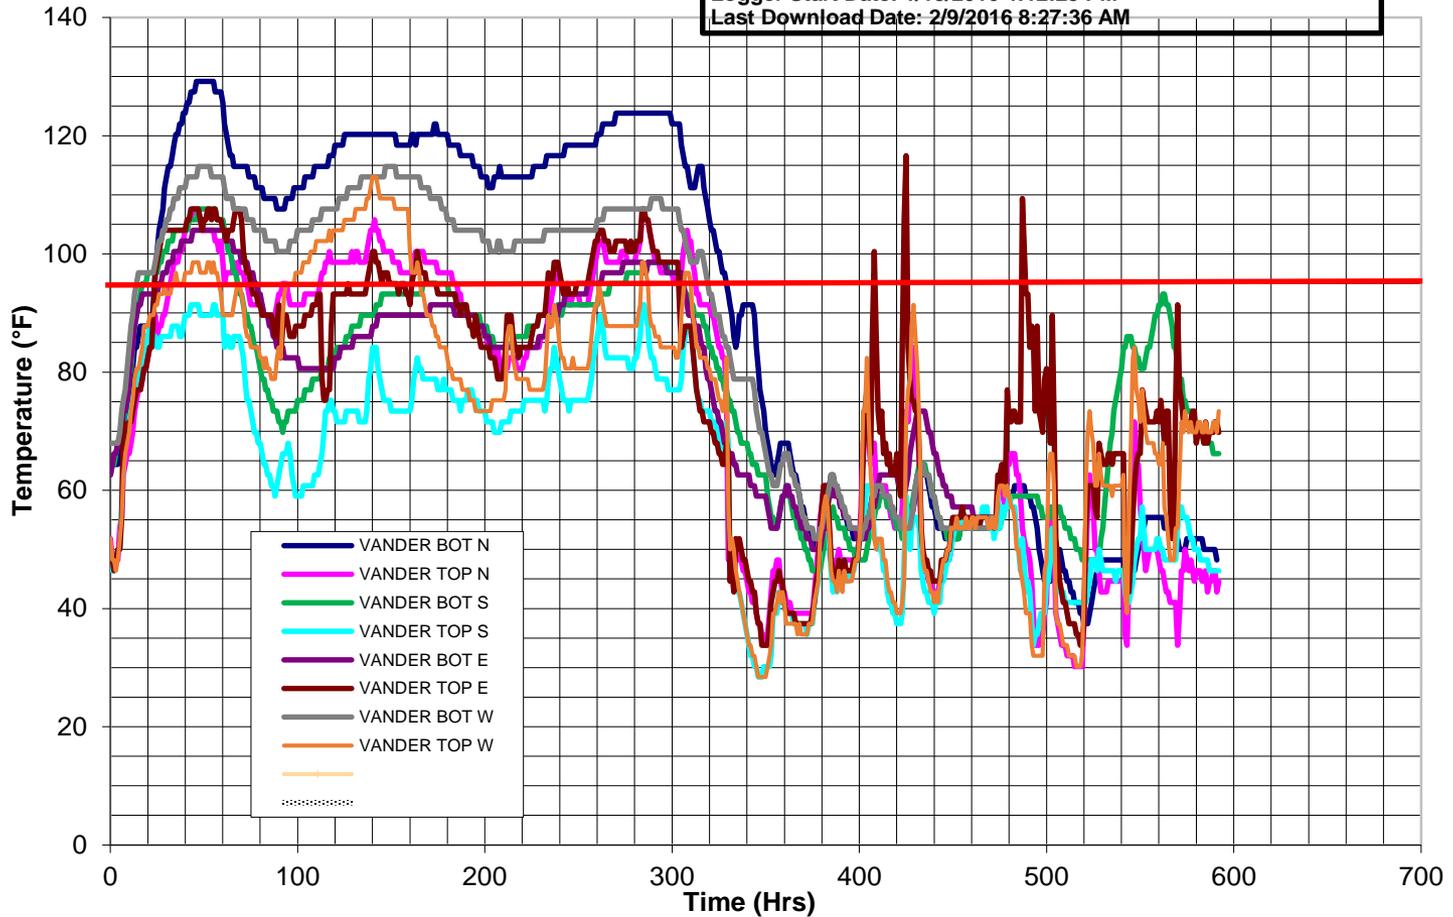
Vandervoort Temperature Data

Logger Temperatures for K BRIDGE 1
 Max Delta Temp: 64.8 °F @ 487 Hrs
 Min Temp: 28.4 °F @ 345.53 Hrs, Max Temp: 129.2 °F @ 45.73 Hrs
 Logger Start Date: 1/15/2016 4:12:25 PM
 Last Download Date: 2/9/2016 8:27:36 AM

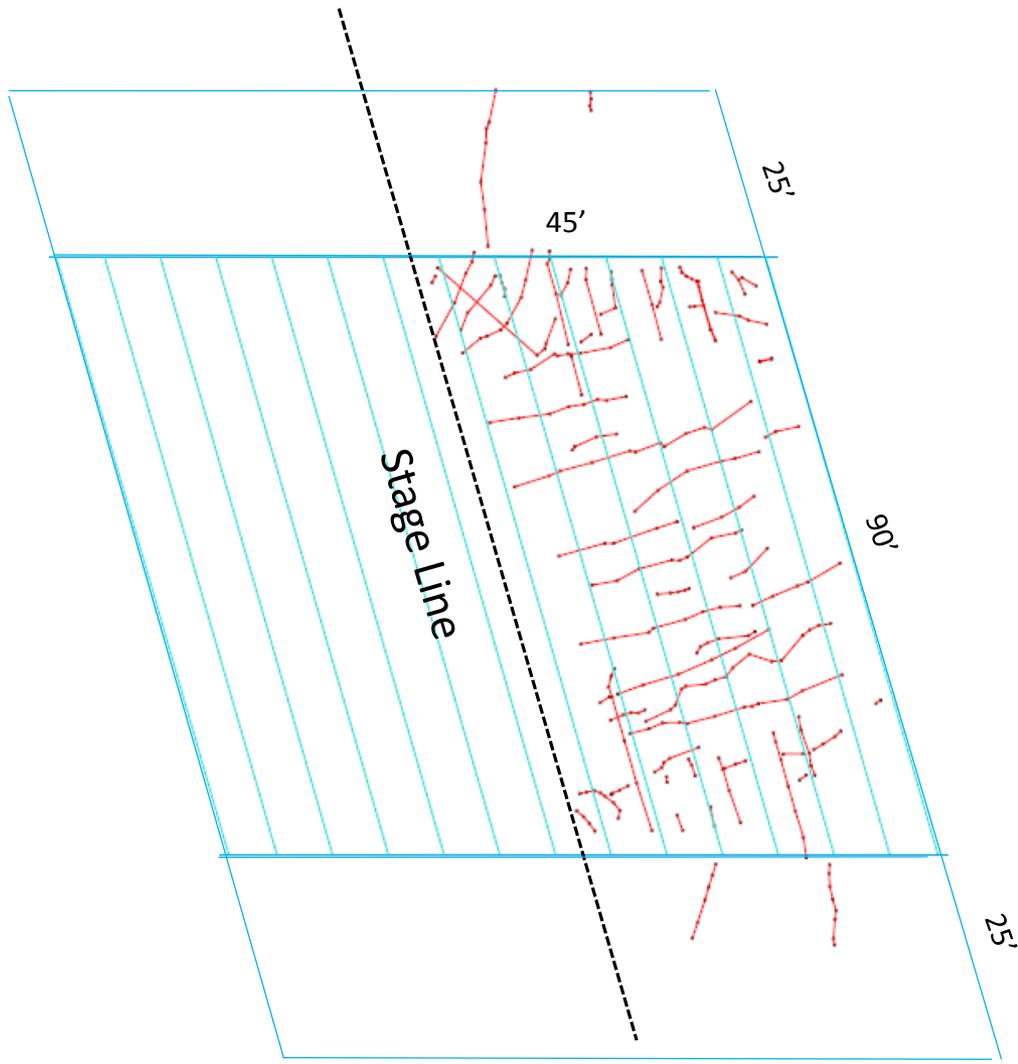
Vandervoort Ave – The Result

- Used one Bidwell to travel the 45' transversely
- Slump was workable
- Late in applying wet burlap cure
- Winter conditions
 - Glycol hoses top
 - Burners under and thru stringer bays
 - Avg. cure temp 94F at 24 hour mark

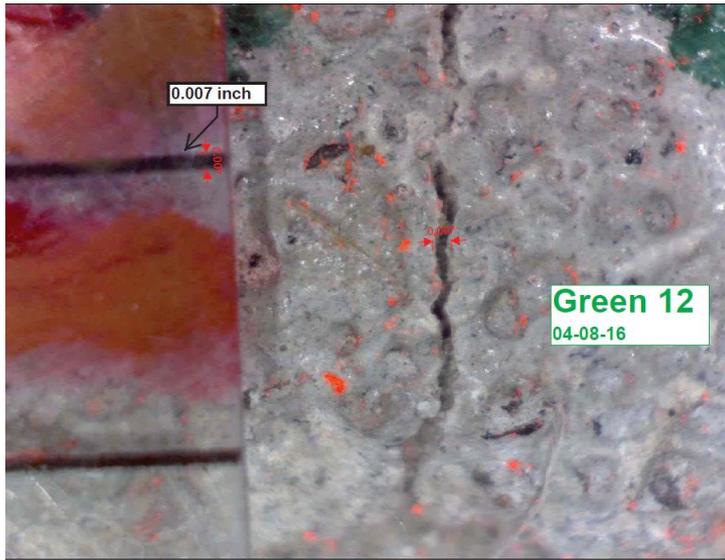
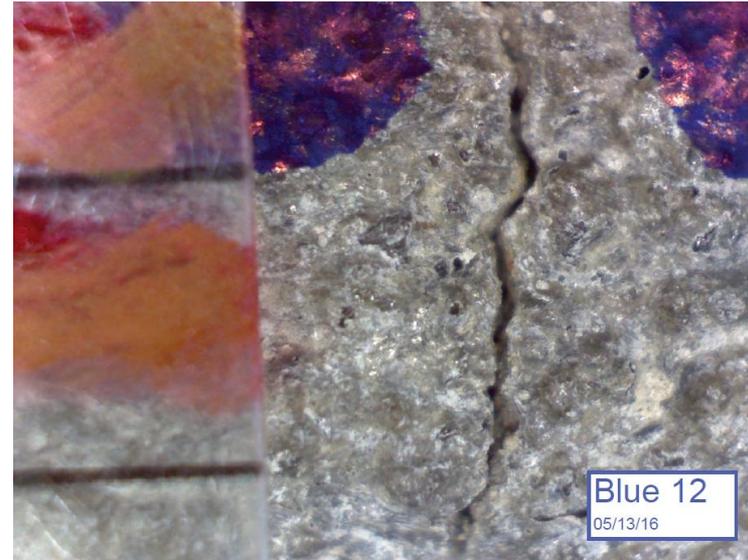
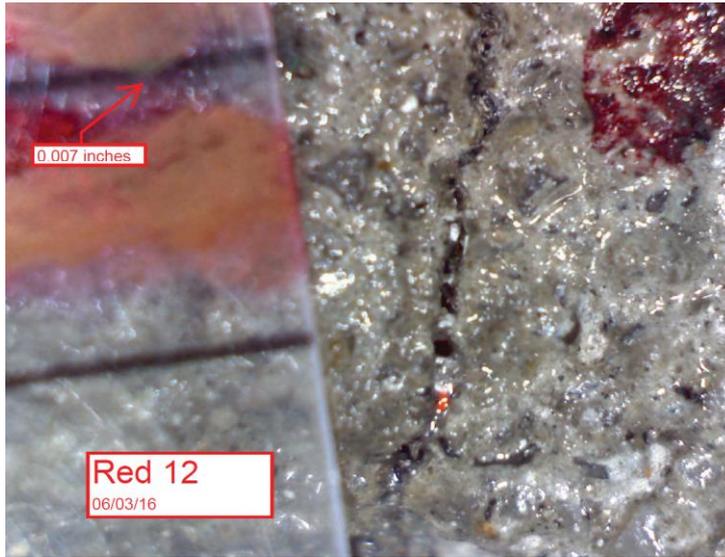
Crack #12 on three separate dates to confirm stability.

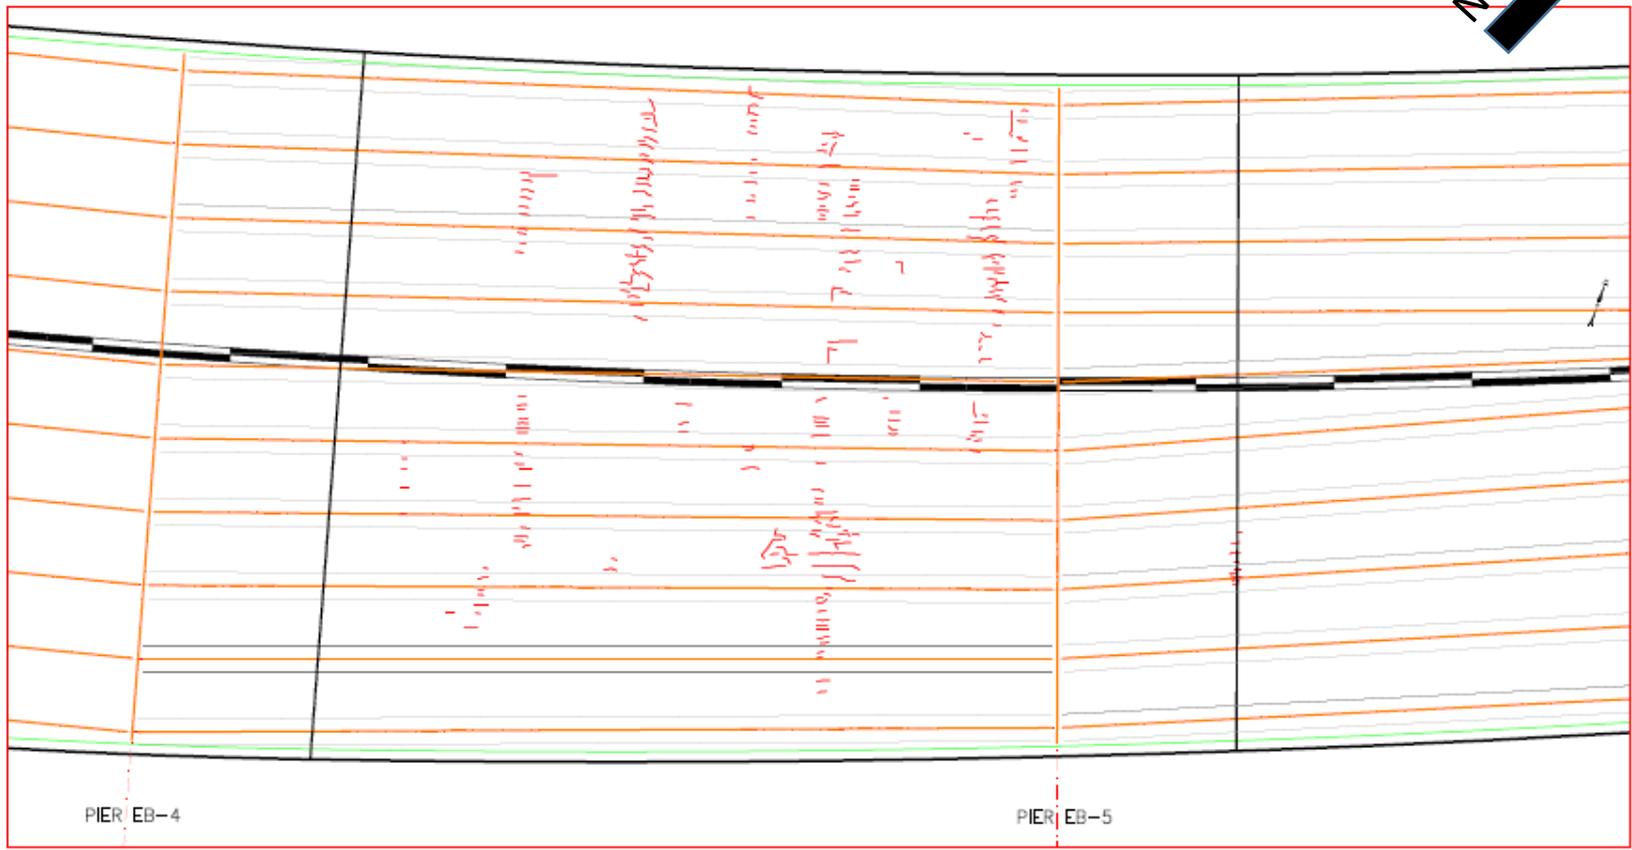
PLACEMENT 8 - SPAN 5 CRACK MAPPING

- Exhibiting short parallel cracking across the deck
- Areas appear dark gray when wet
- Rebar detector shows the cracks to be directly over the rebar.
- Plastic shrinkage cracks most likely - improper mixing - high concentrations of silica fume.
- No bleed water, so not likely settlement cracks
- It is unlikely they are full depth cracks.

- Those over .007" sealed with MMA
- Follow with two coats Silane sealer

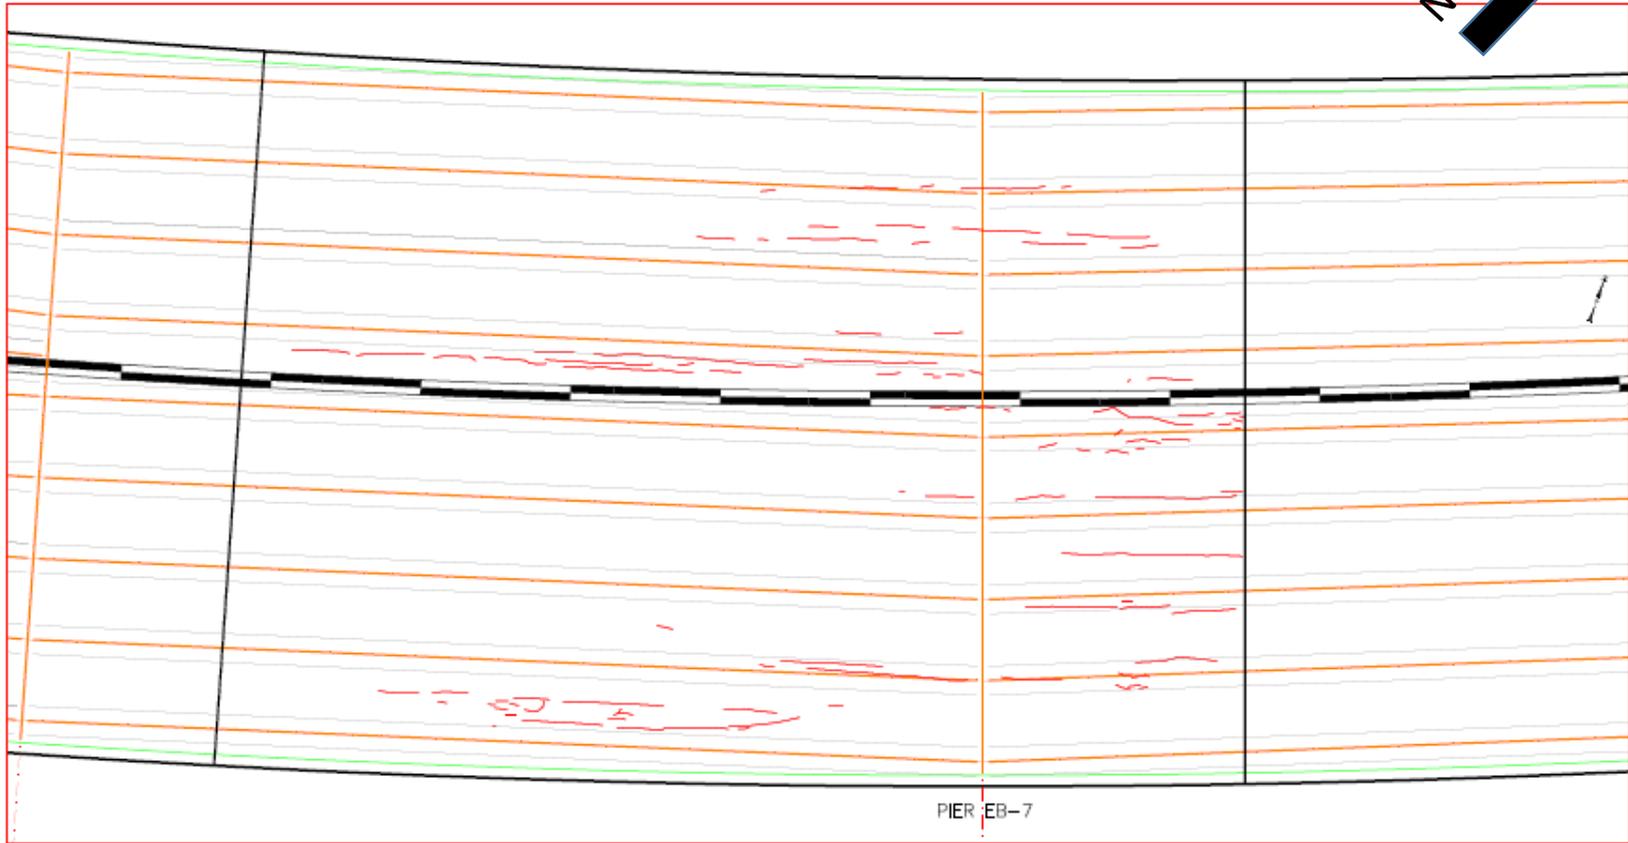
PLACEMENT 6 - SPAN 7, 8 CRACK MAPPING

- Exhibiting longitudinal continuous cracks spaced 8' apart, (same as the width of the curing covers)
- Cracks not in line with the AASHTO girders below.
- Single use natural cellulose fiber covers with perforated plastic membrane were replaced with re-useable nonwoven polypropylene covers with non perforated plastic membrane.
- This indicates they are plastic shrinkage cracks due to the covers not being properly wetted and blown off at the side laps
- It is unlikely they are full depth cracks.

- Those over .007" sealed with MMA
- Follow with two coats Silane sealer
