SÃO VICENTE  
SUSPENSION  
BRIDGE  
REHABILITATION  
AND CABLE  
SUBSTITUION

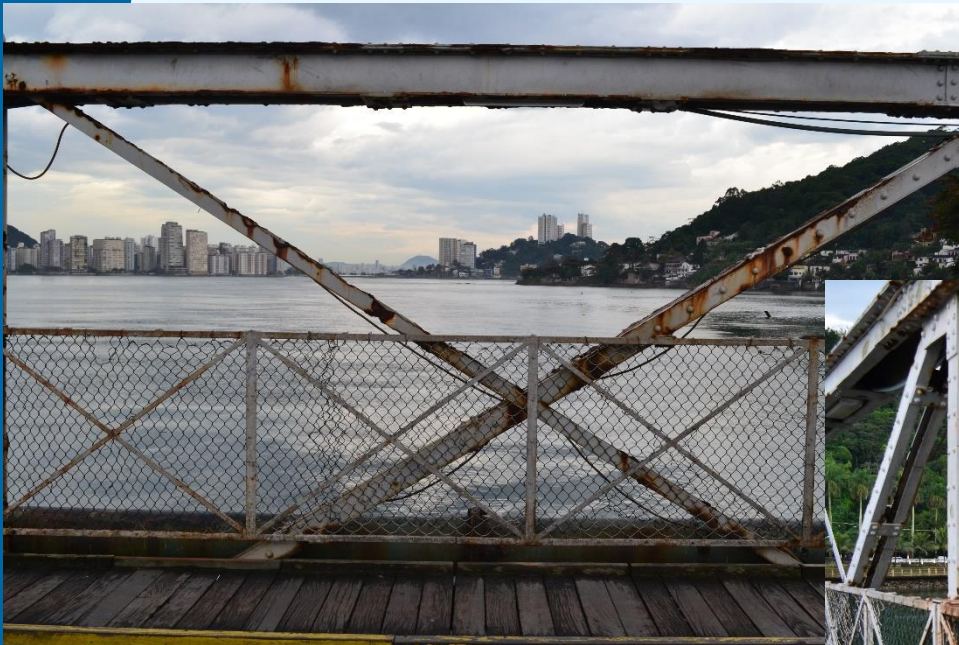
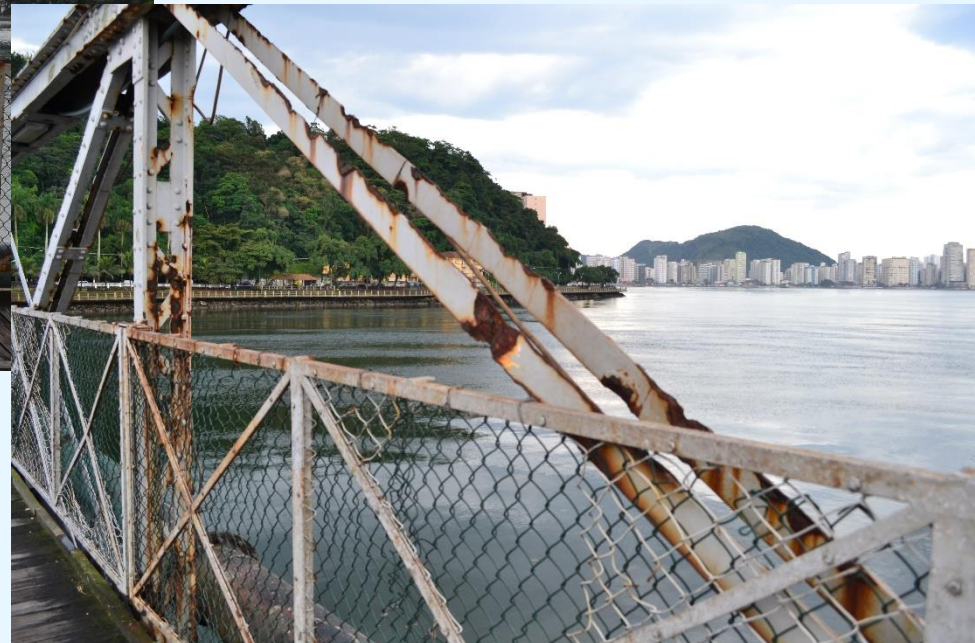
- Corrosion in steel elements

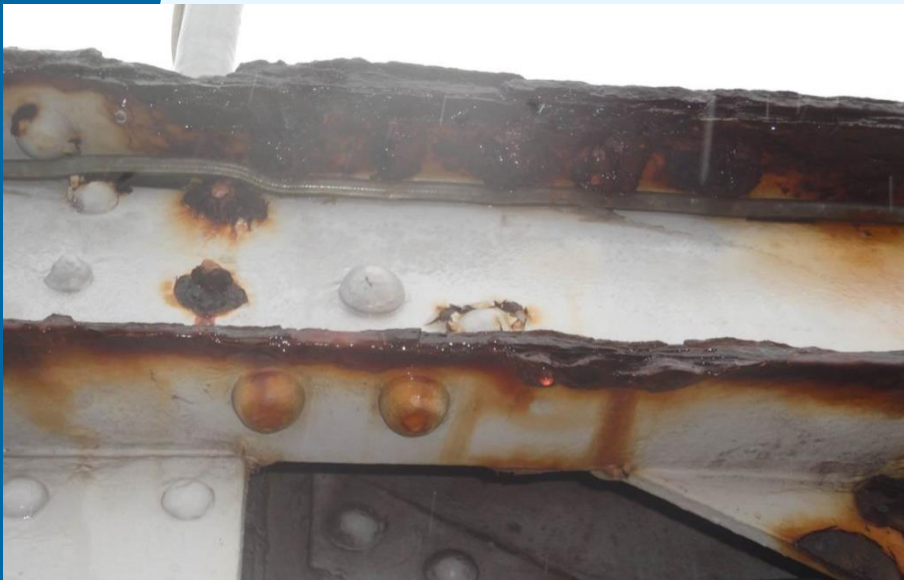
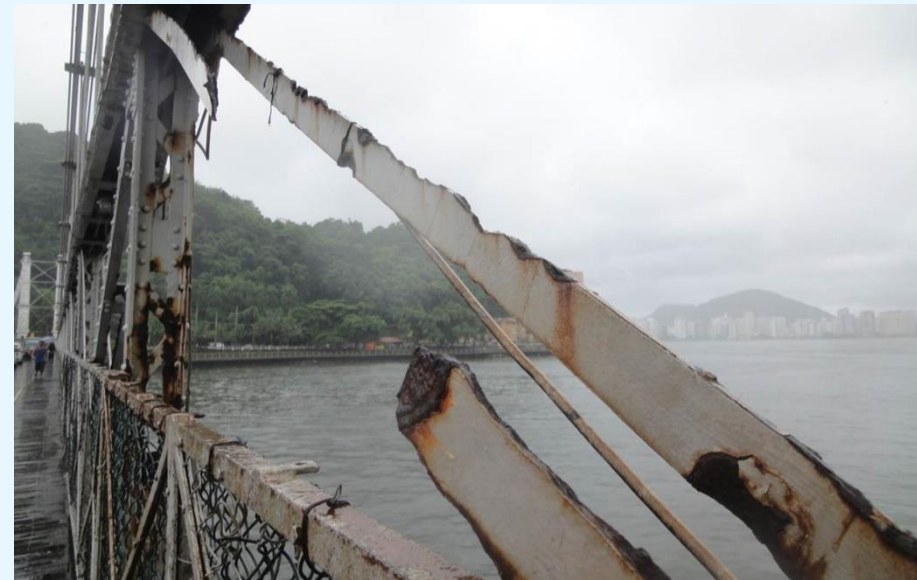
- Corrosion in steel elements

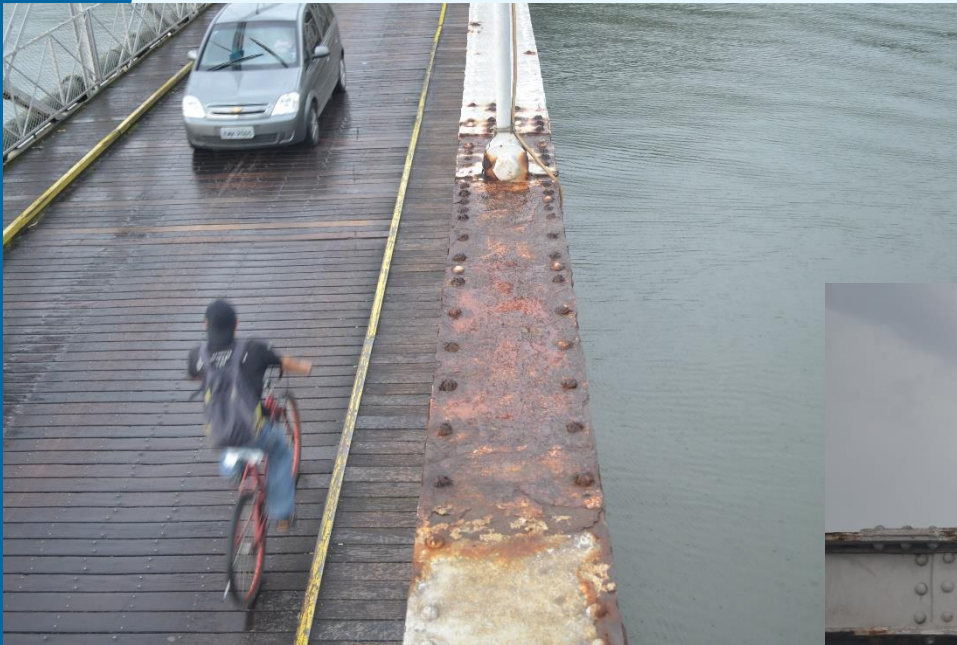
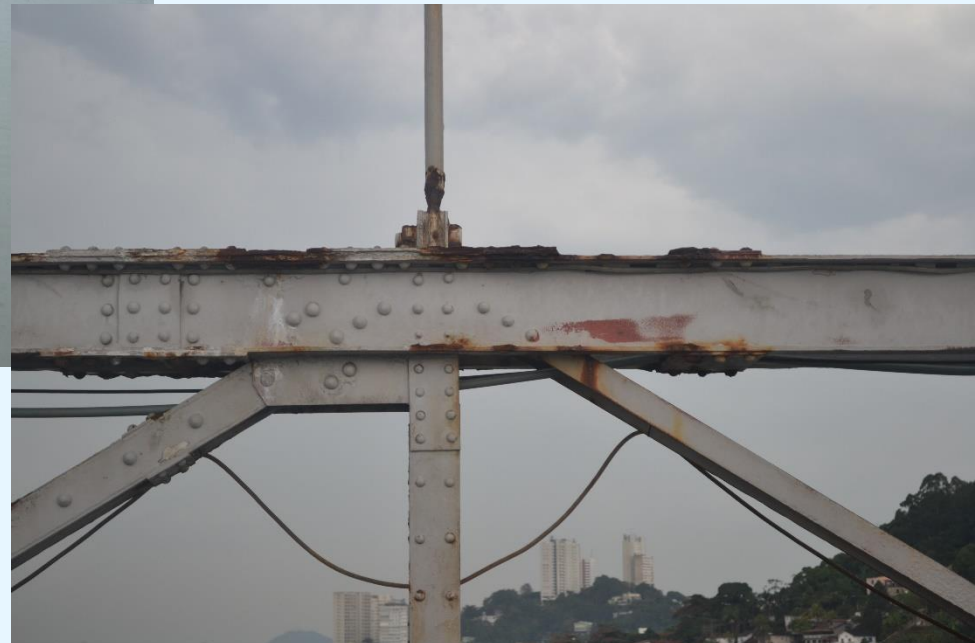
- Corrosion in steel elements

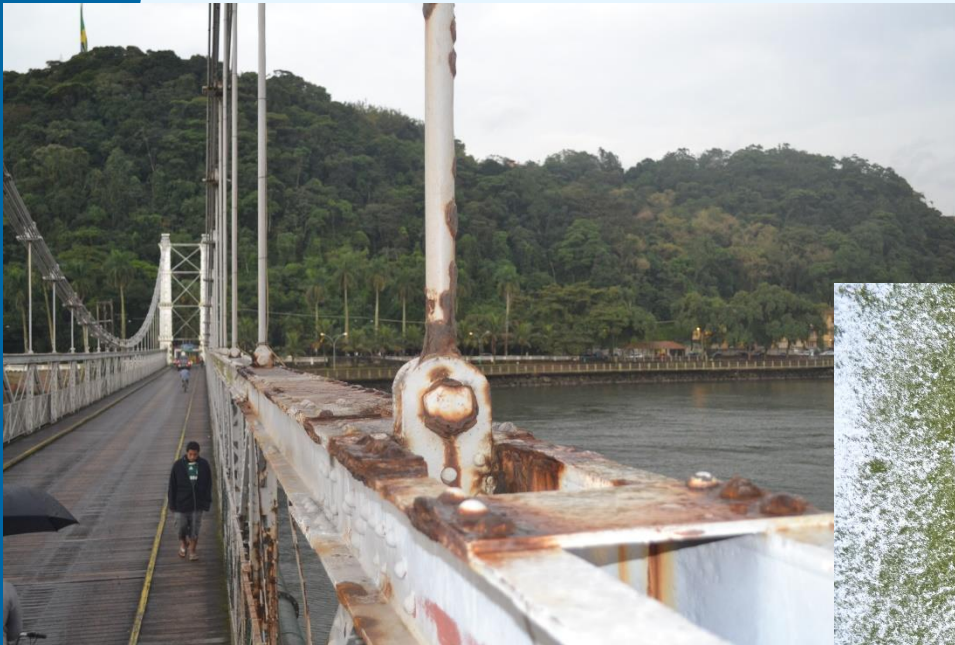
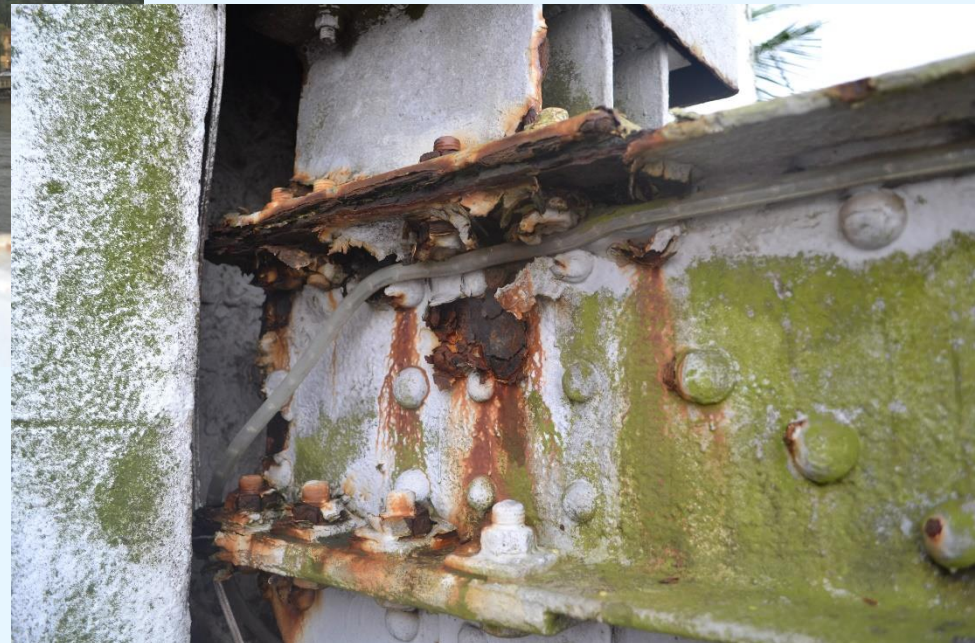
- Corrosion in steel elements

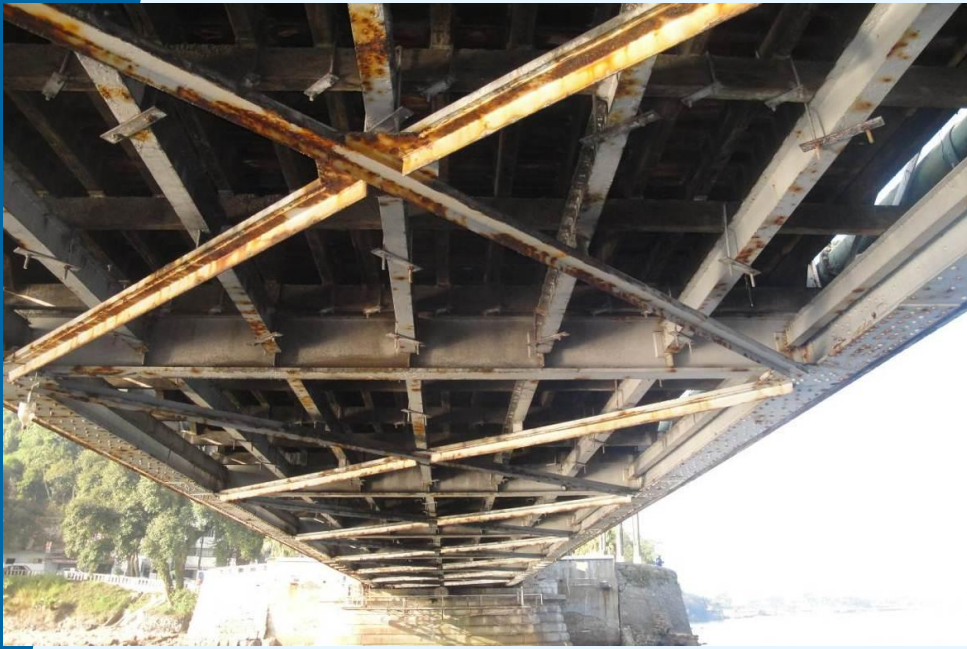
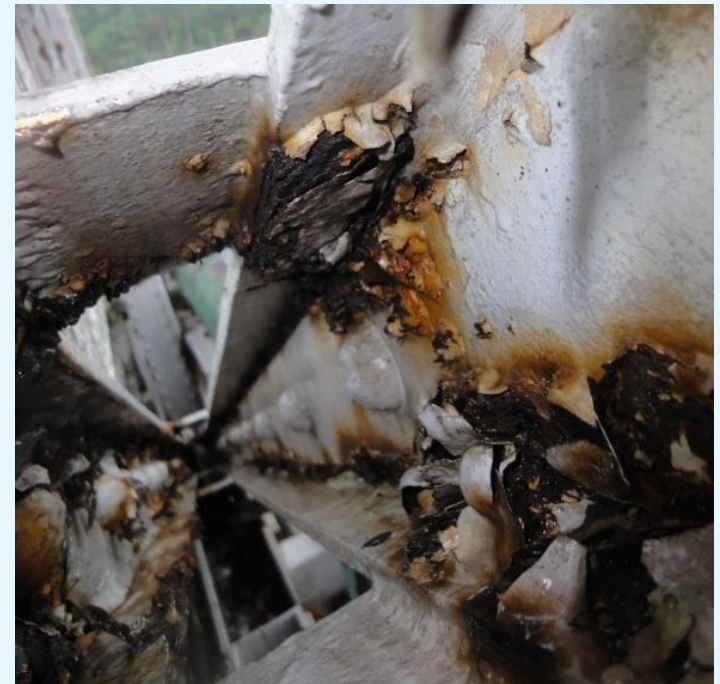
- Corrosion in steel elements

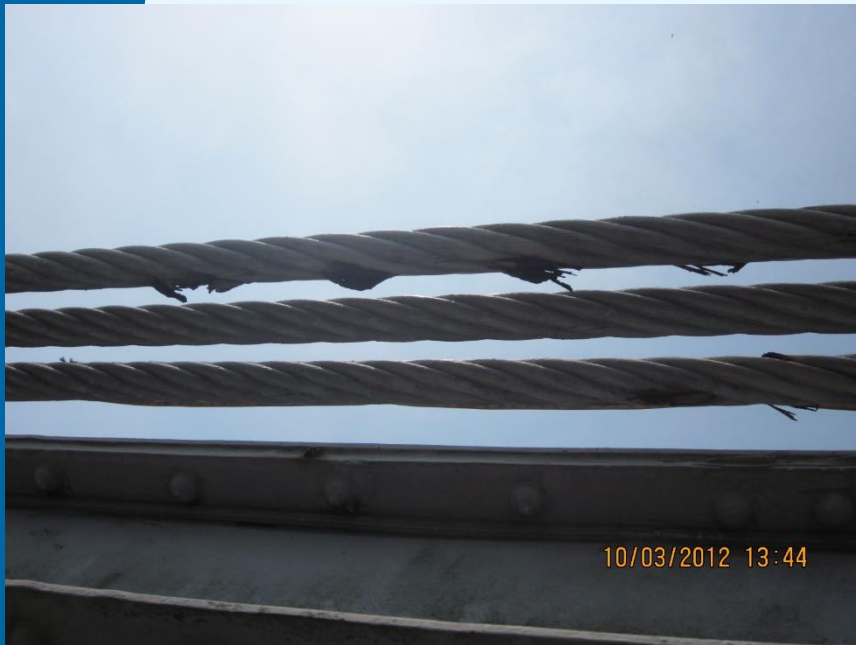
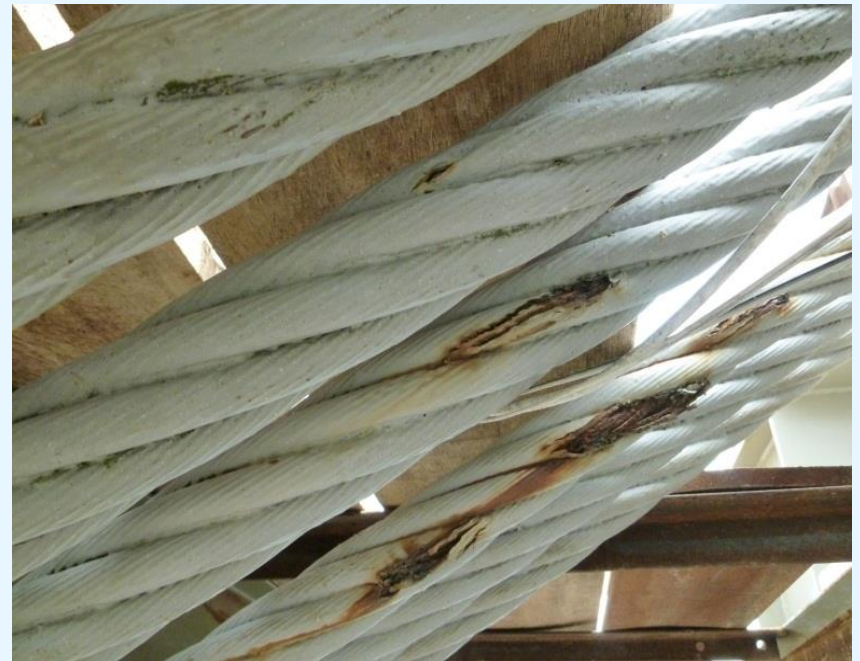
- Damaged and corroded support cables

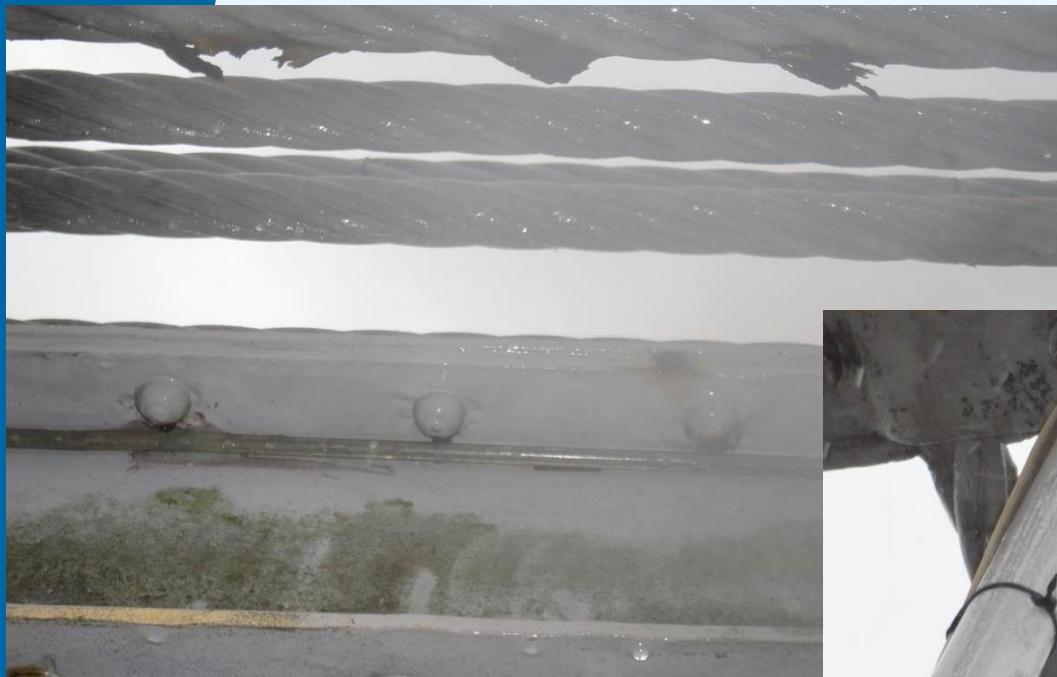
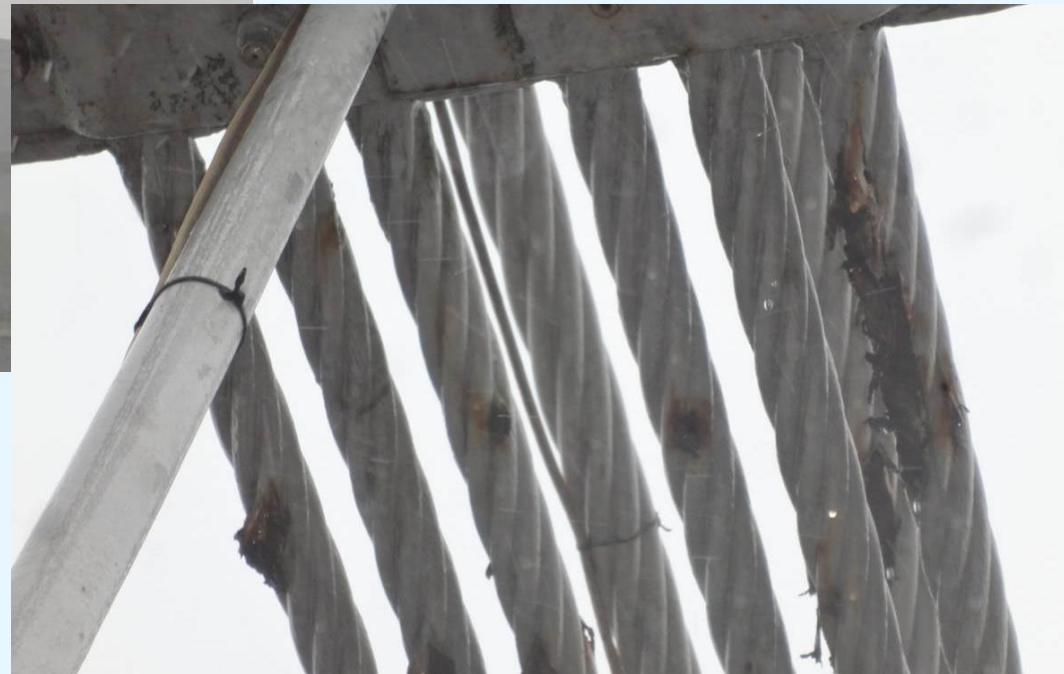
- Damaged and corroded support cables

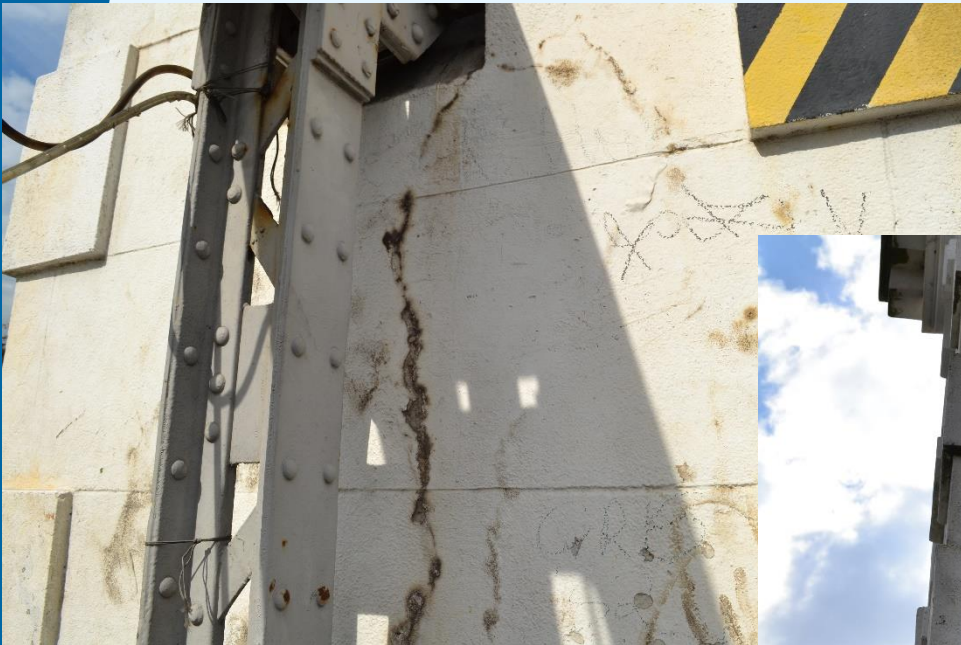
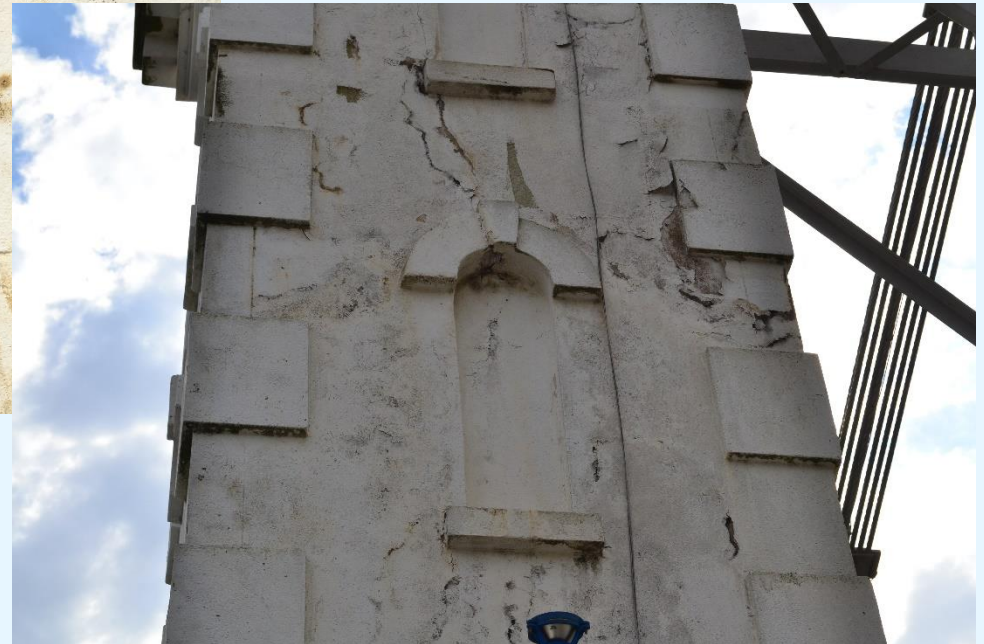
- Cracks on towers

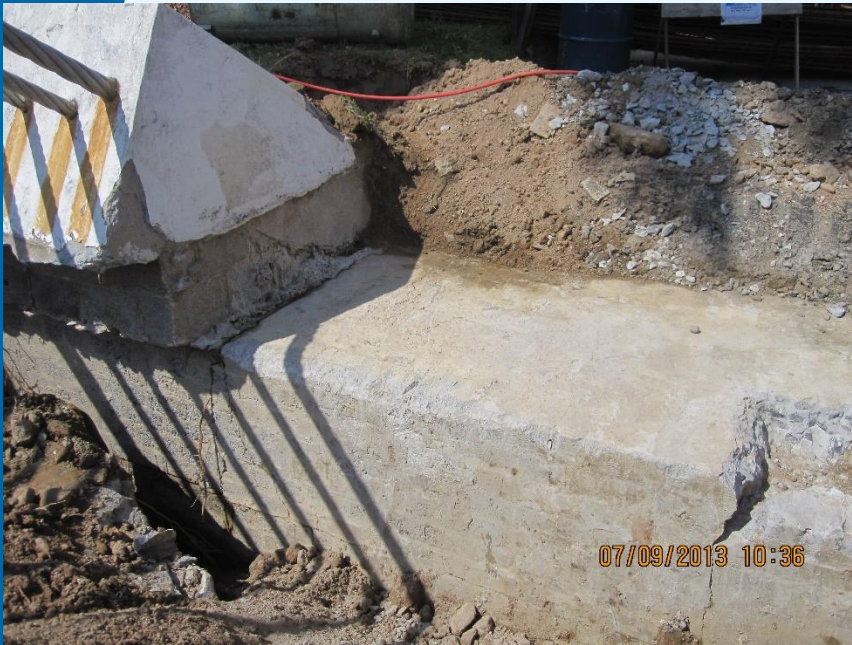
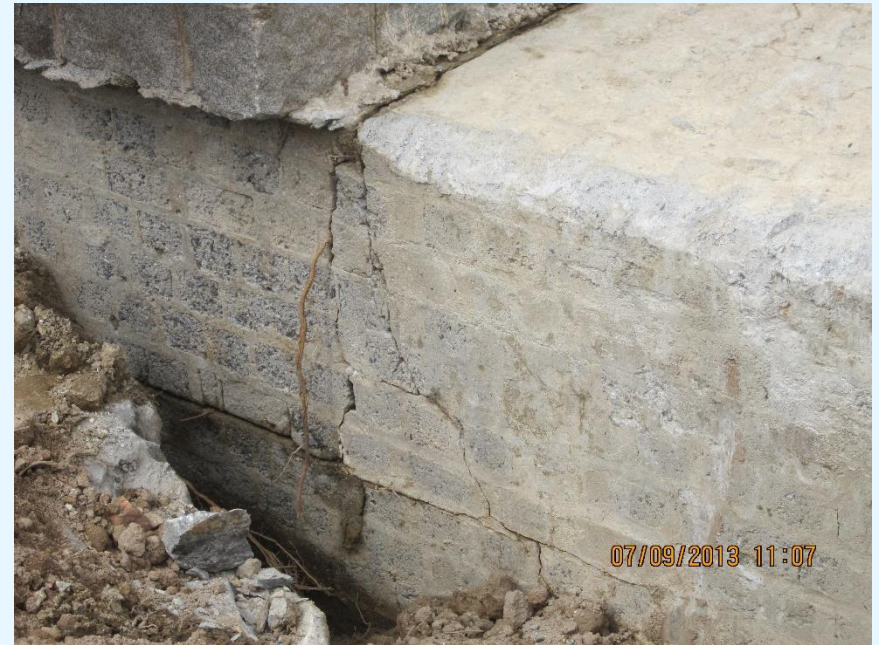
- Cracks in anchor blocks

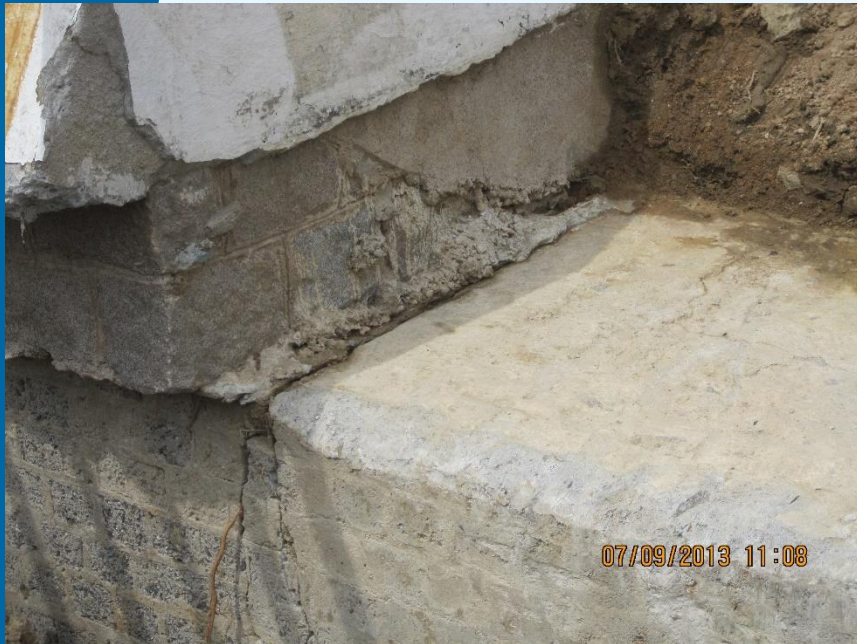
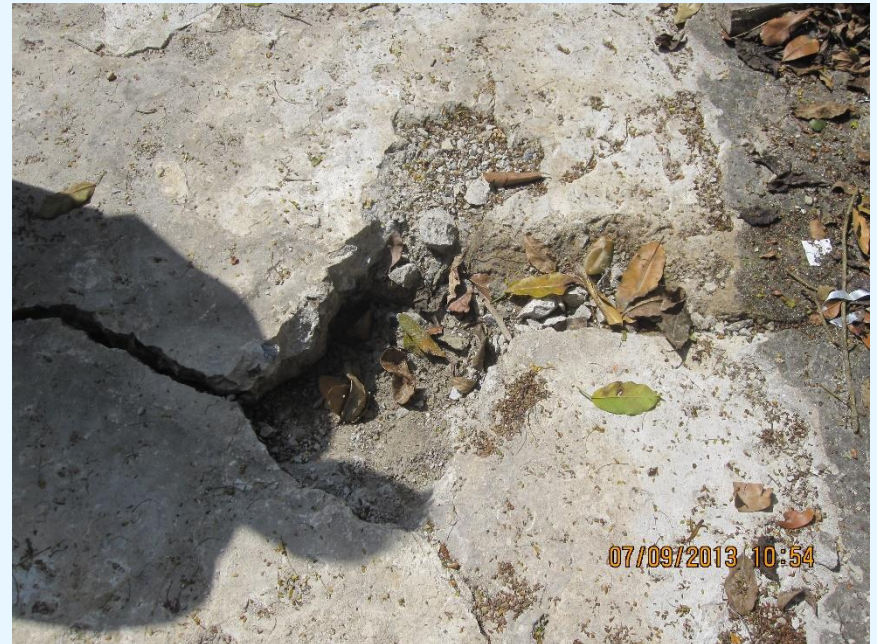
- Trincas em blocos de ancoragem
