# Reinforced Concrete Antenna Pedestal

Evaluation of concrete consolidation using nondestructive testing and statistical analysis

An antenna pedestal recently constructed at the Canberra Deep Space Communications Complex is the subject of this article. The pedestal is a cylindrical structure with a suspended roof slab. After the formwork had been removed, evidence of poor concrete consolidation was visible in the slab soffit. The general contractor contracted with several local testing firms to identify other deficiencies. These firms deployed ground penetrating radar (GPR) and ultrasonic pulse velocity (UPV) test methods, and they removed and tested concrete cores. However, they could find no correlation between the results of the core tests and the observations made using nondestructive test methods. Due to the inconsistency of the results, JPL decided to conduct its own investigation. CTLGroup, Skokie, IL, was contracted to conduct the investigation using alternative nondestructive test methods.

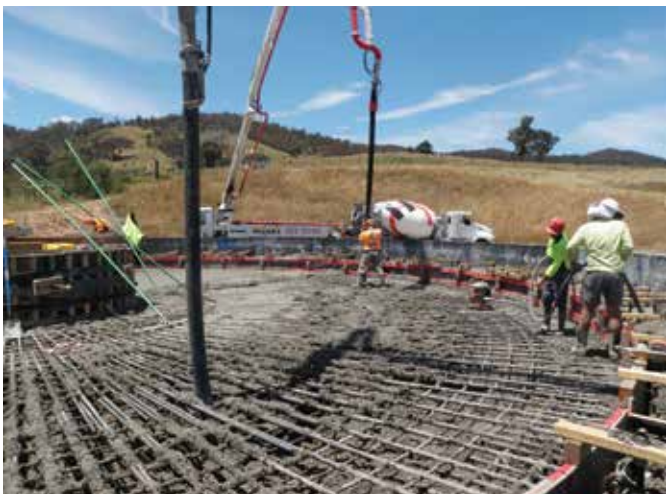
The contractor reported that concrete placement of the roof slab and outer track wall began by filling the outer track forms and adjacent main roof slab to near the roof slab final elevation. Placement then continued from the center outward, in wedge-shaped sections (Fig. 1). After the concrete in the outer track had stiffened enough to be filled above the main slab elevation, the final layer was placed and the lifts vibrated together. Experience has shown that the most likely problem areas would be the lift line between outer perimeter lifts and below the lap splices of the upper and lower reinforcing mats in the roof slab. This was at least partially confirmed by reports that the slab soffit had exhibited zones of poor concrete consolidation at the lower mat lap splices. These locations had been chipped to sound concrete by the time our investigation commenced.

Fig. 1: Concrete placement of the antenna roof slab. Note that the concrete vibrator is not being applied near either delivery point

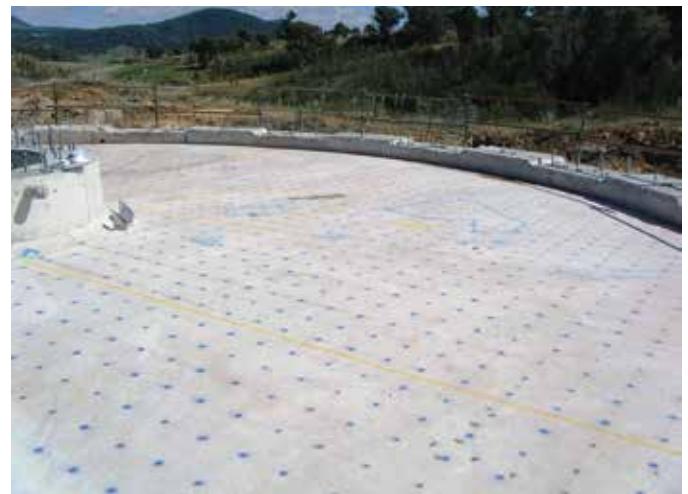
Fig. 2: Test grid marked on roof slab topside (blue lines outline underside concrete removal areas)

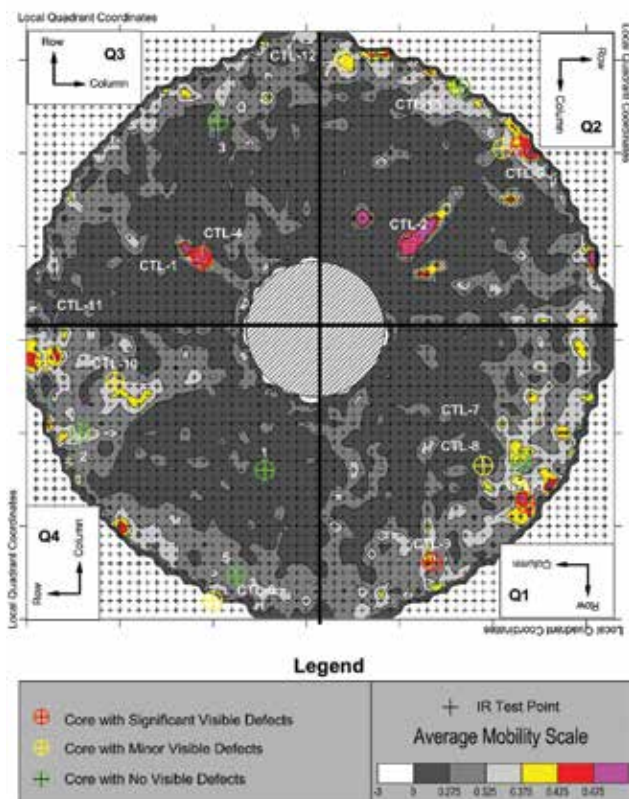
**Fig. 3: Topside impulse response (IR) average mobility results and core locations/condition**

The expected structural response (average of all areas without significant defects) used was an IR mobility value of 0.275 with a standard deviation of 0.05. These values were obtained from Q4, which had very few defects, and were roughly consistent with values from the overall data after high values were removed (that is, data with mobility values less than 0.425 or approximately 3 standard deviations from the mean). Approximately 95% of the values were within 2 standard deviations, 4% were between 2 and 4 standard deviations, and 1% were greater than 4 standard deviations from the mean. The IR results showed widespread low magnitude variation without visible signs of surface deterioration, indicating that subtle defects and material variations were probable.

For this project, significant voids produced average mobility values greater than 0.475. The value of 0.475 corresponds to about 4 standard deviations from the average response which, in our experience, is commonly associated with significant defects in similar structures. All cores removed in or adjacent to areas with mobility greater than 0.475 revealed significant defects (CTL-1, CTL-2, CTL-3, CTL-5, and CTL-9). All cores removed in or adjacent to areas with mobility greater than 0.425, but less than 0.475, revealed signs of concrete irregularities (CTL-6, CTL-11, and Core 6). All cores removed in or adjacent to areas with mobility values within 2 standard deviations of the mean exhibited only minor irregularities.

- A significant void or defect was presumed to exist at any location where the IR mobility test result was 0.475 or higher. These locations were marked for concrete repairs. Repair excavations were expanded as necessary to remove any defective concrete;

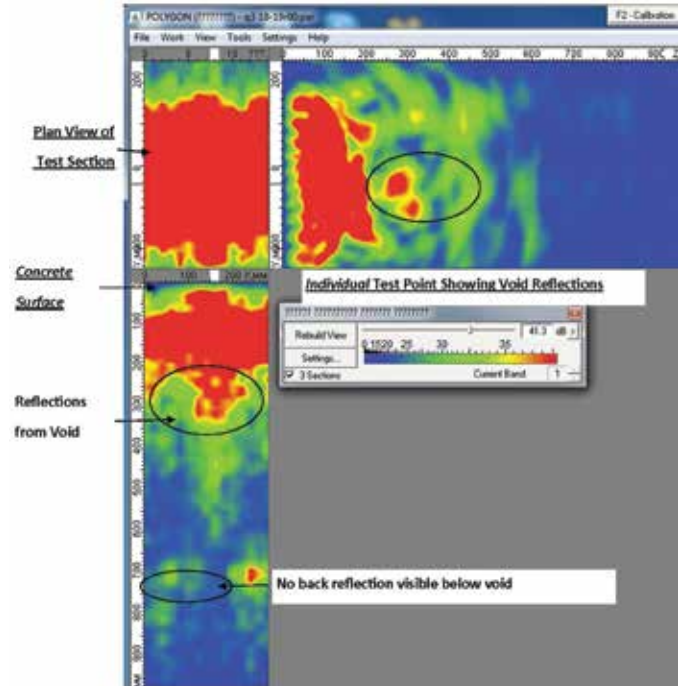
A significant void below the top reinforcing steel was distinguishable from the MIRA test results (Fig. 4) at the location of core CTL-2. However, in areas with material variations such as an increase in entrapped air pockets or the cold joint at the location of core CTL-3, significant defects could not be readily distinguished by MIRA.

Fig. 4: MIRA data showing a void below the upper reinforcing steel near the location of core CTL-2

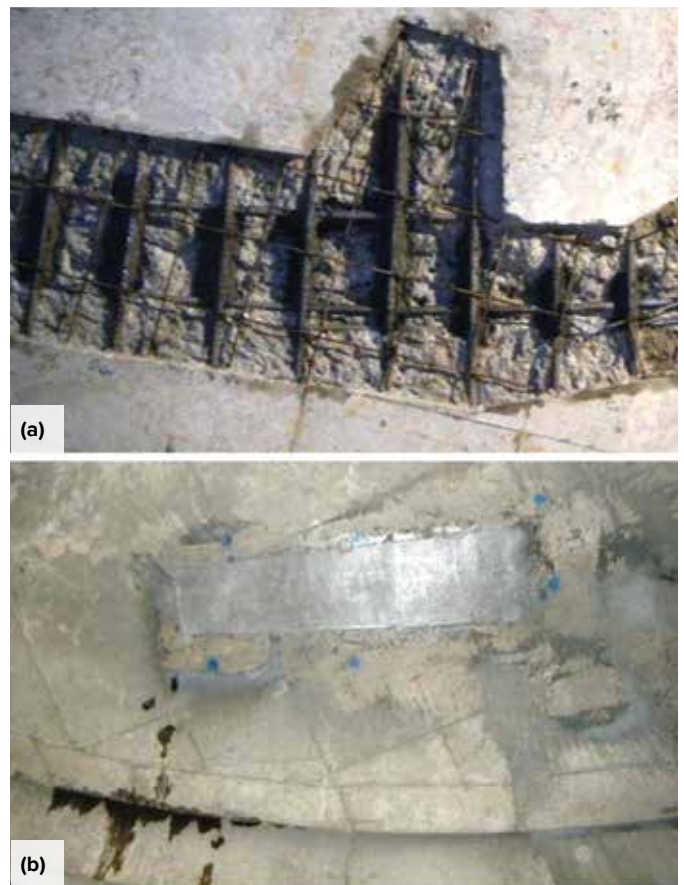
Fig. 5: Shotcrete soffit repair: (a) prepared soffit cavity and mortar packed above reinforcing steel; and (b) completed shotcrete repair

- Soffit—As expected, and as demonstrated by the IR test results, significant defects on the slab underside were primarily limited to the lap splice zones under the lower reinforcing mat. Shotcrete was selected as the repair material for the soffit repairs. Due to the presence of large diameter bars and laps, cavity areas above reinforcing steel were filled with trowel-grade mortar prior to shotcrete application. The preparation, cavity filling, and final shotcrete repair are shown in Fig. 5;
- Perimeter Track—Presence of significant reinforcing in perimeter track walls precluded the use of nondestructive testing techniques. Therefore, a combination of visual inspection and careful exploratory concrete removal was

used to identify areas of concrete for removal and replacement. Voids encountered were generally associated with areas of laps in reinforcing bars. In addition to the repairs stemming from concrete placement delays, a poor bond between the wall placement and the roof slab placement was observed in localized areas; these areas were selected for epoxy injection repairs; and

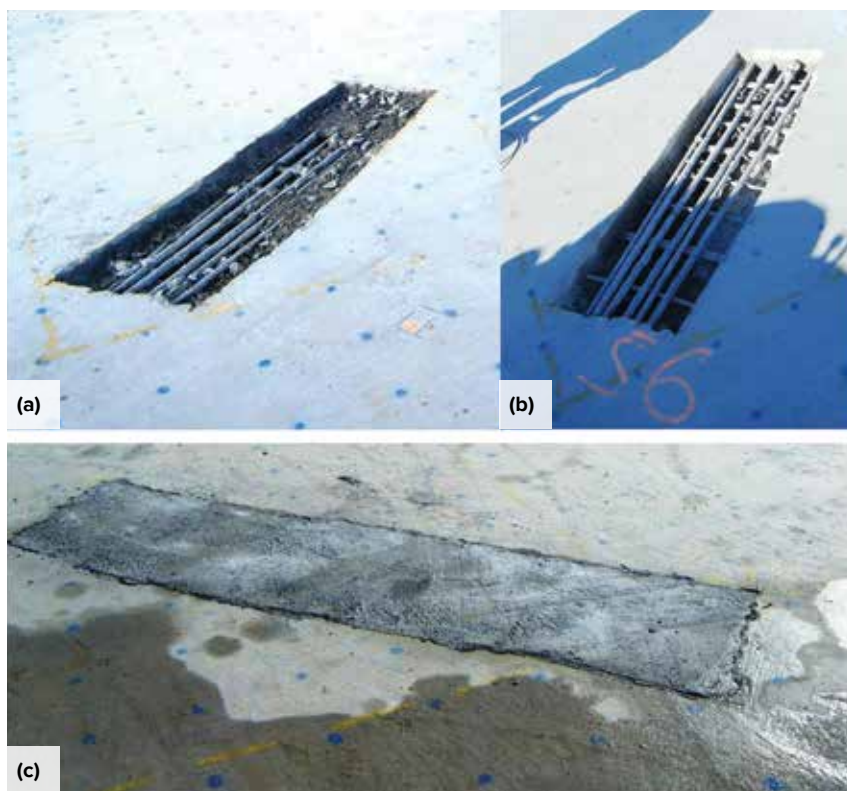
**Fig. 6: Top surface repair area: (a) initial chipping of marked repair area; (b) completed chipping and inspection; and (c) completed repair**

- Top surface—Concrete repairs of the top surface were “remove and replace” operations. The repair extents and completed repair of the relatively large voided area identified at core location (CTL-2) can be seen in Fig. 6. The protocols for top surface repairs were primarily based off the IR test results:
