The Institute's Team for Damage Investigations

Lessons learned from field deployments

by Lucas A. Laughery, Aishwarya Y. Puranam, Christopher L. Segura Jr., and Anahid A. Behrouzi

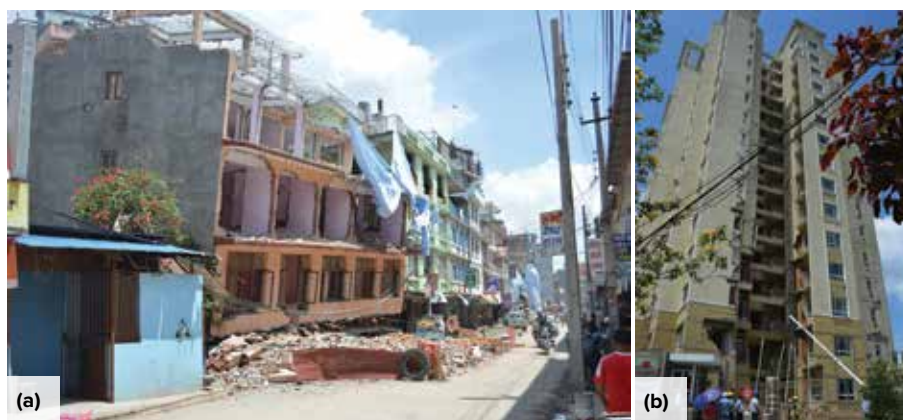
partition walls. Figure 3 shows severe damage to unreinforced masonry infill in low-rise and high-rise buildings.^{18,19} Collapse of the first story in the low-rise building (left) demonstrates the soft-story vulnerability. More information about the reconnaissance can be found in Shah et al.²⁰

Fig. 3: Buildings damaged in the 2015 Nepal Earthquake: (a) low-rise building (after Reference 18, licensed under CC BY-SA 3.0); and (b) high-rise building (after Reference 19, licensed under CC BY-SA 3.0)

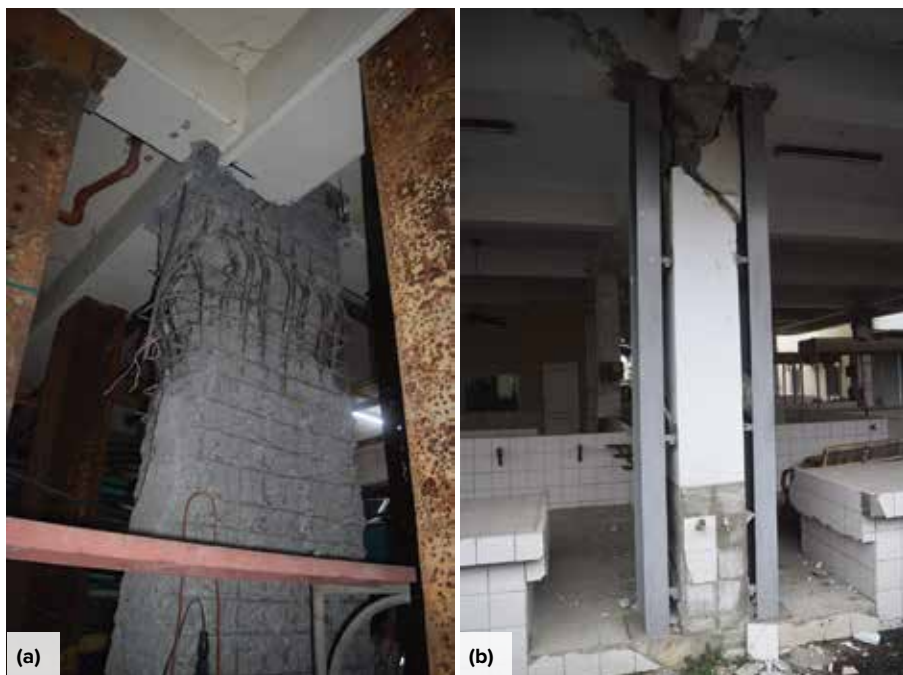
Much damage was observed in Tainan City, approximately 40 km (25 miles) from the epicenter. Reports suggested that most fatalities resulted from the collapse of a 14-story residential building. ACI Committee 133 deployed a team in March 2016, supported in part by the National Science Foundation (NSF), to join researchers from the Taiwanese National Center for Research on Earthquake Engineering (NCREE) to investigate the effects of the earthquake on RC structures. Over 12 days, 119 low-rise school, residential, and government buildings and 11 structures between eight and 23 stories tall were surveyed around Tainan City. In addition to conventional techniques, teams used aerial drones to collect videos of structures. Members of the ACI team investigated the failure of a corner column in a 14-story building in Tainan City, and they concluded that the failure was the result of axial demands imposed from discontinuous RC walls intended to function as partitions.²¹ The team also conducted an evaluation of four different seismic vulnerability screening indices, including that proposed by Hassan and Sozen¹⁶ and another then used in Taiwan. Figure 4 shows damage that was observed in columns in two different buildings.²²

Fig. 4: Damage to columns in the 2016 Taiwan Earthquake: (a) axial compression failure; and (b) shear failure (after Reference 22, licensed under CC BY-NC-SA 4.0)

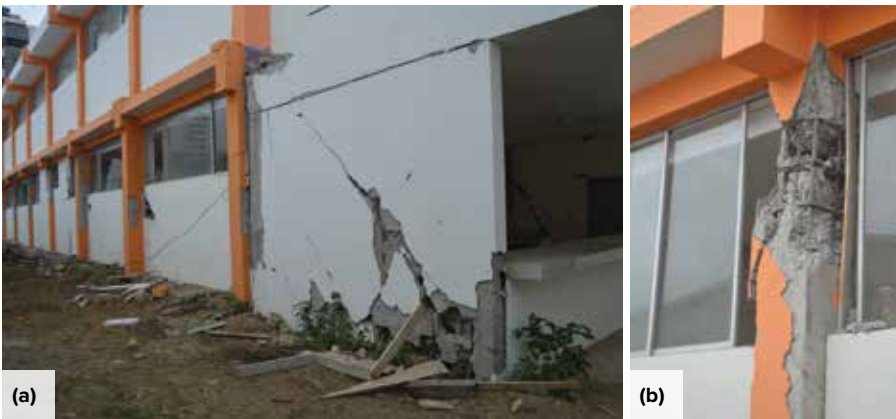
On April 16, 2016, a M_w 7.8 earthquake shook coastal Ecuador, causing severe damage to and collapse of structures, particularly around the coastal province of Manabí. Thousands of aftershocks were reported in the following months. In July 2016, ACI Committee 133 deployed a team that, together with faculty and students from Escuela Superior Politécnica del Litoral (ESPOL), surveyed RC buildings over a period of 8 days. The buildings ranged from one to six stories in height. Most of the buildings had masonry infill walls. Figure 5 shows examples of damage observed in RC frame buildings.²³

Fig. 5: Damage caused in two buildings by the 2016 Ecuador Earthquake: (a) shear failures in masonry infill walls; and (b) shear failure in a short, ground-level column above infill walls (after Reference 23, licensed under CC BY-SA 3.0)

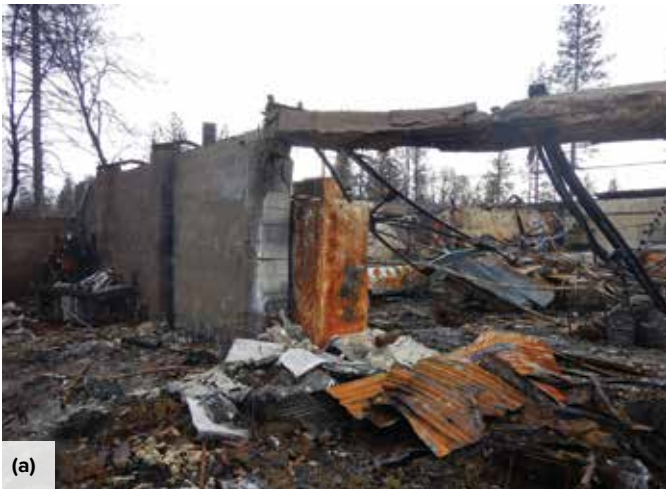
Fig. 9: Remains of buildings destroyed in the Camp Fire: (a) Stratton Market; and (b) Paradise Elementary School (photos courtesy of Erica Fischer)

(Fig. 9(a)). One school building, Paradise Elementary School, had RC columns and timber framing. It also completely collapsed due to the fire (Fig. 9(b)). The ACI team also documented damage to a three-story residential building with RC framing. The fire caused buckling of the building's corrugated metal roof, cracking and spalling around flexural reinforcement in RC roof beams, and vertical splitting and spalling of third-story columns.

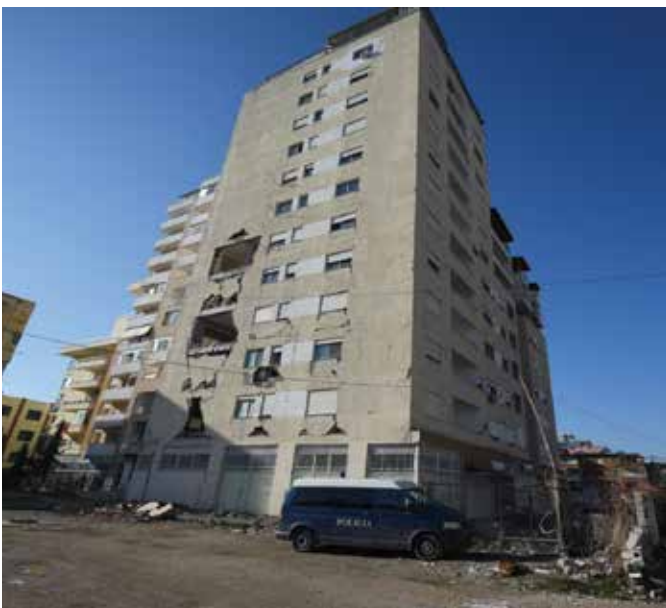
Fig. 10: A damaged mid-rise RC-frame building in Albania

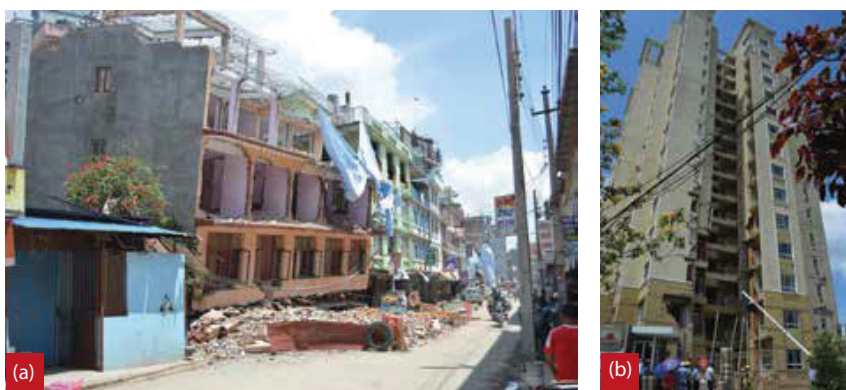
La Figura 3 muestra daños severos al relleno de mampostería no reforzada en edificios de baja y gran altura.^{18,19} El colapso del primer piso en el edificio de baja altura (izquierda) demuestra la vulnerabilidad de la historia blanda. Se puede encontrar más información sobre el reconocimiento en Shah et al.²⁰

Fig. 3: Edificios dañados en el terremoto de Nepal de 2015: (a) edificio de poca altura (después de la Referencia 18, con licencia CC BY-SA 3.0); y (b) edificio de gran altura (después de la Referencia 19, con licencia CC BY-SA 3.0)

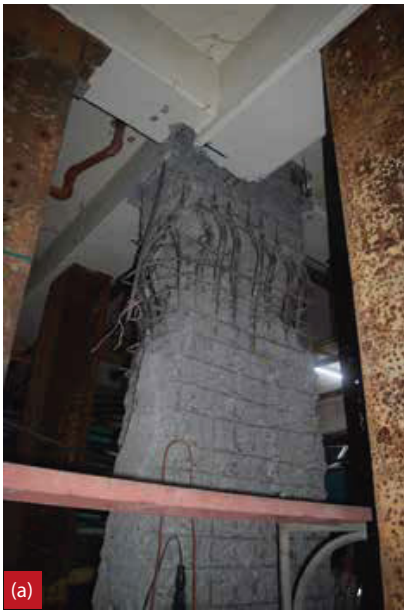
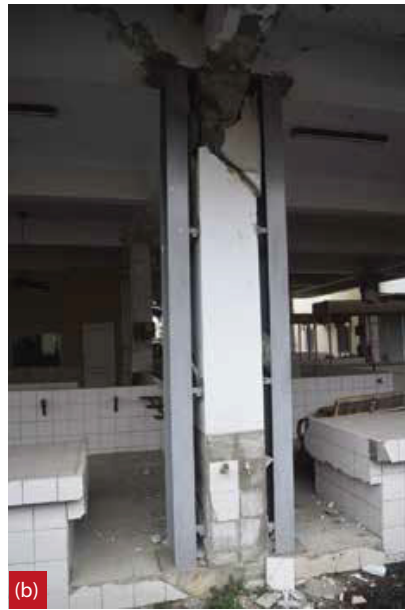
Fig. 4: Daños a columnas en el terremoto de Taiwán de 2016: (a) falla por compresión axial; y (b) falla por corte (después de la Referencia 22, con licencia CC BY-NC SA 4.0)

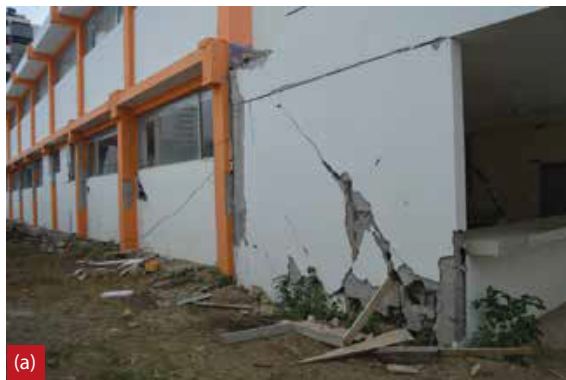
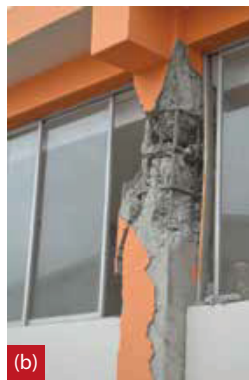
Fig. 5: Daños causados en dos edificios por el Terremoto de Ecuador de 2016: (a) fallas de corte en muros de relleno de mampostería; y (b) falla por cortante en una columna corta a nivel del suelo por encima de las paredes de relleno (después de la Referencia 23, con licencia CC BY-SA 3.0)

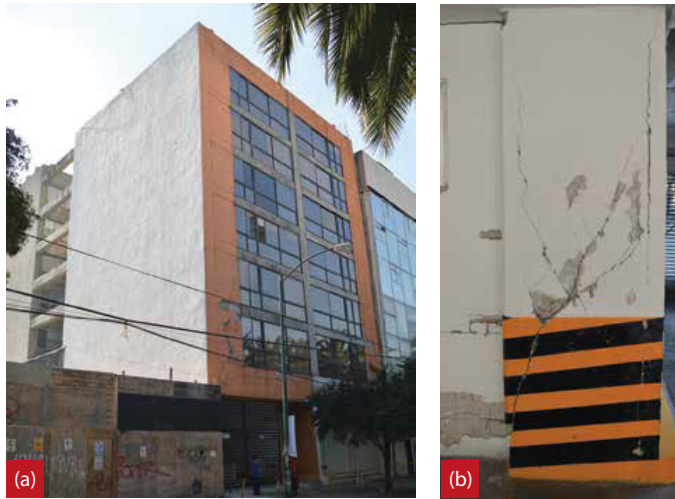
Fig. 6: Un edificio residencial típico afectado por el terremoto de Puebla de 2017: (a) los marcos de borde orientados perpendicularmente a la calle tenían muros de relleno continuos y no presentaban daños significativos; y (b) los marcos de borde orientados paralelos a la calle tenían muros de relleno y fenestración y exhibían fallas por corte en las columnas del primer piso (después de la Referencia 26, con licencia CC BY-NC-SA 4.0)

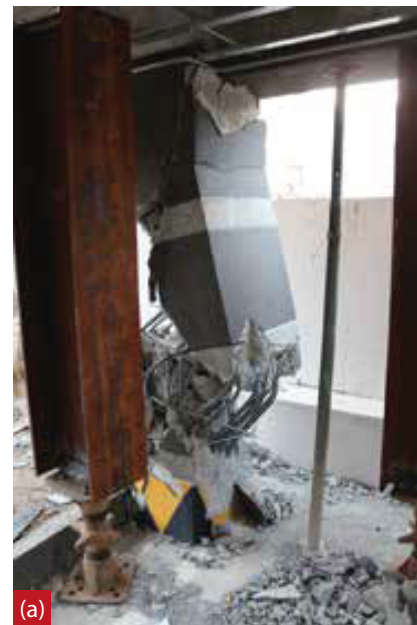
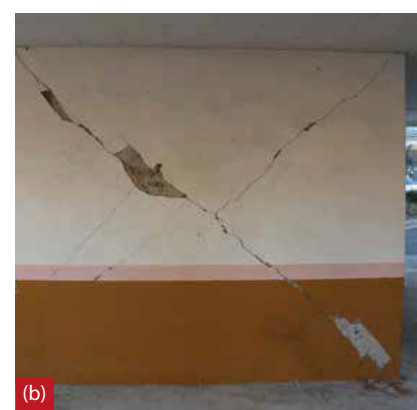
Fig. 7: Daño observado a las estructuras de RC en el terremoto de Pohang de 2017: (a) una columna del primer piso; y (b) un muro estructural en otro edificio (después de la Referencia 28, con licencia CC BY 3.0)

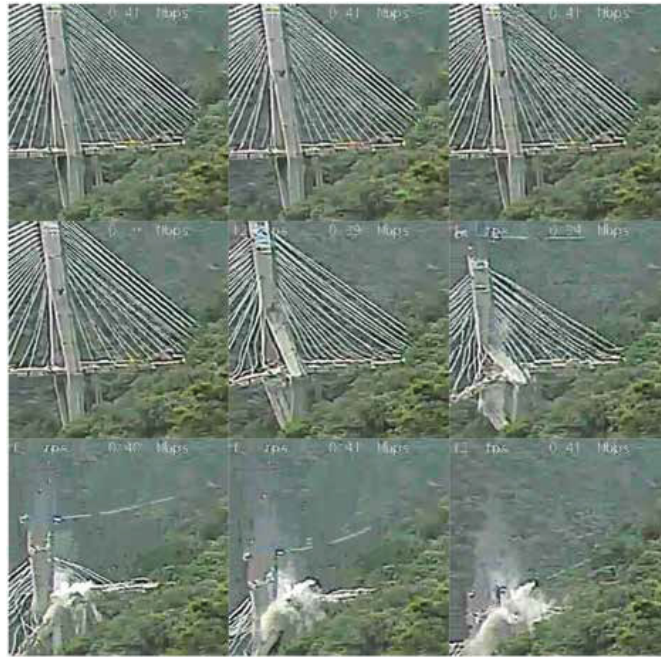
El equipo evaluó las imágenes del colapso (Fig. 8) y realizó inspecciones en el lugar utilizando un telescopio, cámaras y sistemas de aviones no tripulados (Unmanned Aircraft Systems UAS). Una revisión de los dibujos de diseño reveló que la losa de la torre, que aparentemente estaba destinada a actuar como un amarre en la mitad de las torres de soporte en forma de diamante, tenía un refuerzo longitudinal insuficiente para soportar la condición de carga por gravedad estimada en la torre en el momento del colapso. Los hallazgos de la investigación del equipo del Comité 133

Fig.8: Secuencia de falla de la torre oeste del puente Chirajara (después de la Referencia 29)

de ACI ilustran la importancia de 1) exceder las proporciones mínimas de refuerzo del Código en elementos críticos para permitir la propagación de deformaciones inelásticas, evitando así un comportamiento frágil como resultado de concentraciones de deformaciones; y 2) el proceso de revisión por pares, específicamente para estructuras complejas. Los detalles de la investigación se pueden encontrar en Pujol et al.²⁹

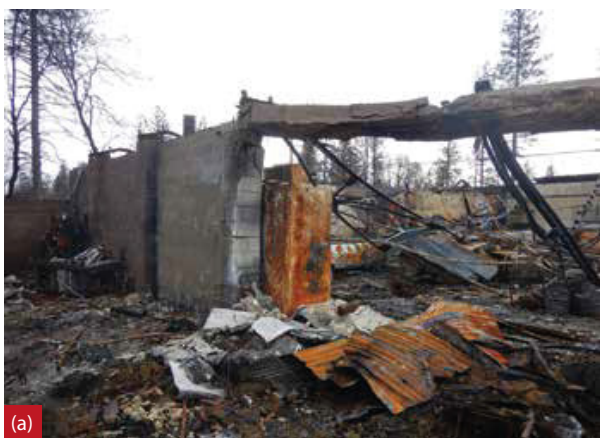
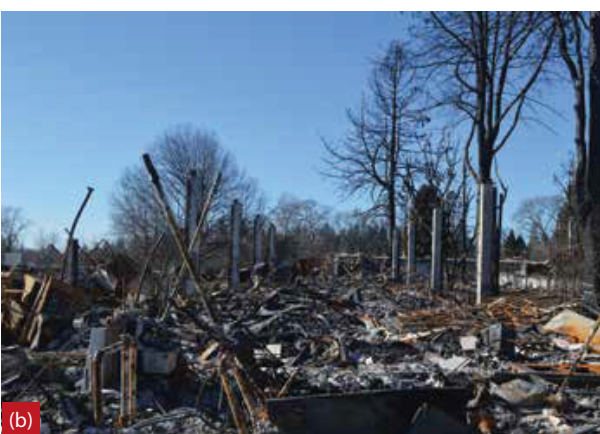
Fig. 9: Restos de edificios destruidos en Camp Fire: (a) Stratton Market; y (b) Escuela Primaria Paradise (fotos cortesía de Erica Fischer)

Un edificio escolar, Paradise Elementary School, tenía columnas de CR y entramado de madera. También colapsó por completo debido al fuego (Fig. 9 (b)). El equipo de ACI también documentó los daños a un edificio residencial de tres pisos con estructura RC. El incendio provocó el pandeo del techo de metal corrugado del edificio, agrietamiento y astillado alrededor del refuerzo de flexión en las vigas del techo de RC, y división vertical y desconchado de las columnas del tercer piso.

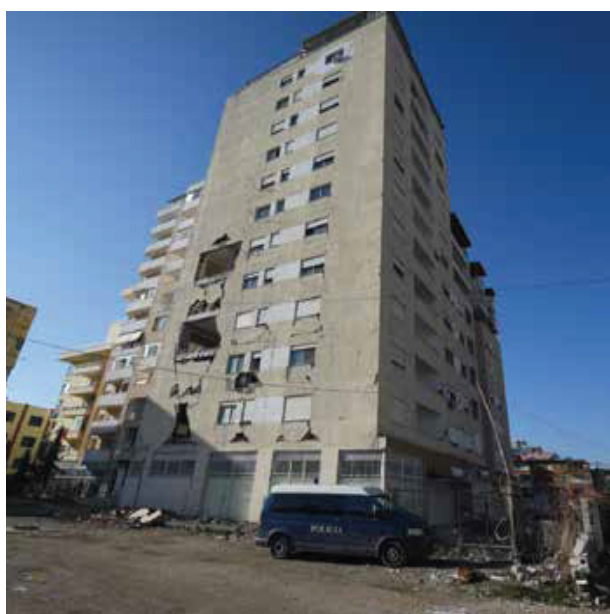
Fig.10: Un edificio de estructura RC de mediana altura dañado en Albania
