Parking Structure Failure and Incidents

by William L. Gamble

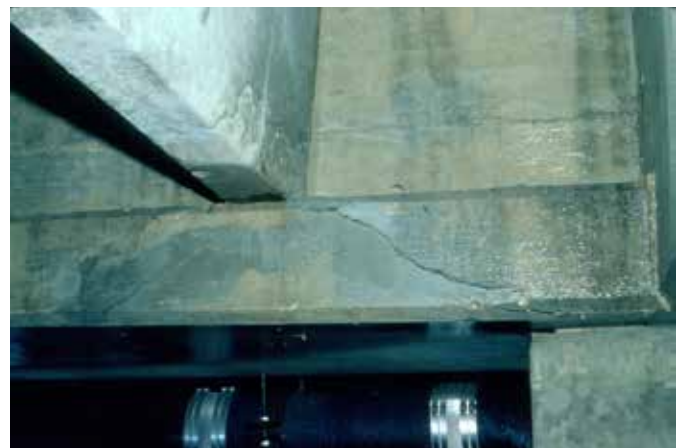
A similar case that did not result in a collapse but certainly was a failure was in a structure built near the University of Illinois campus in 1980. The structure was made of pretensioned double-tee members supported on cast-in-place columns, ledger beams, and inverted-tee sections. The ledges of the beam members were quite small—6 in. (152 mm) wide, as in current practice, but only 8 in. (203 mm) deep as compared to the normal 12 in. (305 mm). The reinforcement was quite different than shown in Precast/Prestressed Concrete Institute (PCI) material of that era. Thin rubber or rubber-like bearing pads were to be placed below every double-tee stem, but placement was quite erratic. In some instances, the double-tee stems had only about 2 in. (51 mm) of bearing width. Fairly soon after construction, significant bearing area distress occurred in a few areas. These areas were patched but to no avail. Figure 1 shows a typical form of ledge distress. Later, in 1988, complex steel auxiliary supports

Fig. 1: A typical form of ledge distress

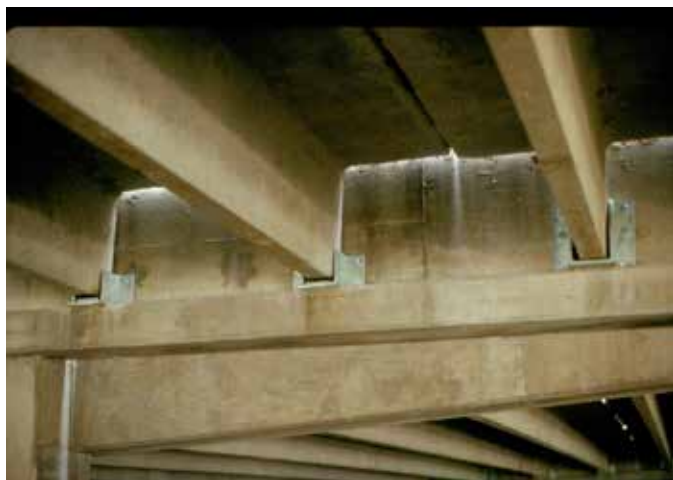
Fig. 2: Added steel support brackets under tee stems

were added under each double-tee stem, as shown in Fig. 2. The structure was abandoned and demolished not many years later. One of my musings at the time was that the designers forgot or did not know that pretensioned members get shorter with time, reducing the available bearing areas. Another musing was that perhaps the center beam line was slightly north of its intended position, because most of the short bearing-length problems were in the south span, with few in the north span.

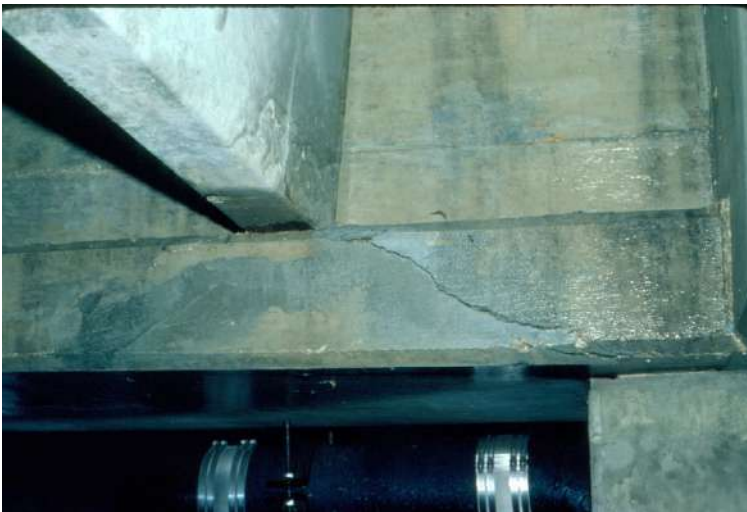
Figura. 1: Una forma típica de peligro en la plataforma

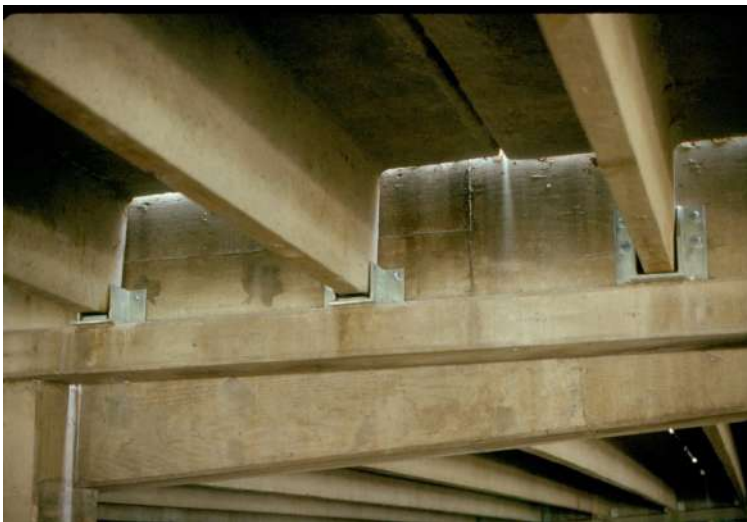
en columnas colocadas en sitio, vigas de apoyo y secciones de T invertidas. Los bordes de las vigas eran bastante pequeños: 152 mm de ancho, como en la práctica actual, pero sólo 203 mm de profundidad, en comparación con los 305 mm habituales. El refuerzo era bastante diferente al mostrado en el material del Instituto de Hormigón Prefabricado/Pretensado (PCI) de aquella época. Debajo de cada vástago de doble T se colocaban unas finas almohadillas de goma o similares, pero su colocación era bastante errática. En algunos casos, los vástagos de doble T tenían sólo unos 51 mm de ancho de apoyo. Poco después de la construcción, se produjeron importantes problemas en las zonas de apoyo. Estas fueron reparadas, pero sin éxito. La figura 1 muestra una forma típica de peligro en la plataforma. Posteriormente, en 1988, se añadieron complejos soportes auxiliares de acero debajo de cada vástago de doble T, como se muestra en la Fig. 2.

Figura. 2: Incorporación de soportes de acero bajo los vástagos de las T
