Report No. UT-20.103

# SALT LAKE CITY AIRPORT PARKING GARAGE VISUAL INSPECTION REPORT

Utah Department of Transportation  
Research Division

Utah Valley University  
Department of Engineering

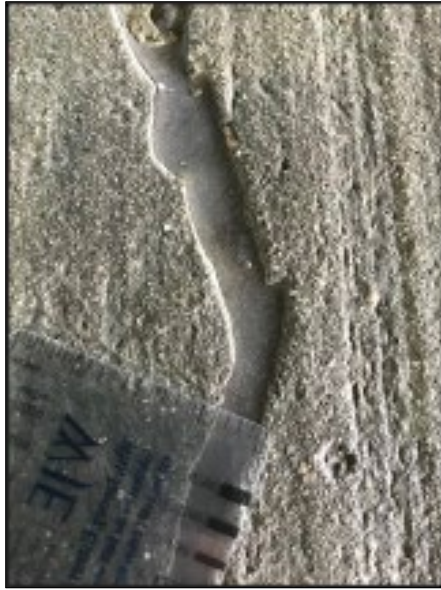
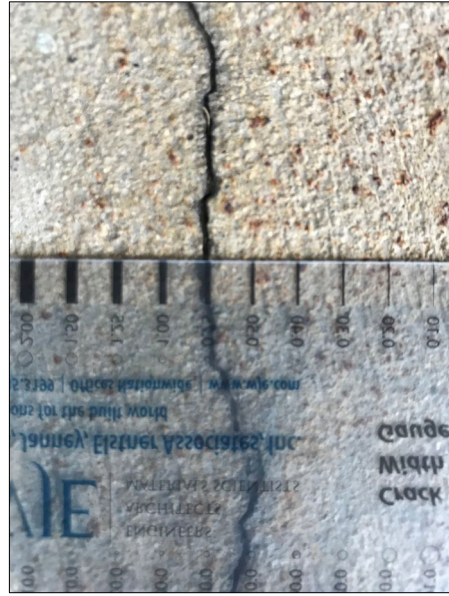
**Figure 2-3 (a) Typical epoxy filled crack found on suspended levels of parking garage and (b) unsealed surface cracking on the 1<sup>st</sup> level in structure B with a 0.75mm width.**

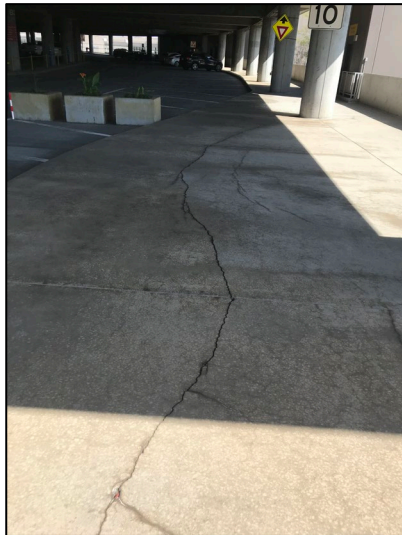
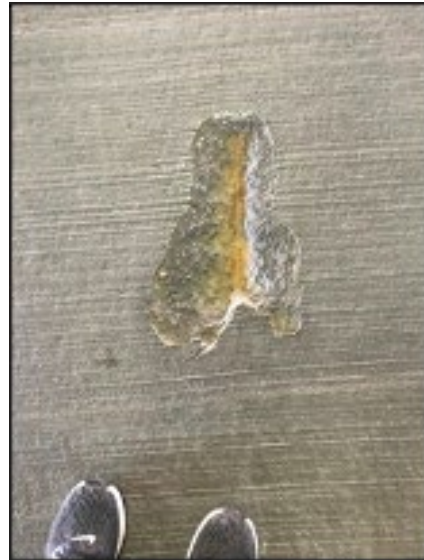
floor slabs where the reinforcement was exposed, and the concrete cover spalled off. There were also a few spalling locations seen on the underside the northwest downward helix ramp.

**Figure 2-4 (a) Wide floor crack found on the sidewalk on the southeast corner of the 1<sup>st</sup> level structure D, near the entrance ramp and (b) spalling and exposed rebar near the surface on the 1<sup>st</sup> level near northwest end of parking garage.**

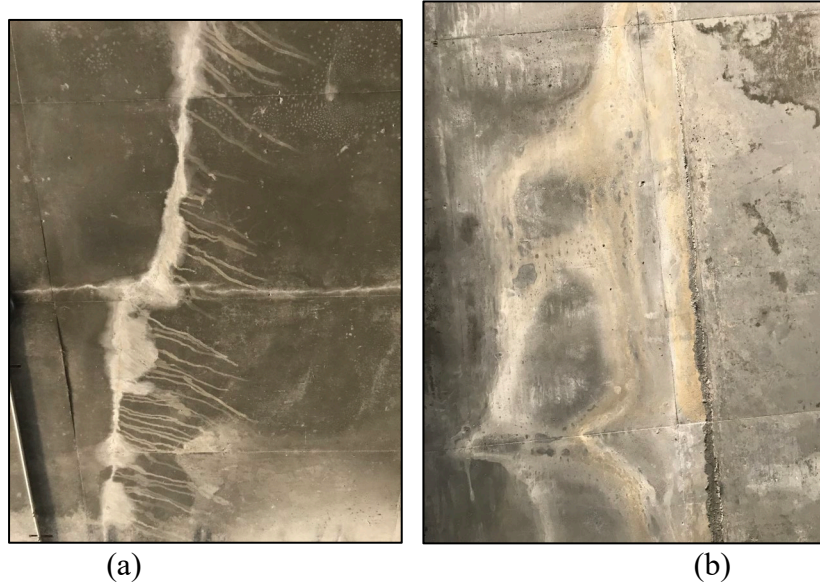
**Figure 2-5 (a) Ceiling efflorescence seen while standing on 1<sup>st</sup> level looking up at the 2<sup>nd</sup> level slab in structure C and (b) efflorescence around an epoxy-filled seam looking up from level two onto the bottom of the level three slab.**

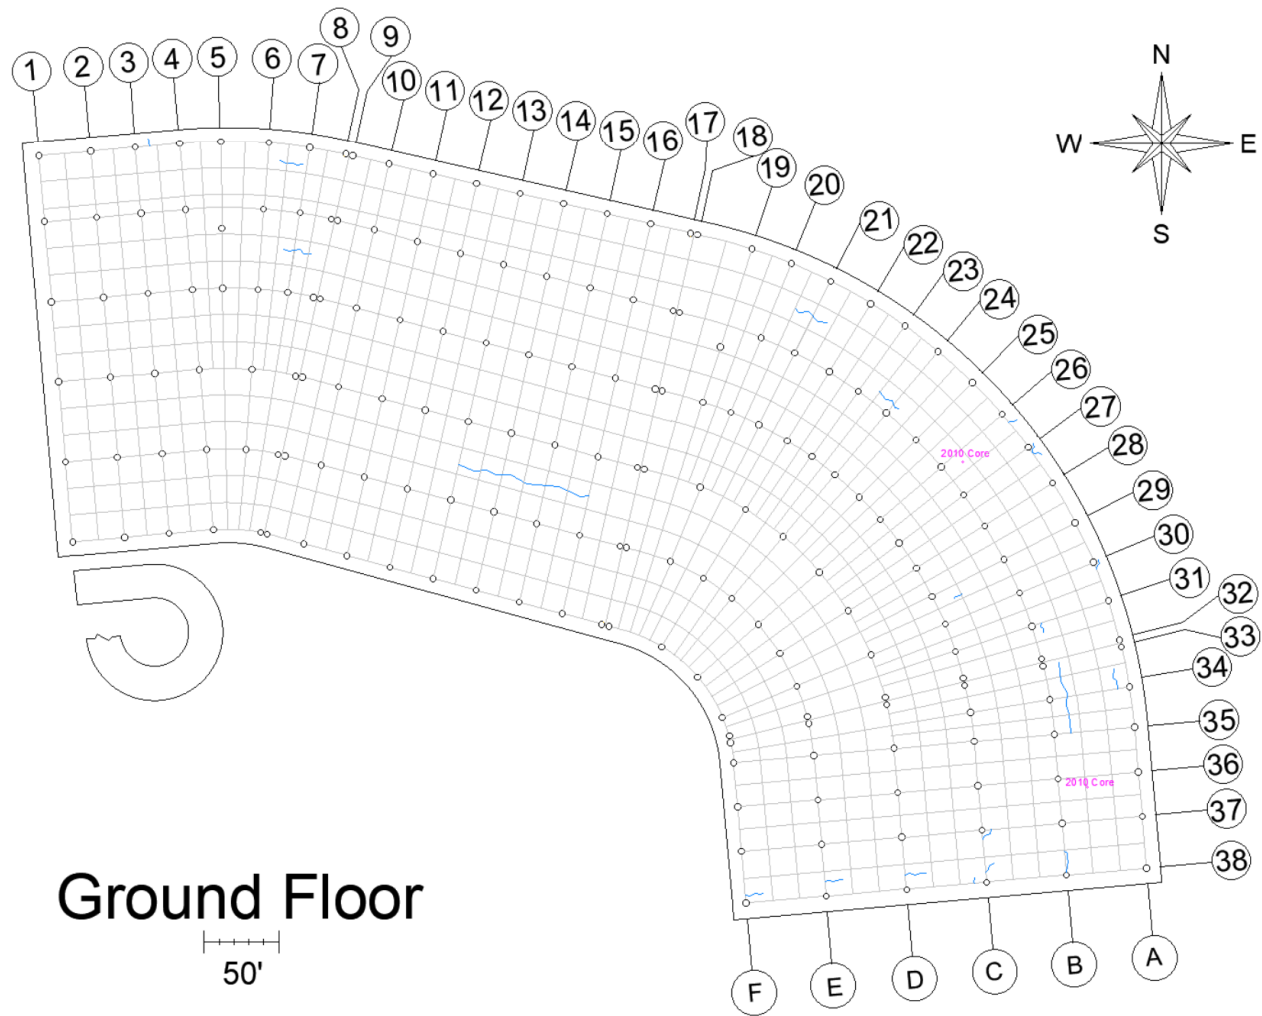
**Figure 3-1 Crack map of plain concrete, unreinforced ground floor showing blue top-down cracks, grey saw-cut joints, and locations of the cores taken in 2010 study by Hooton et al. This floor was used only by rental car companies.**

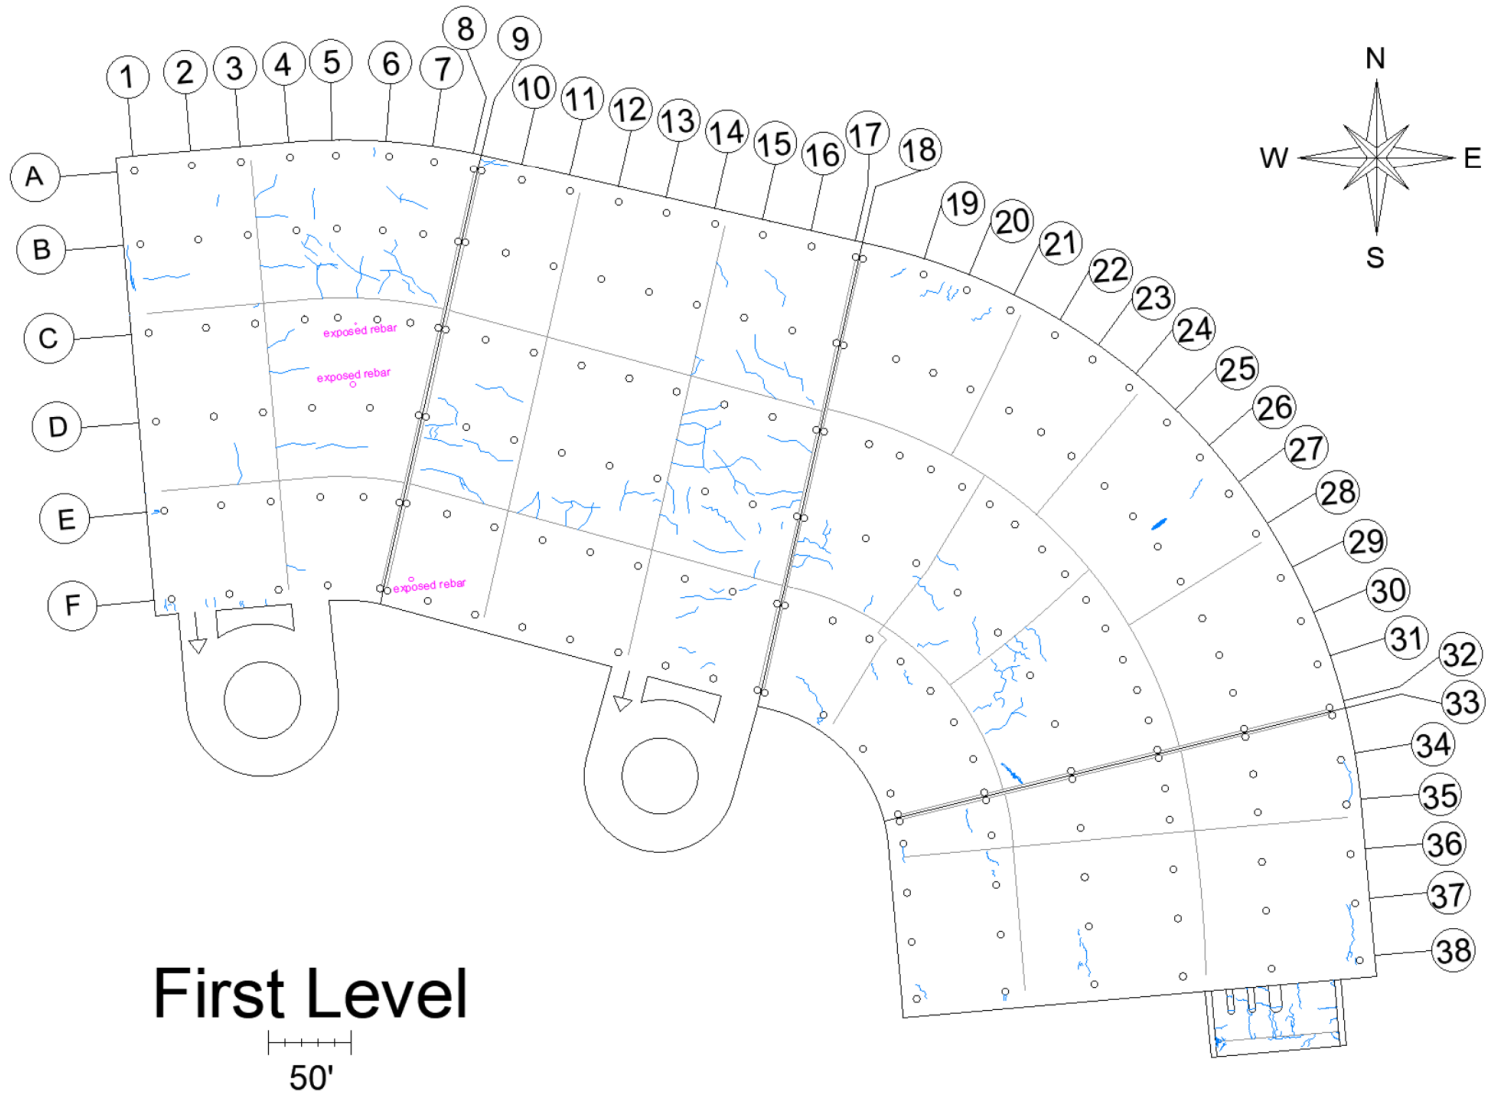
**Figure 3-2 Crack map of silica fume concrete suspended, reinforced first floor and entrance bridge with blue top-down cracks, grey epoxy-filled construction joints, and locations of visually exposed rebar.**

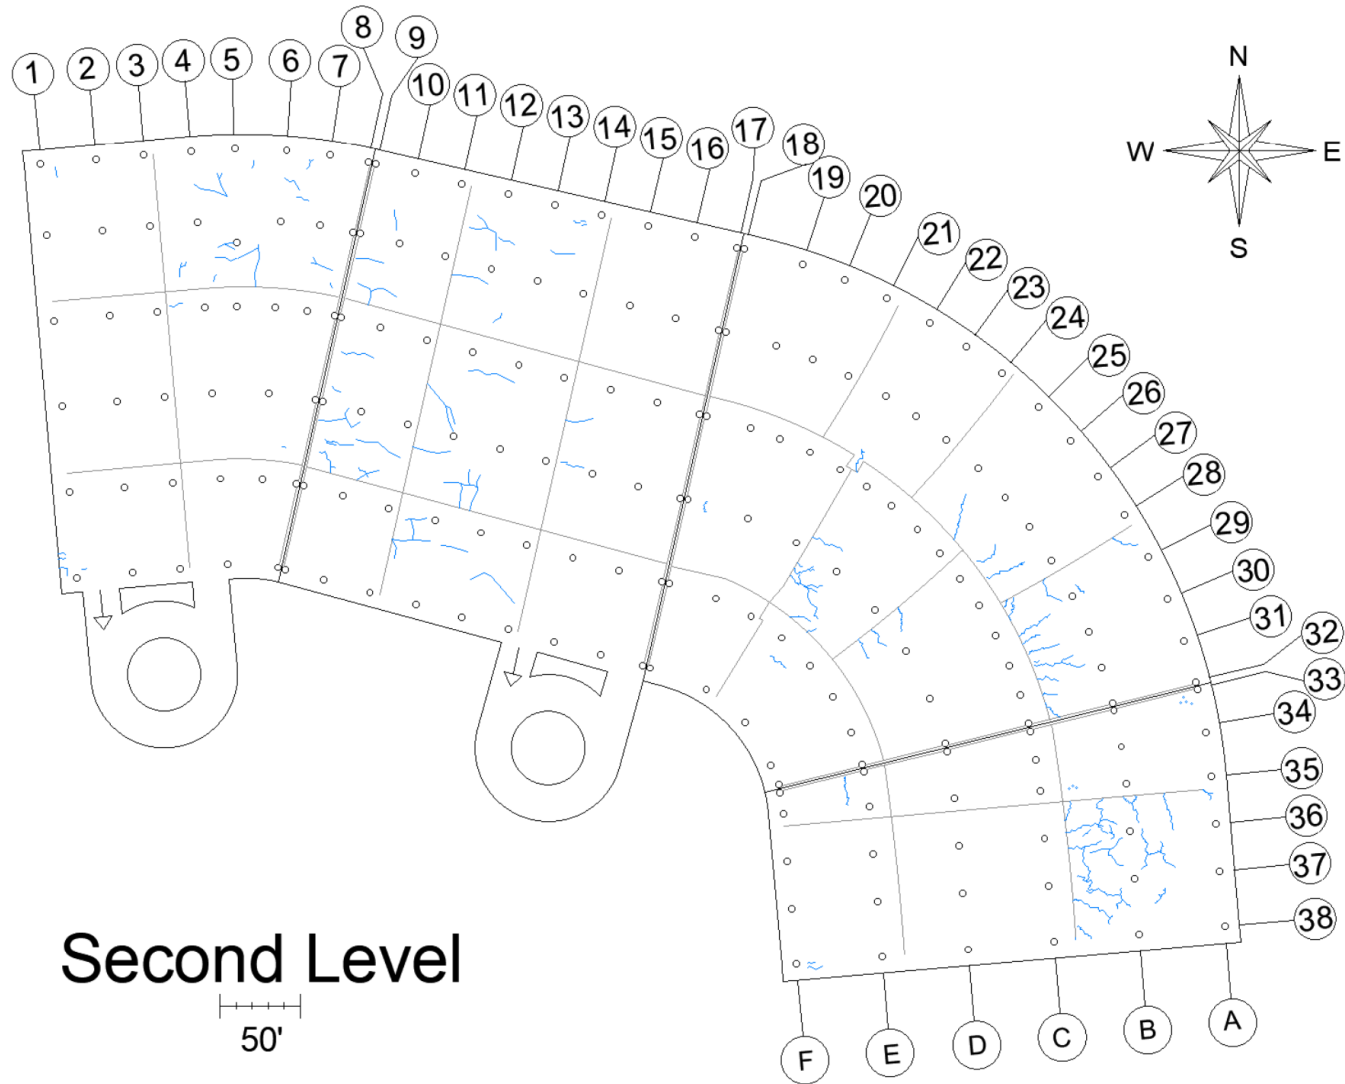
The suspended slab area with an observable higher crack density on the 2<sup>nd</sup> floor (between columns B-C and 37-38) was selected for further analysis with the grid point system. The VEI data (not shown in this report) indicated low impedance (meaning either low cover depth or significant internal cracking, defects, or rust) was identified on the top 3<sup>rd</sup> floor (between columns B-C and 1-2) even though there were no visible surface cracking there. The entrance bridge (1<sup>st</sup> floor) and ground floor were also selected for the grid point system testing to see extremes in exposure (covered vs uncovered), expected salt concentrations, material (silica fume vs plain concrete), and reinforcement (epoxy + PT versus unreinforced); but both entrance bridge and ground floor expected to have the highest traffic. The upwards (south/east) helix was selected instead of the downwards (north/west) for analysis primarily for safety reasons since at the time demolition had begun and all parking garage traffic was channeled to use the downwards helix.

**Figure 3-3 Crack map of silica fume concrete suspended, reinforced second floor with blue top-down cracks, grey epoxy-filled construction joints, and no locations of visually exposed rebar.**

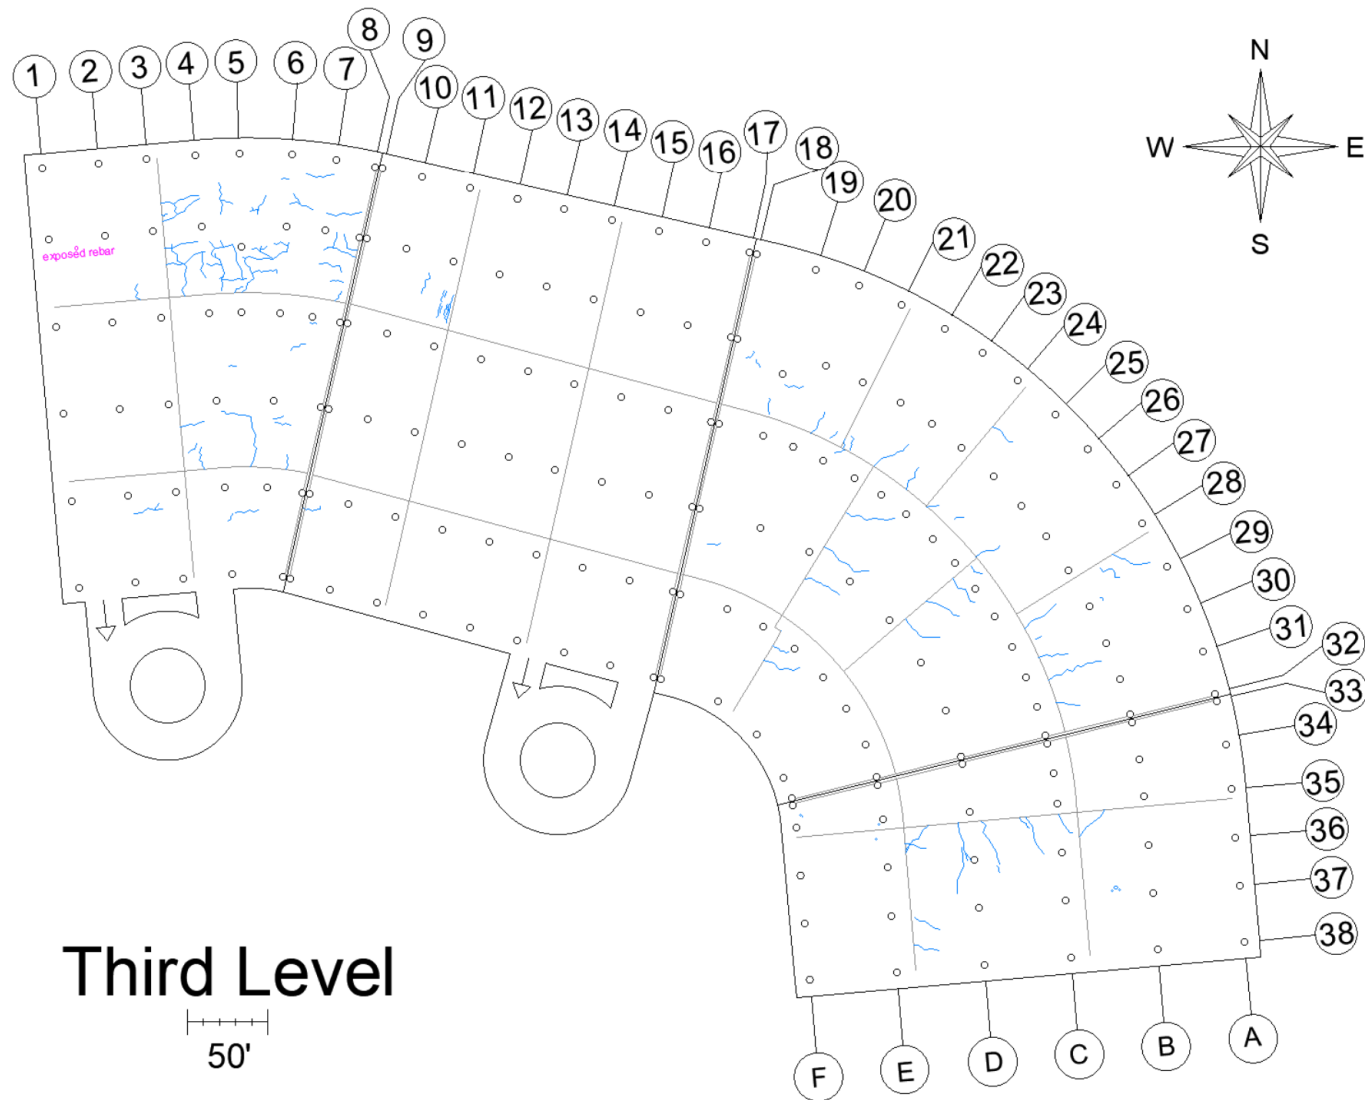
**Figure 3-4 Crack map of silica fume concrete suspended, reinforced third (top) covered floor with blue top-down cracks, grey epoxy-filled construction joints, and location of a visually exposed rebar.**

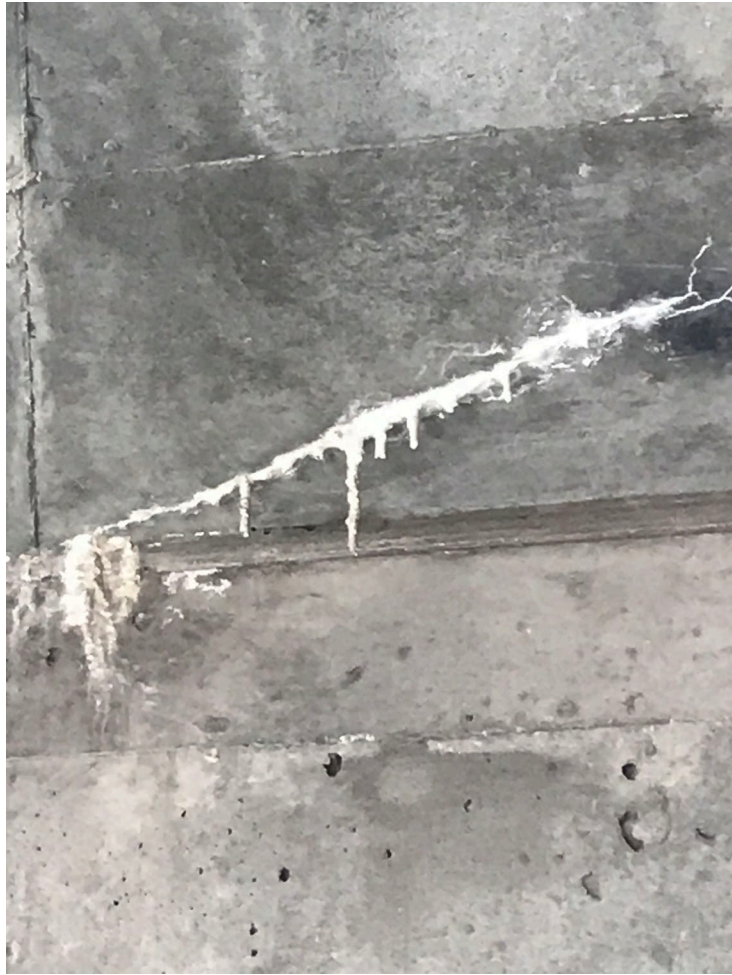
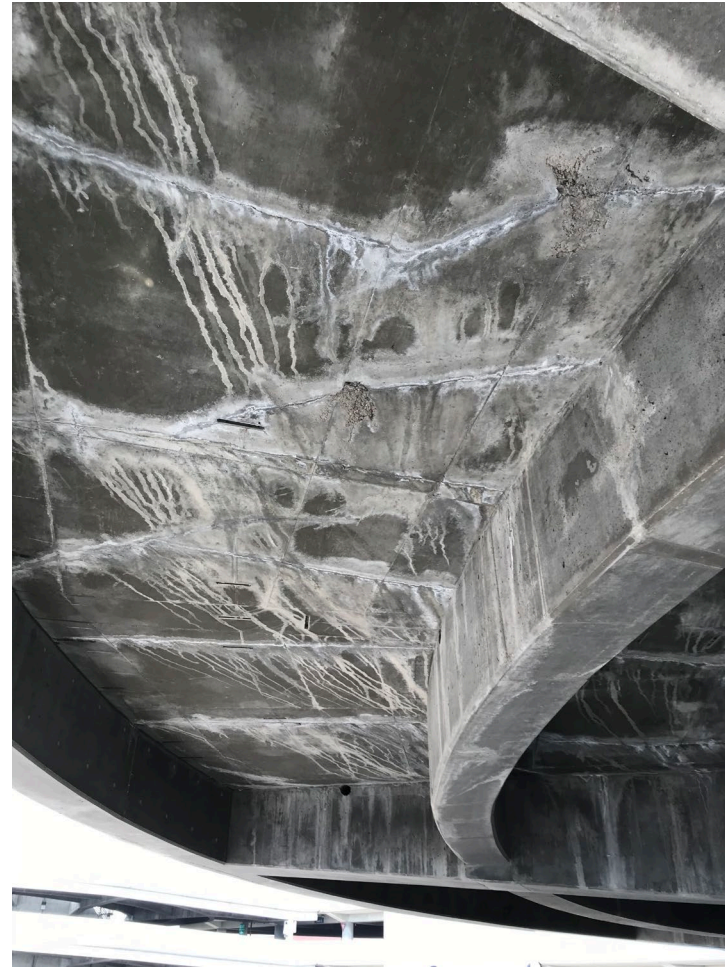
Several instances of exposed rebar were also present on the ceilings of the helices. Where the rebar was exposed, there were large amounts of discolored efflorescence present suggesting rebar corrosion.

**Figure 3-6 (a) Photo of stalactites growing on the ceiling between first and second level on southeast helix, and (b) photo of the ceiling halfway between the first and second levels on the southeast helix. The efflorescence and cracking in this photo are similar to efflorescence and cracking on the ceilings of both helix structures.**

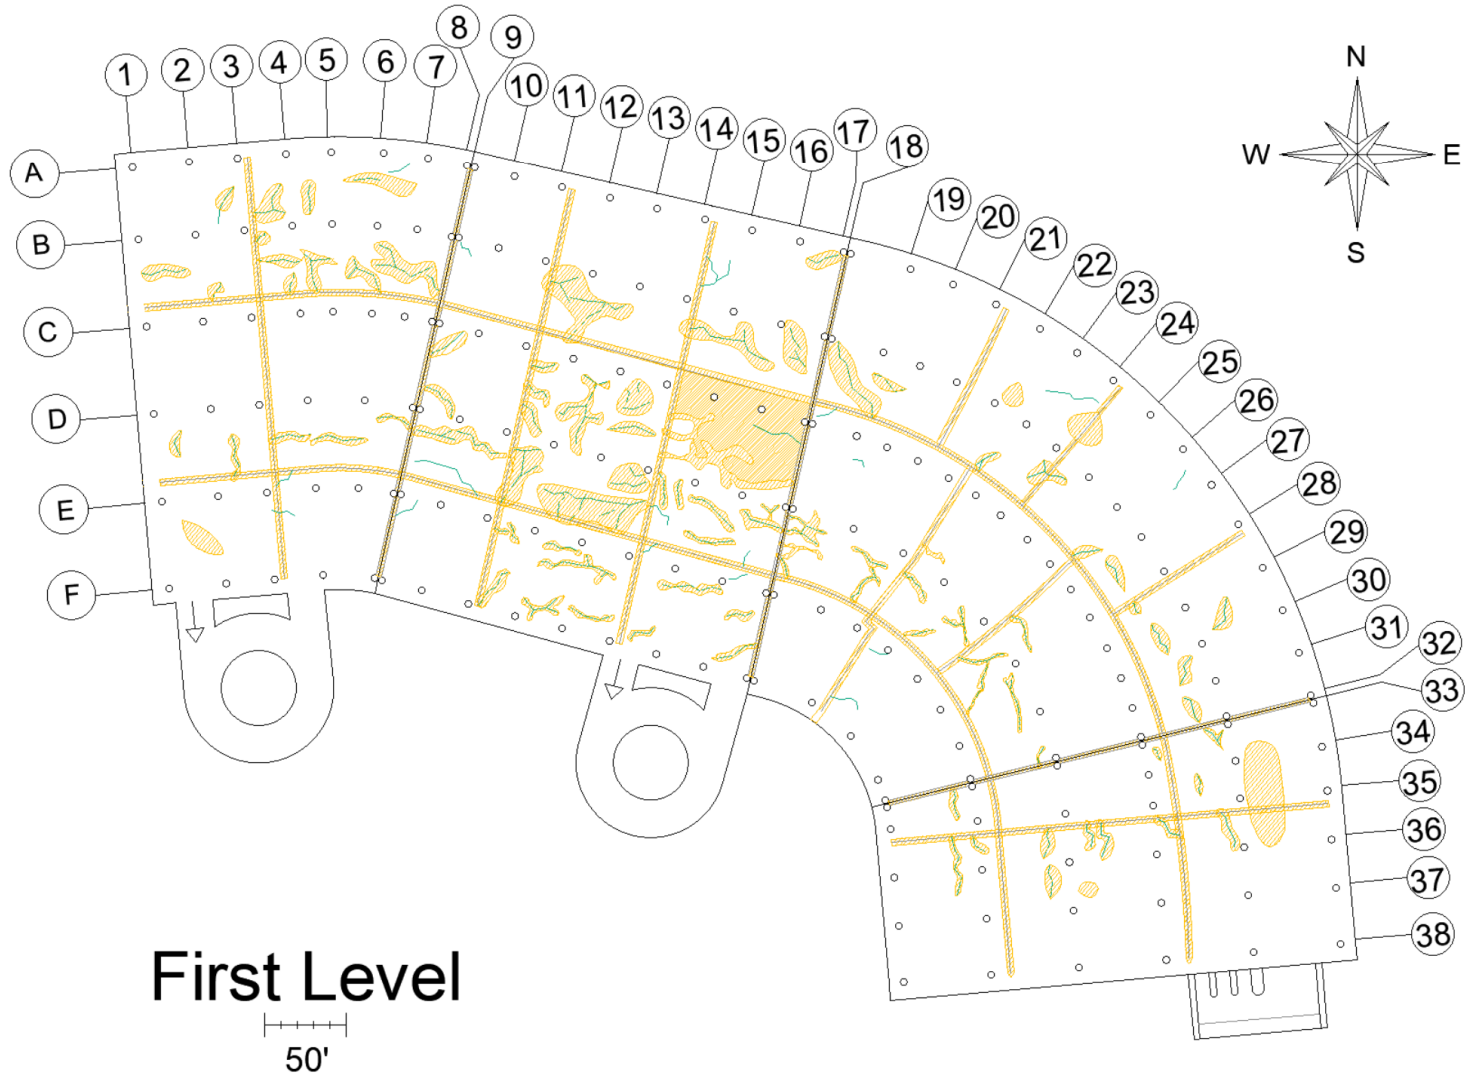
**Figure 3-7 Crack map of the first suspended, reinforced silica fume concrete slab with green bottom-up cracks (some occurring along grey epoxy-filled construction joints) and yellow zones of efflorescence.**

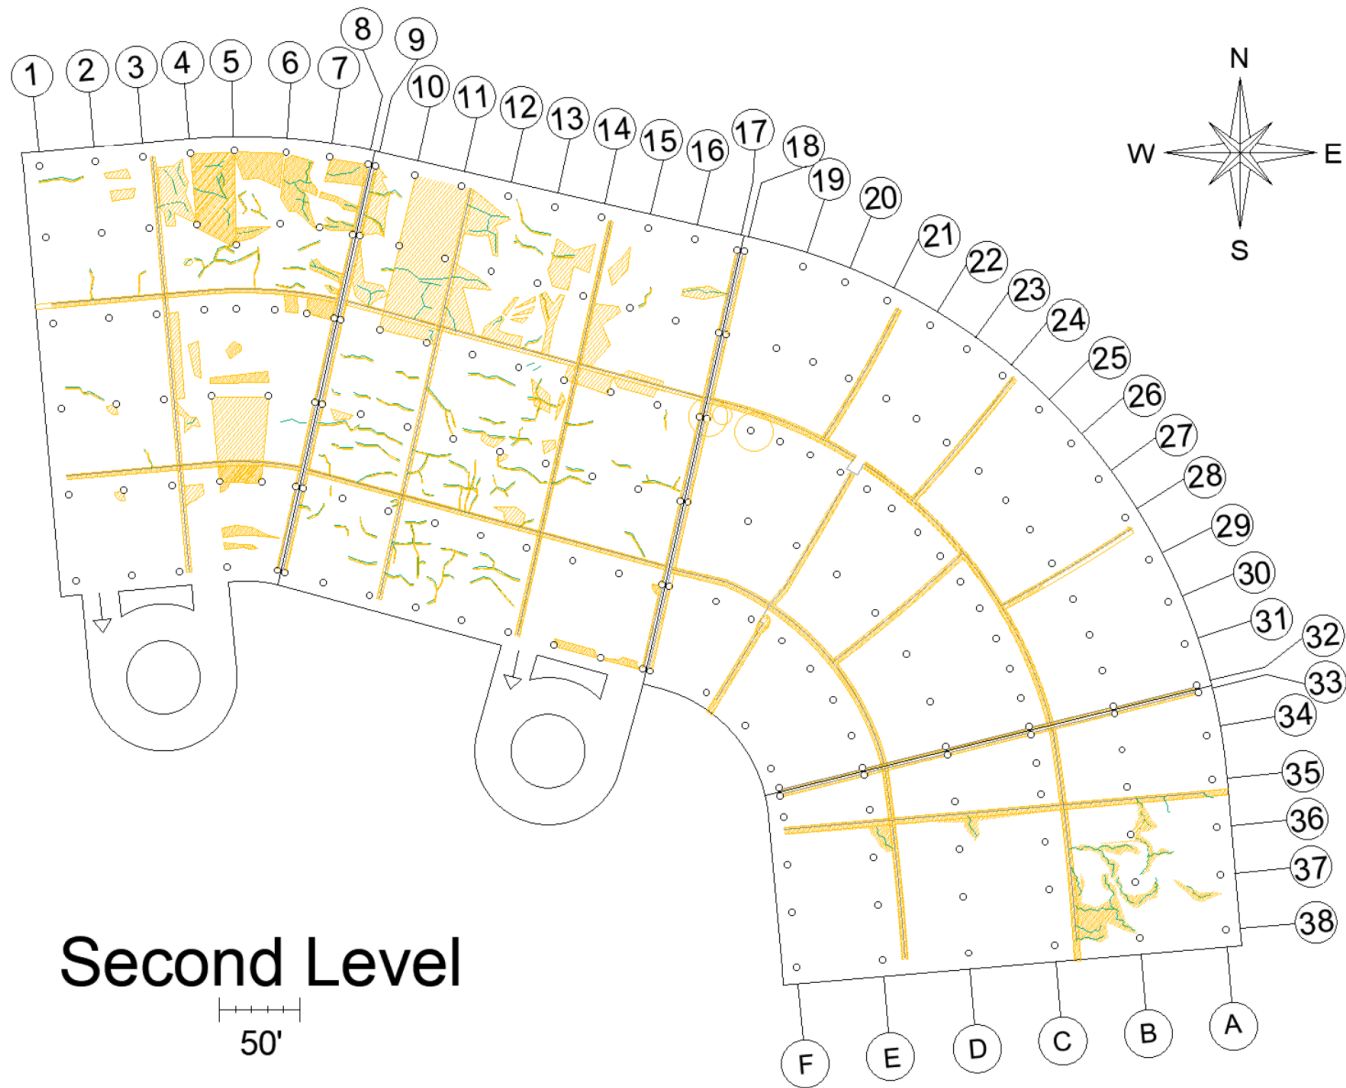
**Figure 3-8 Crack map of the second suspended, reinforced silica fume concrete slab with green bottom-up cracks, yellow zones of efflorescence, and grey un-cracked epoxy-filled construction joints.**

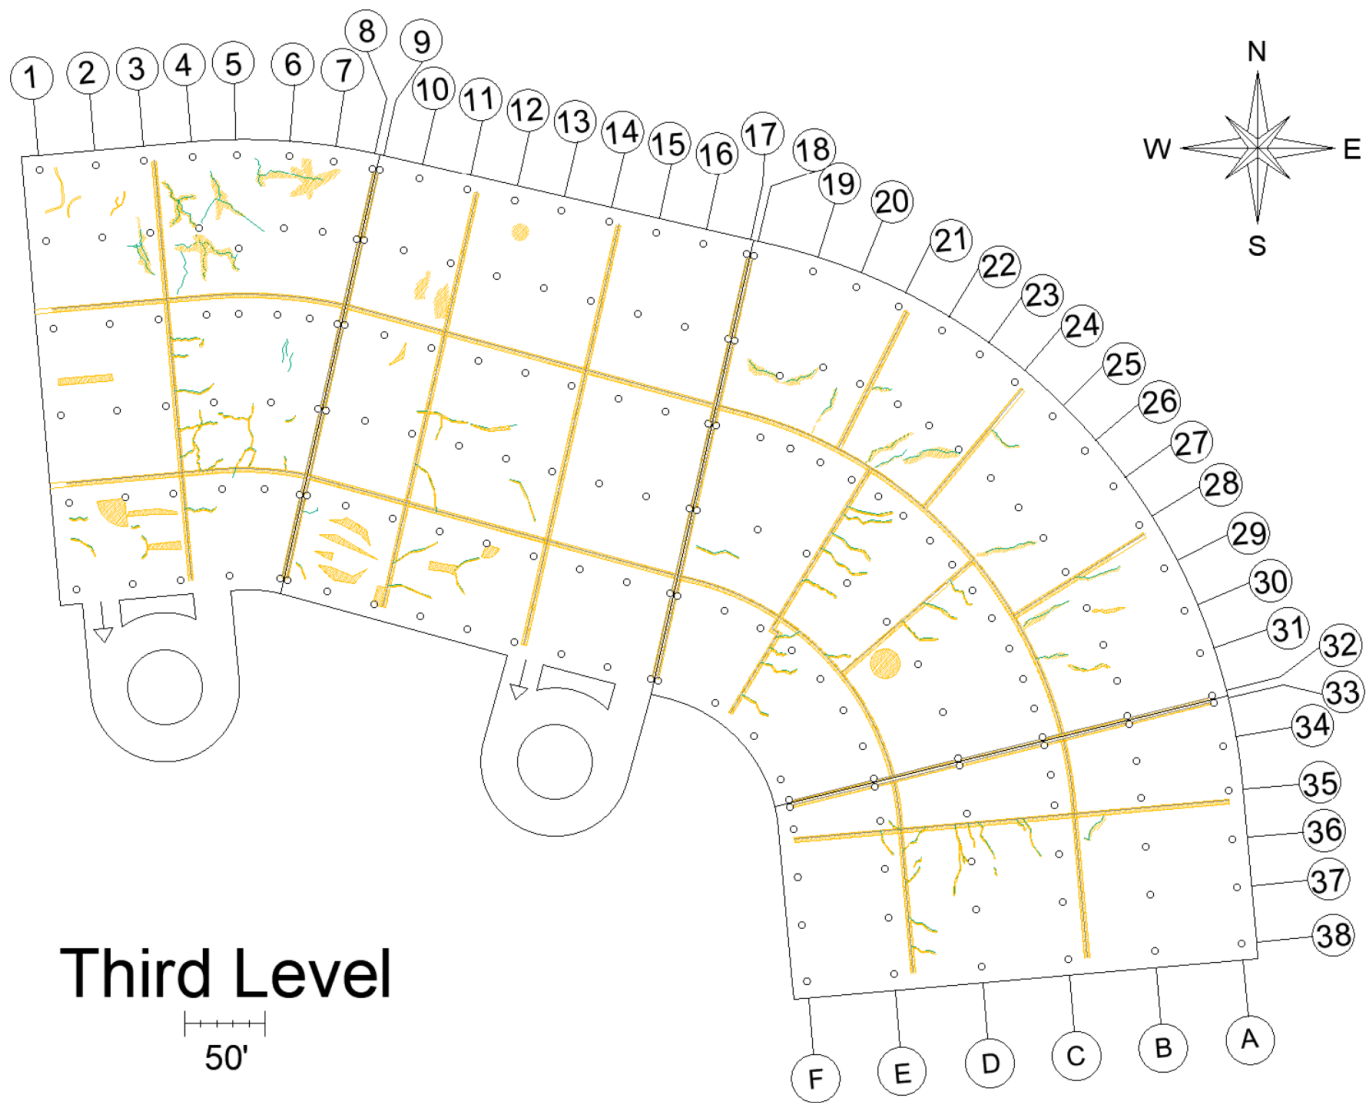
**Figure 3-9 Crack map of the second suspended, reinforced silica fume concrete slab with green bottom-up cracks, yellow zones of efflorescence, and grey un-cracked epoxy-filled construction joints.**

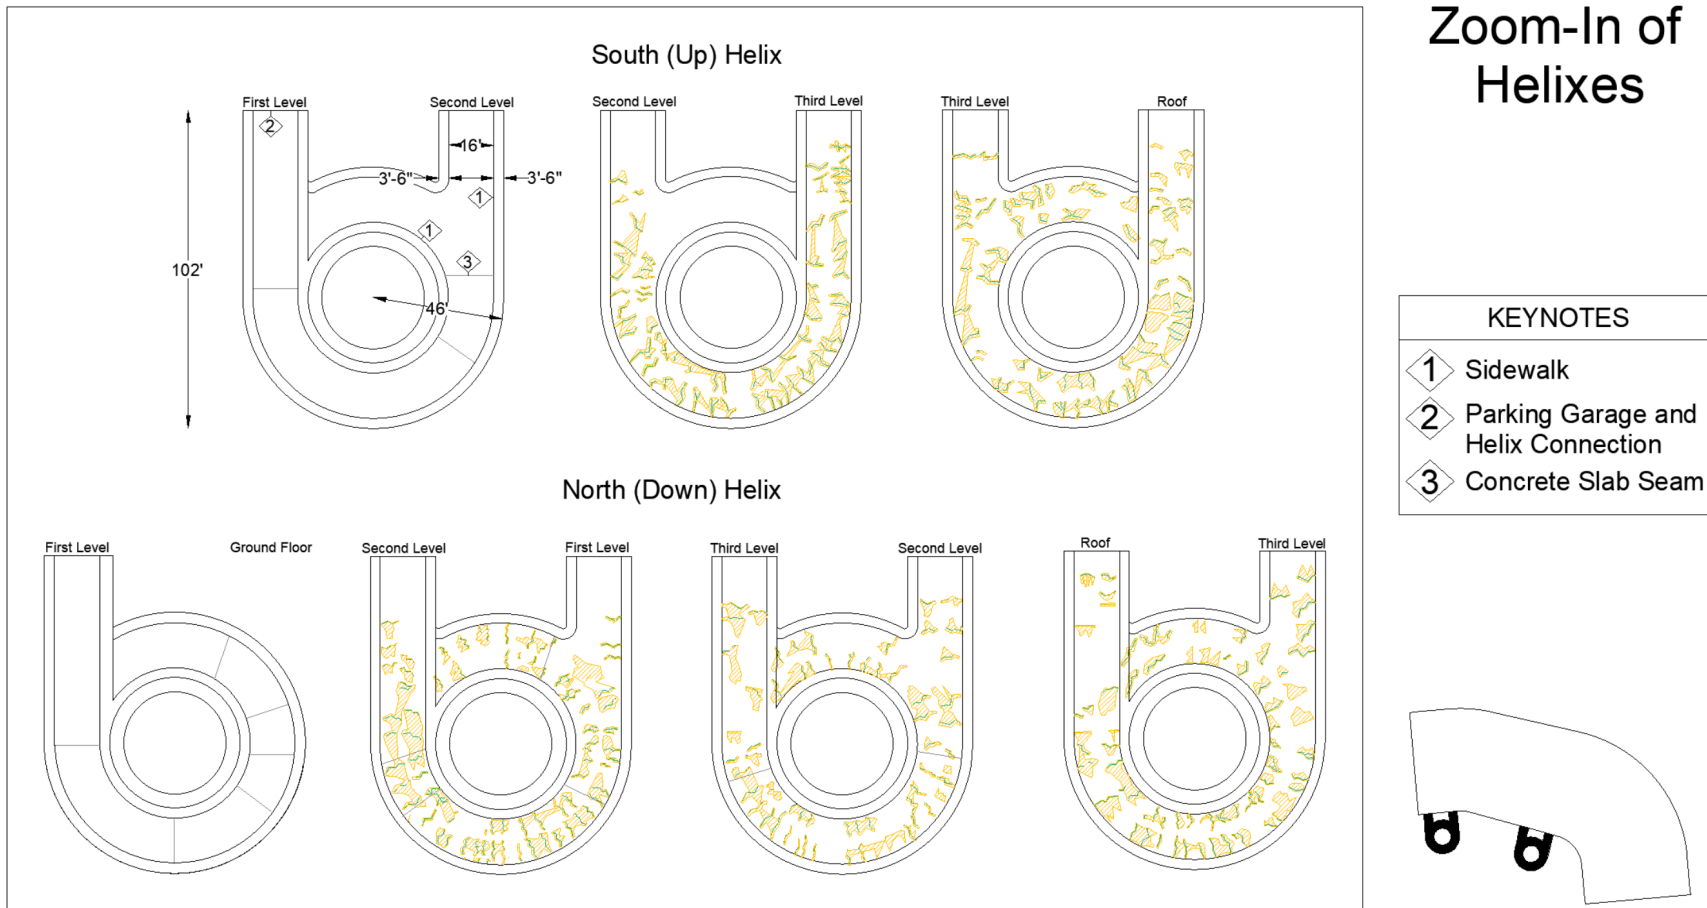
**Figure 3-10 Crack map of the suspended, reinforced silica fume concrete helix ramps with green bottom-up cracks, yellow zones of efflorescence, and grey un-cracked epoxy-filled construction joints.**
