# ICRI 2024 Project Awards

The International Concrete Repair Institute (ICRI) announced the winners of its 2024 Project Awards.

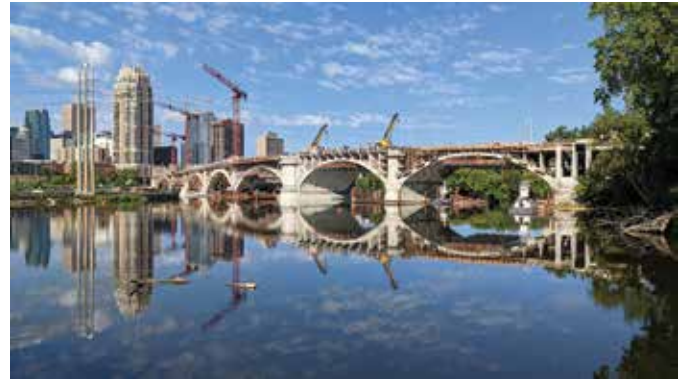
View of historic 3rd Avenue Bridge during rehabilitation

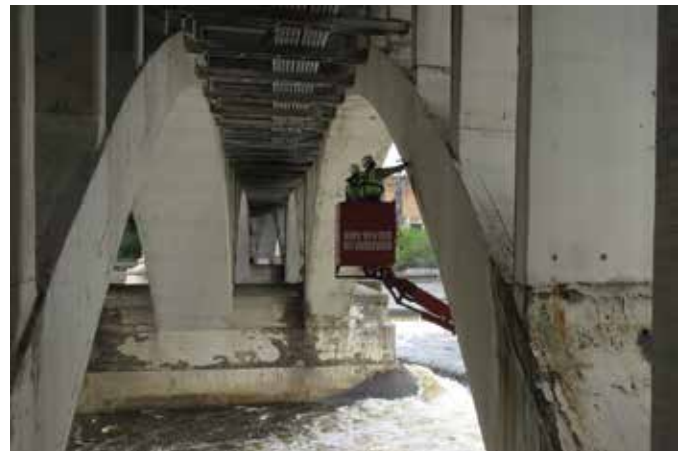
Hands-on inspection from under-bridge inspection unit, showing deterioration of arch ribs and pier bases

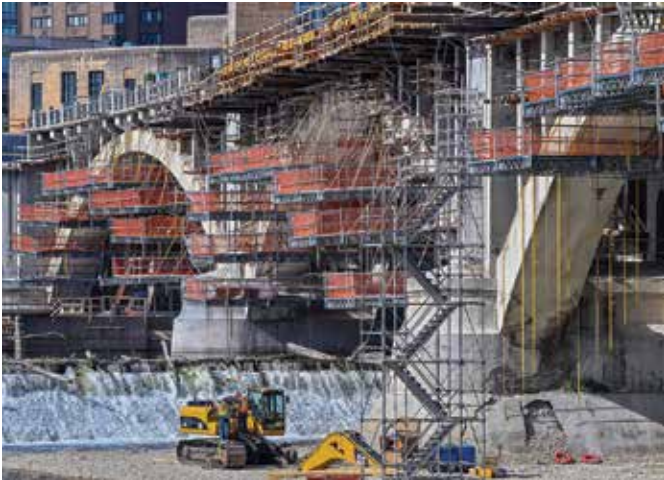
**Access to the substructure required complicated suspended scaffolding and dewatered cofferdams** (photo courtesy of Joe Szurszewski Photography)

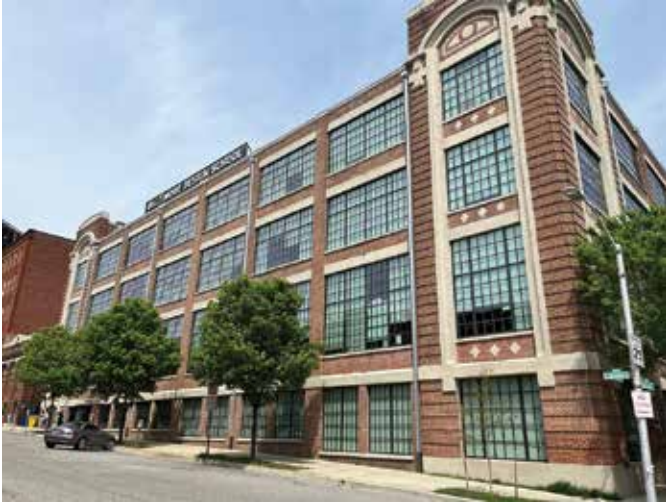
The Baltimore Design School

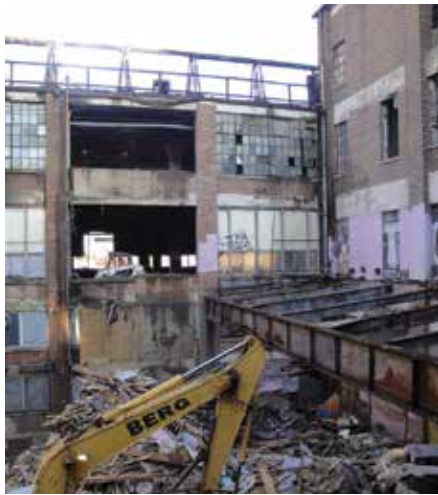
A massive clean-out operation had to be carried out to remove equipment, furniture, and litter from over the years

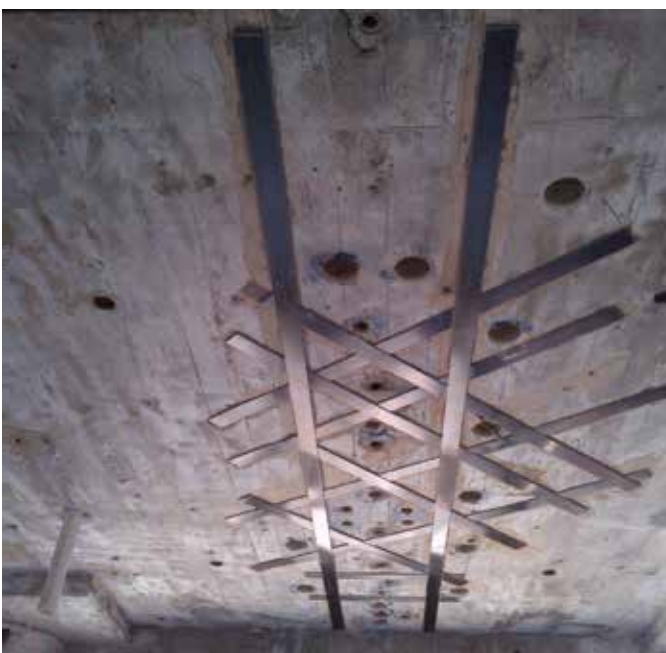
Carbon fiber plates were installed for strengthening

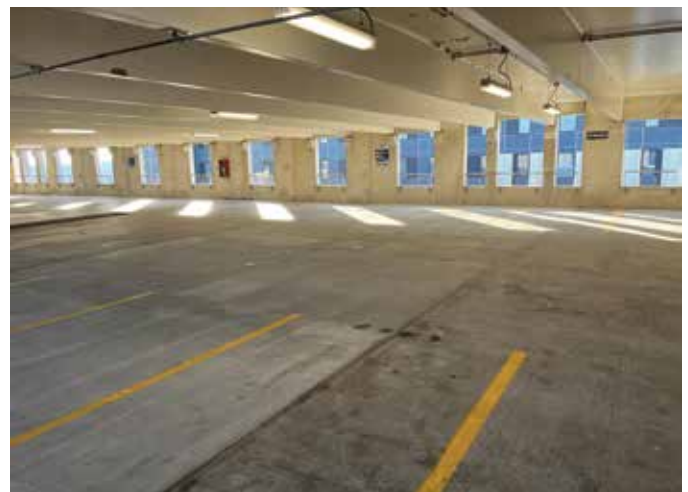
NEIU parking deck after repairs

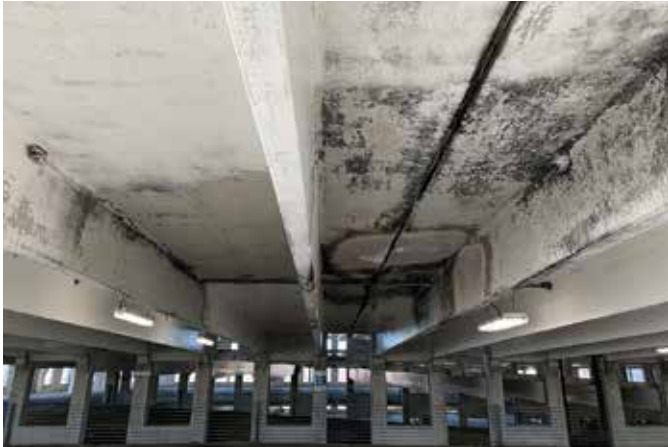
Fire damage to the underside of the level four precast double tees

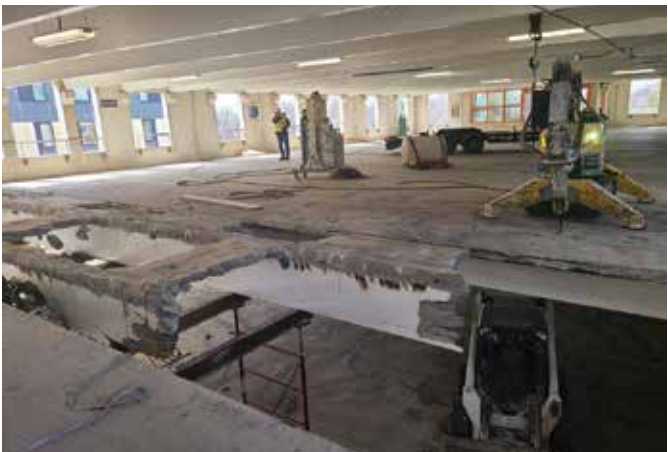
Remote-controlled demolition

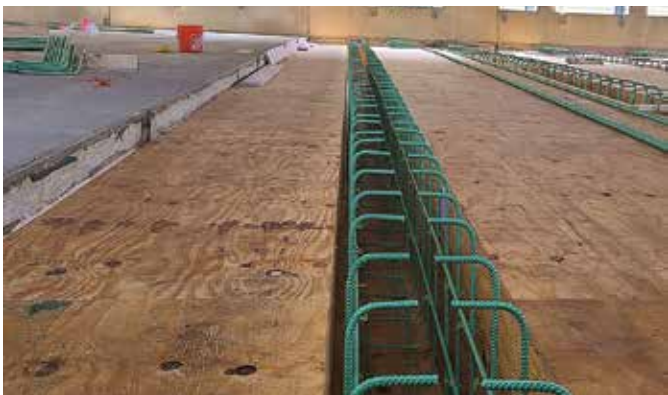
Partial reinforcing bar detail with formed repair

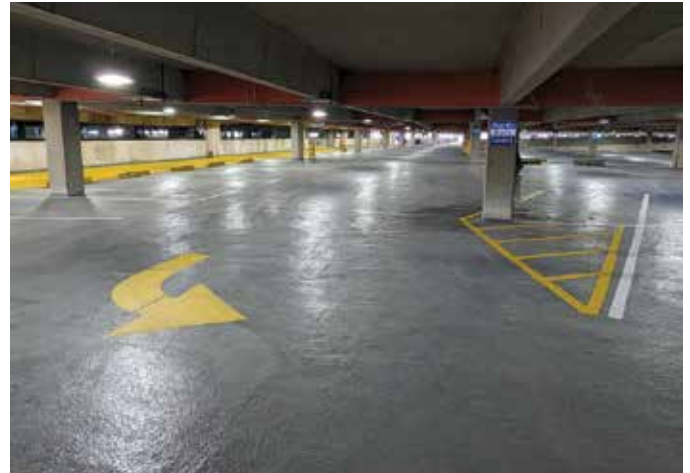
**Hartsfield-Jackson Atlanta International Airport North and South Domestic Terminal**
