## **Thermal Detection of Subsurface Delaminations in Reinforced Concrete Bridge Decks Using Unmanned Aerial Vehicle**

**Synopsis:** Bridge deck condition assessment is commonly conducted through visual inspection by bridge inspectors. Considering the colossal backlog of aging bridge structures, there is a need to develop cost-effective and innovative solutions to evaluate bridge deck conditions on regular time intervals, without interrupting traffic. This makes remote sensing technologies viable options in the field of bridge inspection. This paper explores the potential for applying infrared thermography (IRT) using unmanned aerial vehicle (UAV) to detect and quantify subsurface delaminations in concrete bridge decks. The UAV-borne thermal sensing system focuses on acquiring thermal imagery using a UAV and extracting information from the image data. Two in-service concrete bridge decks were inspected using a high resolution thermal camera mounted on a UAV. The captured images were then enhanced and stitched together using a tailored procedure to produce a mosaic view of the entire bridge deck, indicating the size and geometry of the detected delaminated areas. The results were v

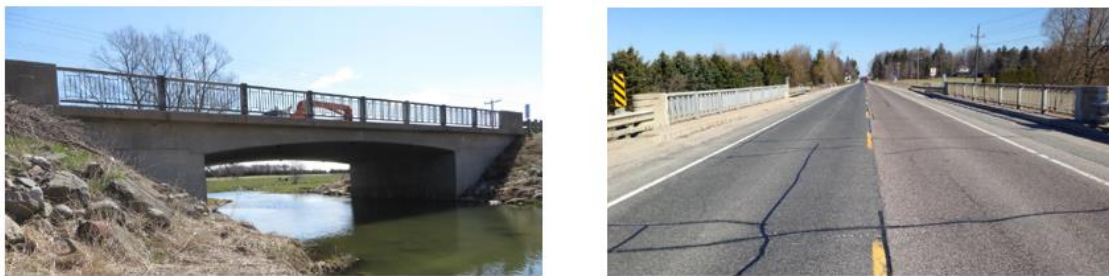
**Figure 1**-East elevation of the surveyed concrete bridge (2) and an overview of the deck condition.

The UAV-borne thermal survey for this study was conducted onsite in a real-world application on two in-service RC bridge decks located in the city of London, Ontario. The bridges were scheduled, by the Ministry of Transportation Ontario (MTO) for rehabilitation because delaminations, the extent of corrosion and high chloride ions content in the bridges were recently identified by a condition survey. Thus, the bridges were considered as good candidates and selected for the UAV survey. The two bridges, (named herein bridge (1) and bridge (2)) were constructed in 1965 as single span cast-in-place RC frames passing over a creek. The frames are supported directly on the abutments, and paved with about 100 mm (4 in.) asphalt wearing surface, as indicated in the structural drawings. The bridge structures have a north-south orientation and their outer limits have concrete curbs and steel handrails. The critical deck characteristics include a total length of 15.24 m (50 ft.) with a transverse width of 12.18 m (40 ft.), which supports one lane of traffic with one side shoulder in each direction. The structural drawings of both bridges indicate a deck slab thickness varying from 0.91 m (3 ft.) at the abutments to 0.48 m (1.6 ft.) at the mid-span of the deck with a parabolic soffit. **Figure 1** illustrates the surveyed bridge (2) and a view of the condition of its deck. The utilized drone, thermal camera and the data collection methodology are briefly discussed below.

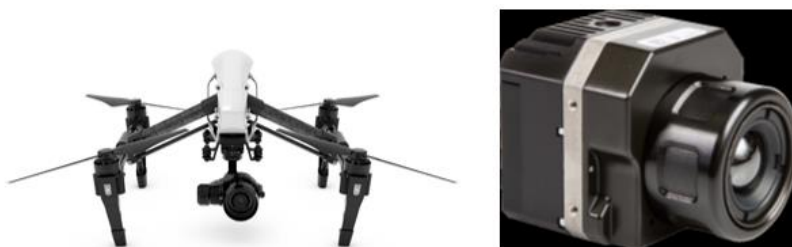
**Figure 2-**Aircraft (Inspire 1 Pro) and thermal camera (FLIR Vue Pro) utilized in this study.

The utilized aircraft in this study was Inspire 1 Pro, a quadcopter drone, which is equipped with a retractable arm system whereby the underside of each propeller motor has a foot to act as a landing pod when the arms are lowered. Thus, the propeller arms rest in a lowered position when the drone is on the ground and once in the air, they can be retracted to give the camera unobstructed views across 360-degrees. Using intelligent flight batteries allows up to 18-22 minutes of flight time and a maximum flight speed of 18 m/s (59 ft/s). The flight battery constantly supplies the flight computer with remaining voltage. Applying special algorithms, the computer supplies the operator with estimates of remaining flying distance and time to return. The drone relies on a GPS-based stabilization system that is able to hold a position even when experiencing wind interference and can automatically bring the aircraft to the home point in the event of signal loss. The system allows the drone to hold a position with  $\pm 2.5$  m ( $\pm 8.2$  ft) horizontal and  $\pm 0.5$  m ( $\pm 1.64$  ft.) vertical accuracy. **Tables 1** summarizes the specifications and features of the drone.

The FLIR Vue Pro thermal camera was utilized in this study. The camera weighs 113 grams (4 ounces), which makes it ideal for UAV applications. The camera is compatible with the utilized drone and can be mounted via an integrated 3-axis gimbal to maximize stability and weight efficiency while minimizing space. The gimbal uses brushless servo motors to keep the shot stable and the horizon level. The camera pans a full 360-degrees so that no matter which way the quadcopter turns; the camera can remain locked on the subject. Manual panning and tilting can be affected using controls on the transmitter (radio controller). Once the controller is ready to go, a tablet or smartphone can be attached, which allows the operator to see what the drone is viewing along with other statistics concerning its flight. The camera processes the temperatures by an automatic gain control (AGC) into a maximum of 256 shades of gray to display a thermal image. Since the imaging system is sensitive enough to distinguish many more than 256 different temperatures, each “shade of gray” represents a range of temperatures. The raw scene data could be stored as still images (TIFF, JPEG or in FLIR File Format (FFF)) for post processing using FLIR image processing software. It has an uncooled microbolometer detector and displays thermal images with a resolution of 640 x 512 pixels. **Table 2** summarizes the specifications and features of the camera.

The UAV-borne thermal imaging in this study was conducted by a consultant specializing in aerial photography, videography and thermography who has completed UAV training, IRT training, pilot licensing, and acquired special risk aviation insurance and gained a special flight operation certificate as per the requirements of the Canadian Aviation Regulations. The setup of both the drone and the thermal camera was firstly completed by the UAV operator. This includes the installation of the propellers and downloading the drone and camera operating software. The DGI Go app controls the flight and allows for a real-time view of a live video to line up the perfect shot where the data is automatically saved on the used mobile device. The FLIR Vue Pro app allows the setup of image format, orientation, shutter speed, camera focus adjustment, shooting mode, and color palette and communication options with the mobile device. All the batteries were recharged and the camera was mounted on the drone and oriented facing straight-down to be perpendicular to the concrete deck surface being investigated. It was not possible to measure the angle while flying. Hence, an estimation of the drone’s perpendicular position to the deck surface was made from the live stream video of the flight displayed in real-time on the monitor. **Figure 2** illustrates the utilized drone and thermal camera.

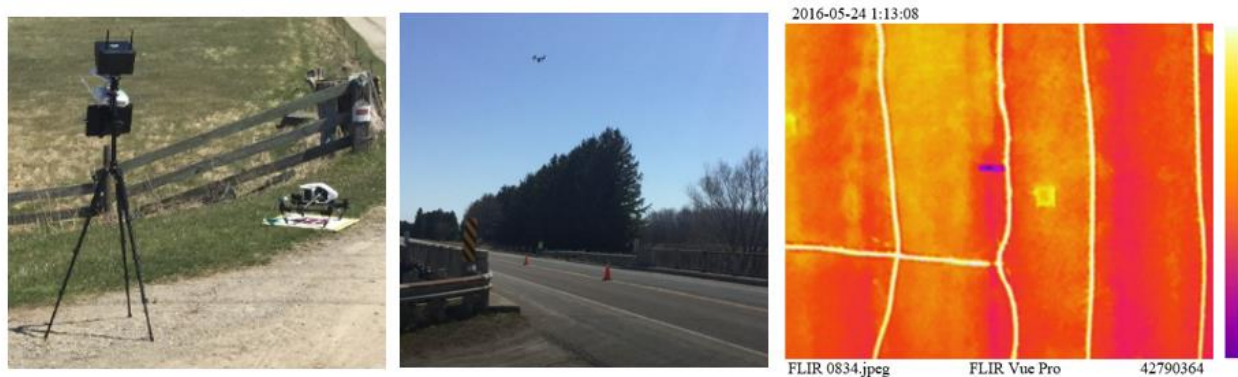
**Figure 3**-Setup of UAV-borne thermal system and a snapshot during flight over bridge (2).

Time of data collection is the most critical factor in a passive IR survey. In a study conducted by Washer *et al.* (2013) on concrete bridges, it was found that the effective time to perform a thermal IR test depends on the depth of the delamination. The most contrast appears on the thermal IR image approximately 4 hr after sunrise for a 50 mm (2 in.) deep delamination and 7 hr after sunrise for a 75 mm (3 in.) deep delamination. Therefore, the surveys were conducted on May 24<sup>th</sup>, 2016 at 1 PM, six hours after sunrise. During the survey, the ambient temperature was 26° C (79° F), relative humidity was 22%, and wind speed was 8 km/hr (5 mi/hr.). Bridge deck dryness was considered during data collection since surface moisture can reduce the thermal contrast on thermal IR images. Road traffic was not closed during data collection of the two bridges. While the total time taken to complete a bridge deck inspection from setup to tear-down was approximately 20 minutes, the total flight time was about three minutes for each bridge deck. A calibrated 9 mm (0.35 in.) focal lens (69° x 56°) was utilized, which allowed a FOV of 13.74 m (horizontally) x 10.62 m (vertically) (45 ft. x 34.8 ft.) for each image taken at a constant 10 m (32.8 ft.) altitude and resulted in 2.5 cm (1 in.) spatial resolution. Hence, a total of four thermal images, at spacing of 5 m (16.4 ft.), were collected with an overlap of 50% to cover the entire deck length. Each image covers the entire deck width and shoulders, in addition to the sidewalks at both sides. The still images were taken at the center of each bridge deck. **Figure 3** illustrates the UAV hovering process and a captured thermal image.
