# PROCEEDINGS

## SECOND CONVENTION.

### ANNUAL PRESIDENTIAL ADDRESS

BY RICHARD L. HUMPHREY.\*

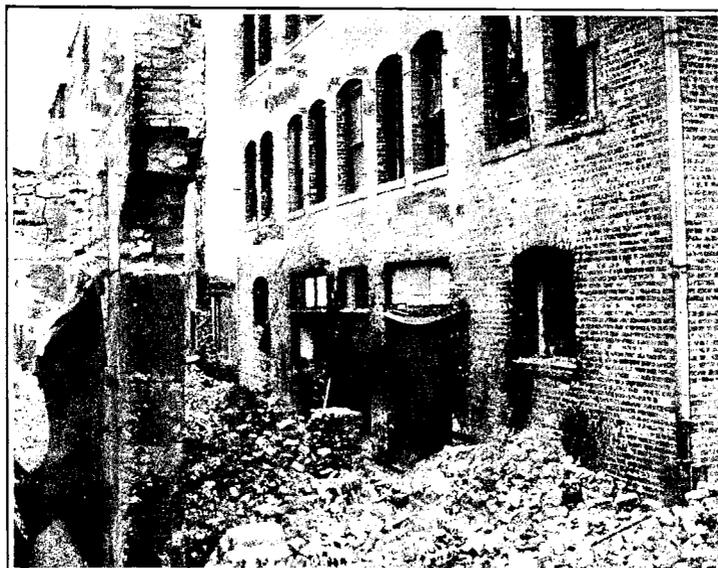
FIG. 6.—VOLKMAN BUILDING, SHOWING PROTECTION AFFORDED BY FIREPROOF DOORS AND WINDOWS.

Fig. 6 shows the exterior of the Volkman Building, where may be seen fireproof doors and windows of the approved type, which not only resisted the fire from without, but also successfully withstood the blows of the falling walls of the adjoining building.

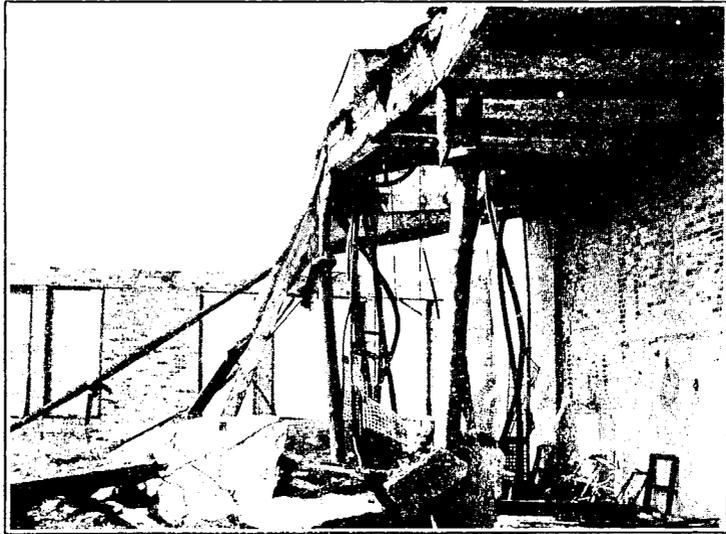
FIG. 12.—FAILURE OF CAST IRON COLUMNS, CAUSING COLLAPSE OF CINDER CONCRETE FLOOR.

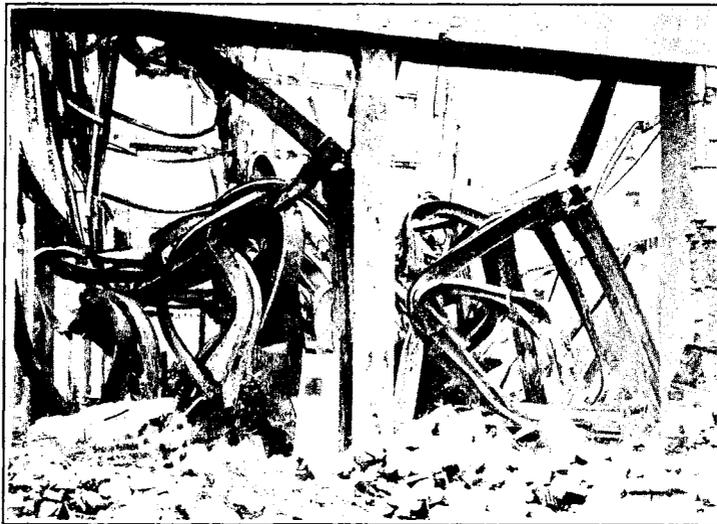
FIG. 13.—RESULT OF FIRE IN BUILDING WITH UNPROTECTED STEEL STRUCTURAL MEMBERS.

beams of steel and with a floor of concrete, that the building is fireproof. One has only to look at Fig. 13 to see how foolish this supposition is. Here the total collapse of the unprotected steel work of such a building stands as a monument to bad construction, and of the fallacy of calling such a structure fireproof.

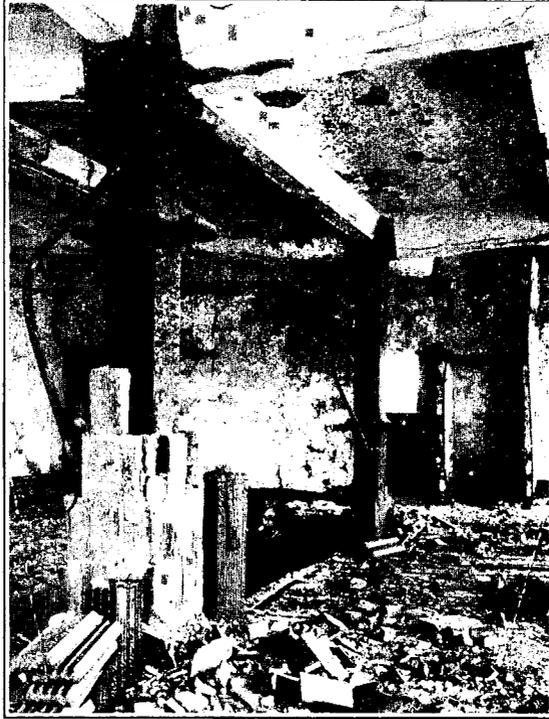
FIG. 20.—FAILURE OF STEEL COLUMN THROUGH EXPANSION OF ENCLOSED PIPES DESTROYING THE TERRA COTTA FIREPROOFING.

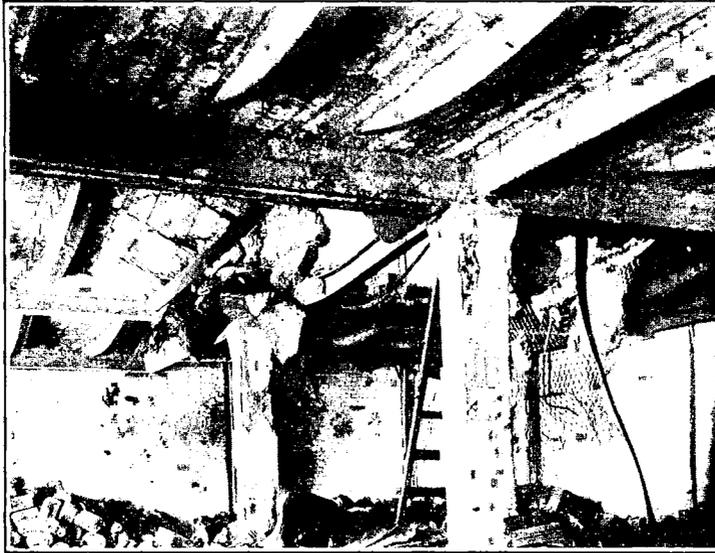
FIG. 29.—FAILURE OF FIREPROOFED FLOOR DUE TO EXPOSURE OF LOWER FLANGE OF BEAMS.

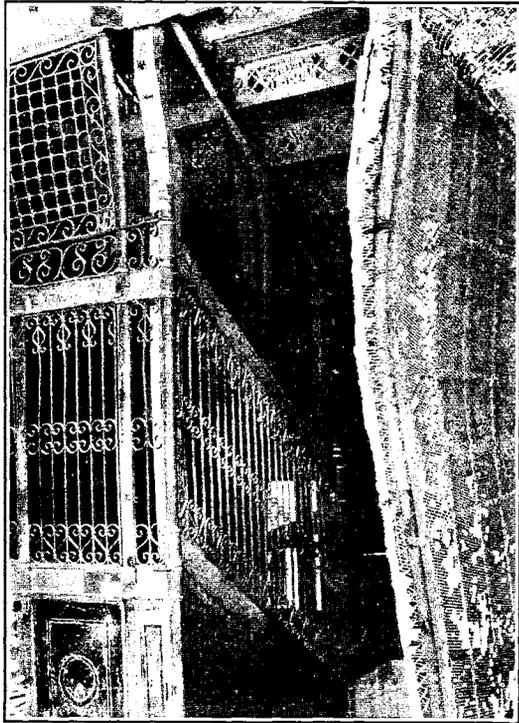
FIG. 30.—FAILURE OF PARTITION OF PLASTERED METAL FABRIC SUPPORTED BY ANGLE IRONS.

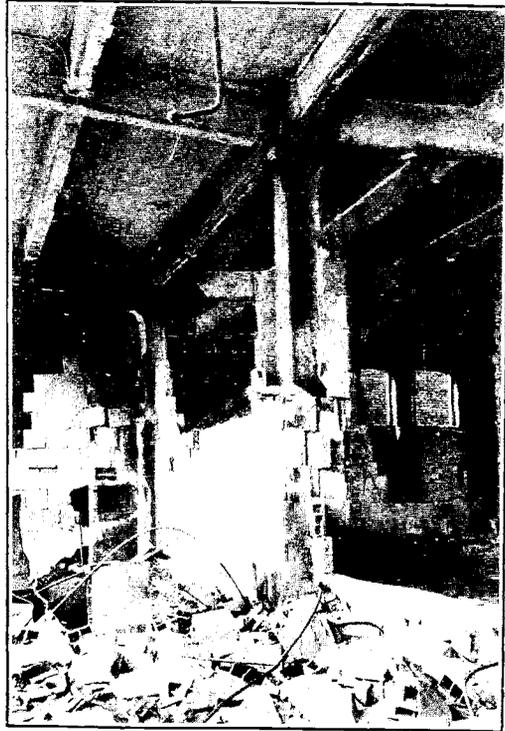
FIG. 31.—FAILURE OF TERRA COTTA PARTITION.

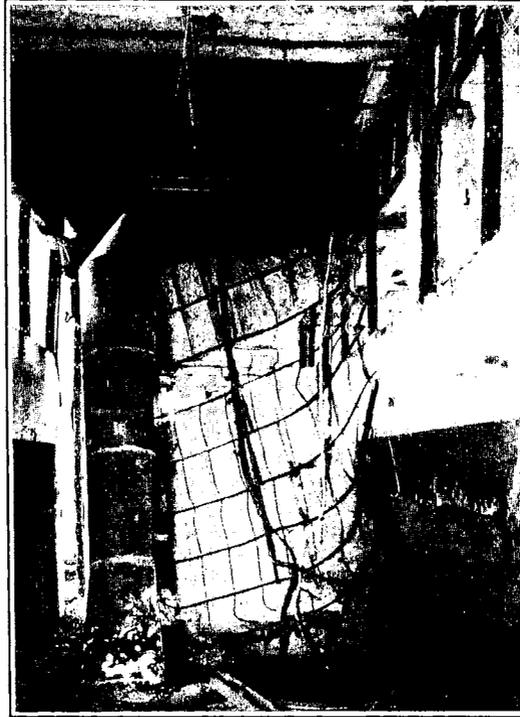
FIG. 35.—FAILURE OF SUSPENDED CEILING.

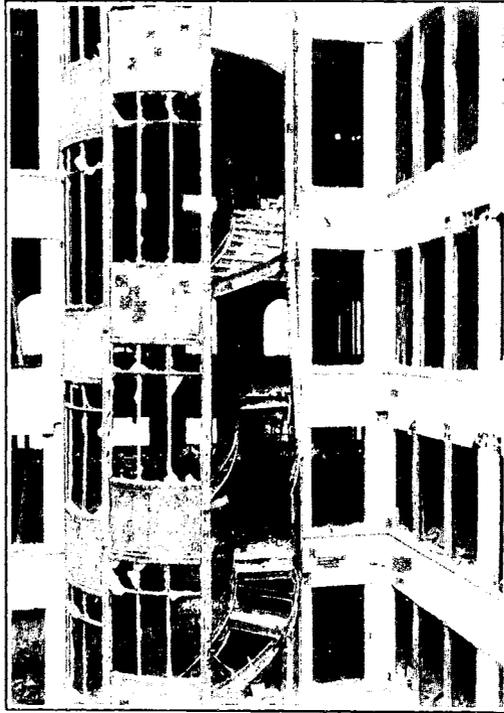
FIG. 42.—FAILURE OF POORLY PROTECTED STAIRWAY.

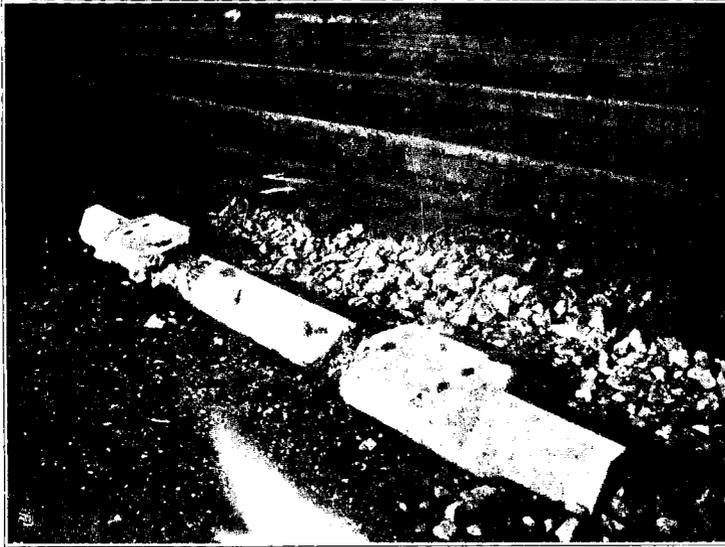
FIG. 8.—MANNER OF FAILURE OF REINFORCED CONCRETE TIES IN LONDON AND SOUTHEASTERN RAILWAY.

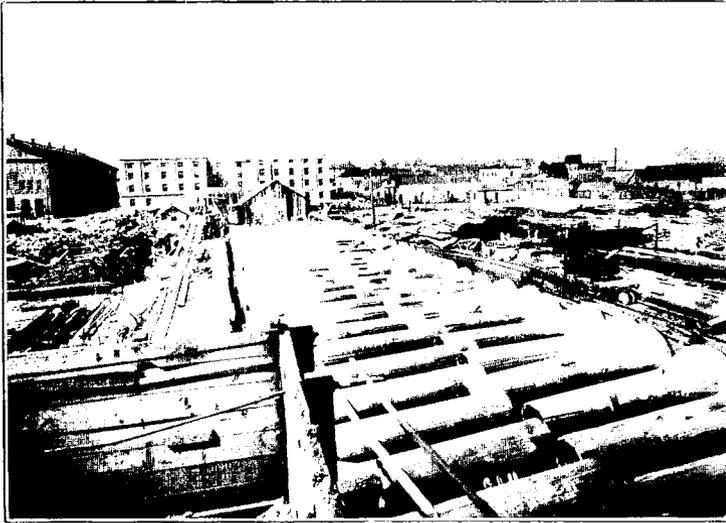
FIG. 12.—REINFORCED CONCRETE PILE SHELLS FOR PIER 8, NAVY YARD, PUGET SOUND, WASHINGTON.
