Overview of the NIST-ATC Project on Benchmarking of Evaluation Methodologies for Existing Buildings

Siamak Sattar

National Institute of Standards and Technology

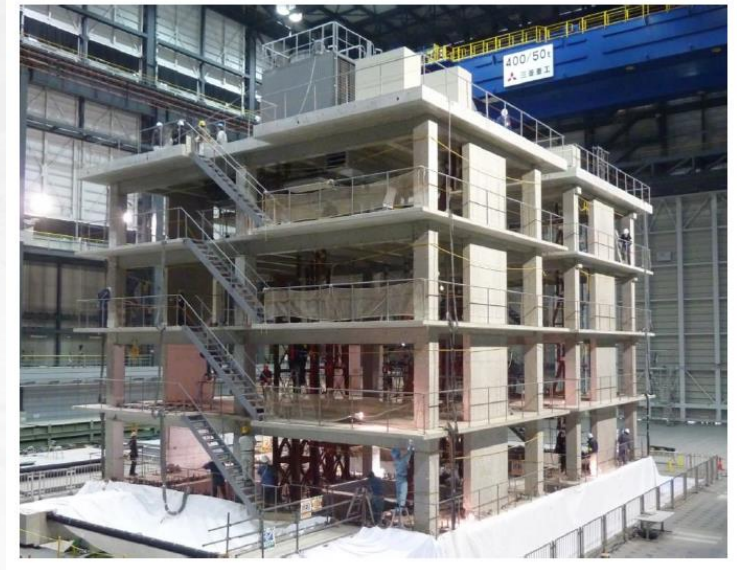
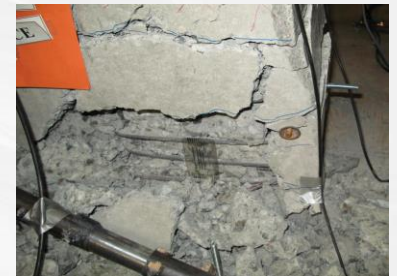
E-Defense Shake Table Test

- 4-story full scale reinforced concrete frame and shear wall buildings
- Tested under multi-directional seismic loading
- Damage:
 - Column and beam hinging
 - Sever joint shear failure
 - Sever damage in the boundary element of shear walls and sliding

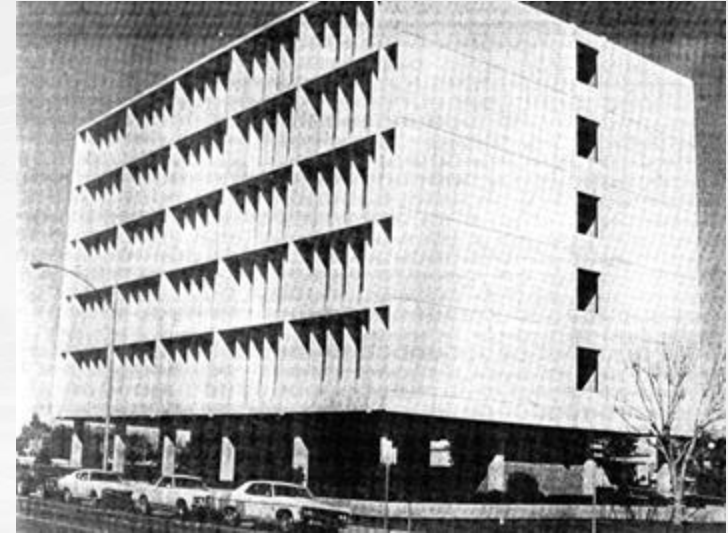
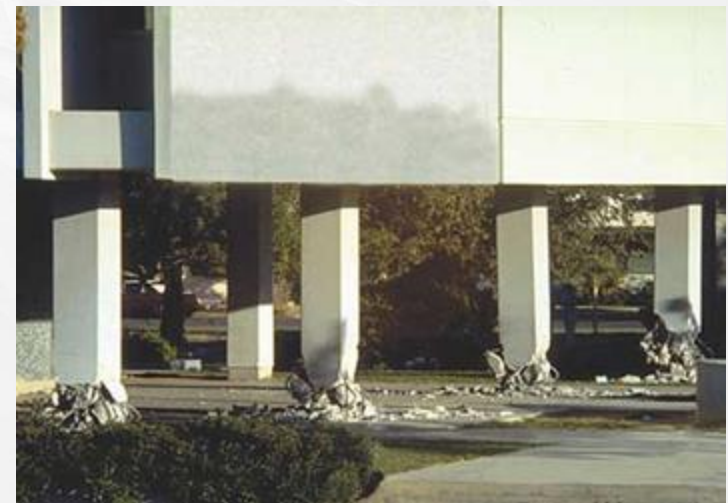
Imperial County Services Building

- 6-story building
- Frame in one direction and wall-frame in another direction
- Damaged in 1979 Imperial Valley EQ
- Include irregularities: weak/soft story, wall discontinuity, torsional sensitivity
- Damage:
 - Biaxially driven column failure on the east end

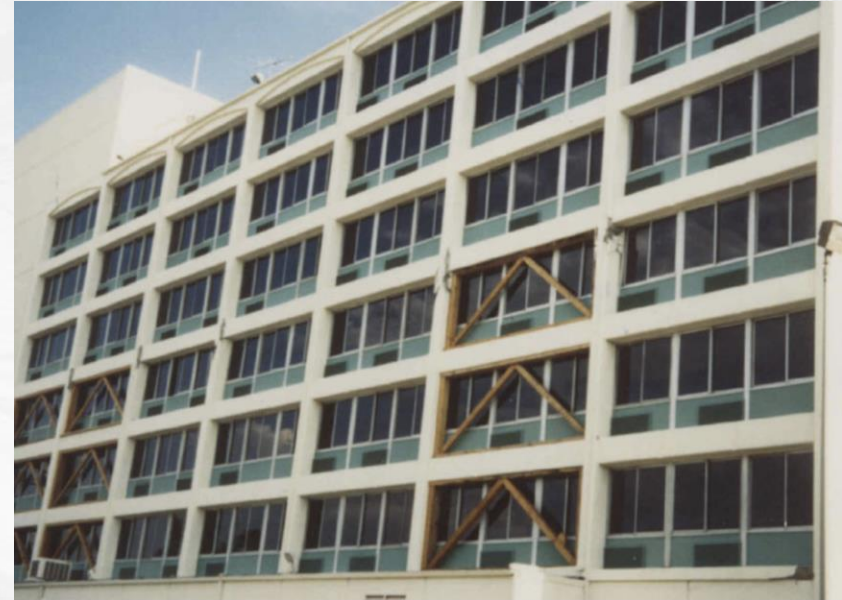
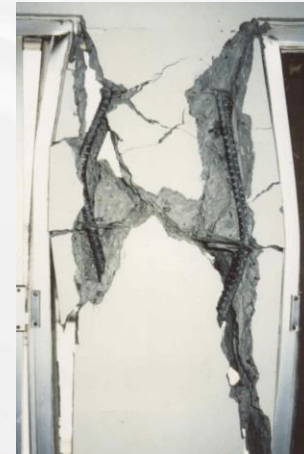
Holiday Inn Van Nuys

- 7-story building
- Built in 1966
- Perimeter spandrel beam-column frame and interior slab-column frame
- Damage:
 - 1994 Northridge earthquake caused shear failure in several columns in the 4th and 5th stories

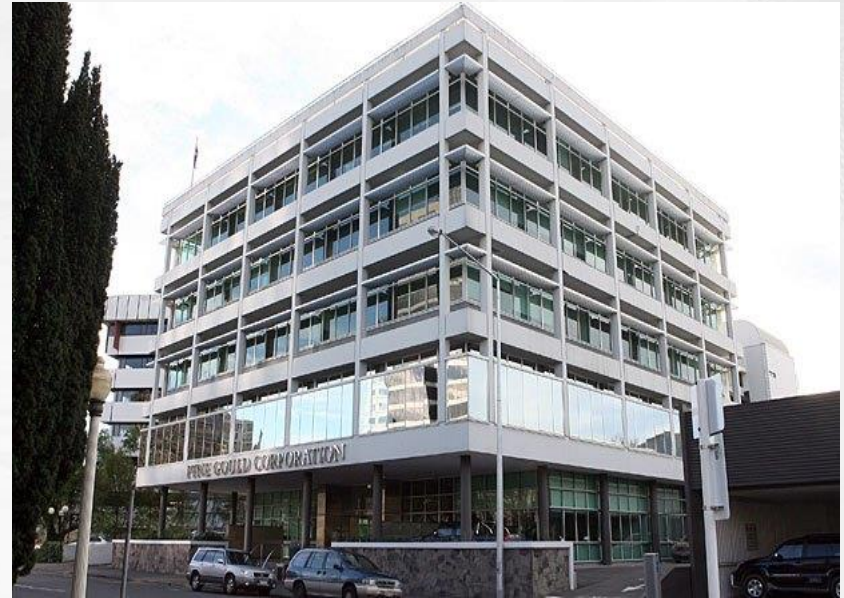
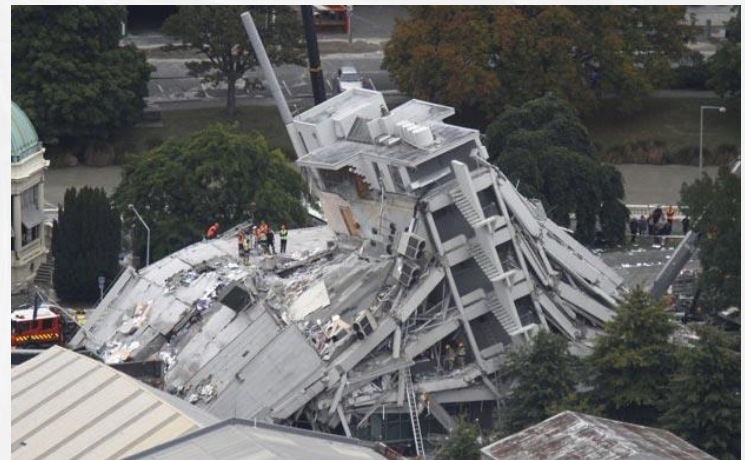
Pyne Gould

- 5-story building
- Built in 1966 in Christ Church
- Reinforced concrete walls with gravity RC frame
- Damage:
 - The building was collapsed

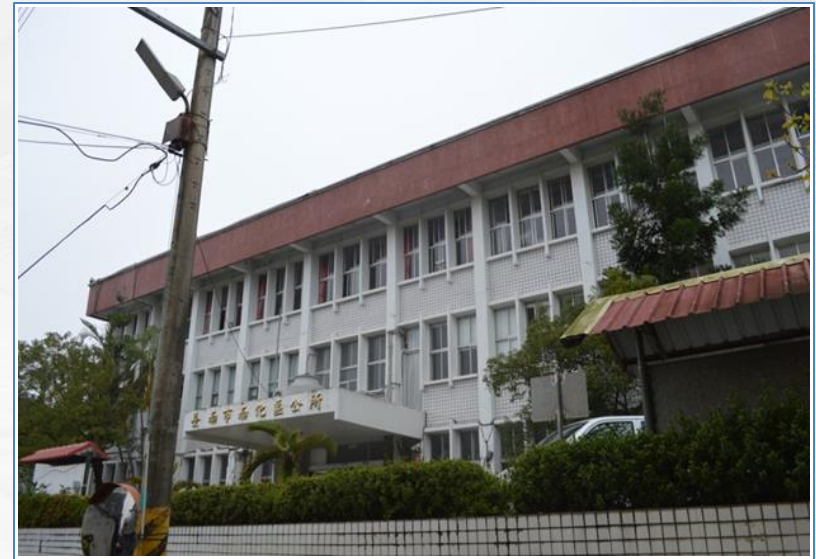
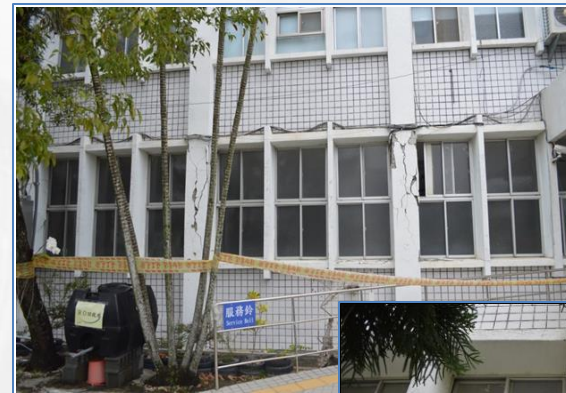
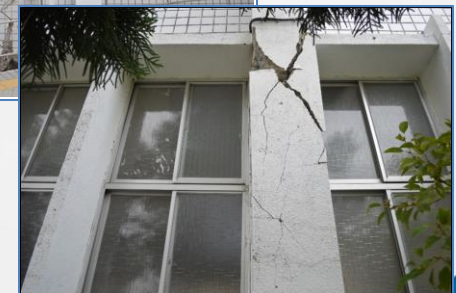
Nanhua District Office Taiwan (2016 Meinong EQ)

- 3-story building
- Built in 1967
- One-way slab-beam-column moment frame
- Full-height and partial-height infill walls
- Damage:
 - Diagonal cracking of columns and infill walls in the first story

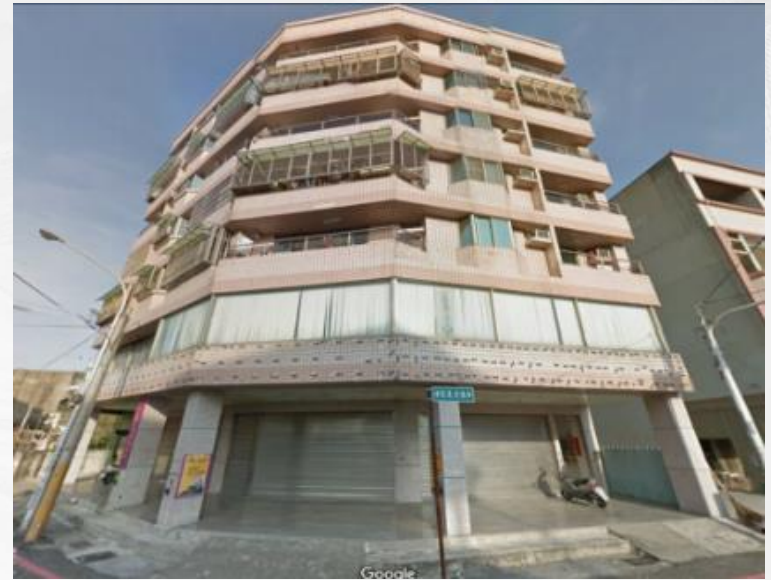
Xingfu District Office Taiwan

- 7-story building
- Built in 2000
- Slab-beam-column moment frame
- Full-height RC walls and partial-height infill walls
- Damage:
 - Partial collapse of the building

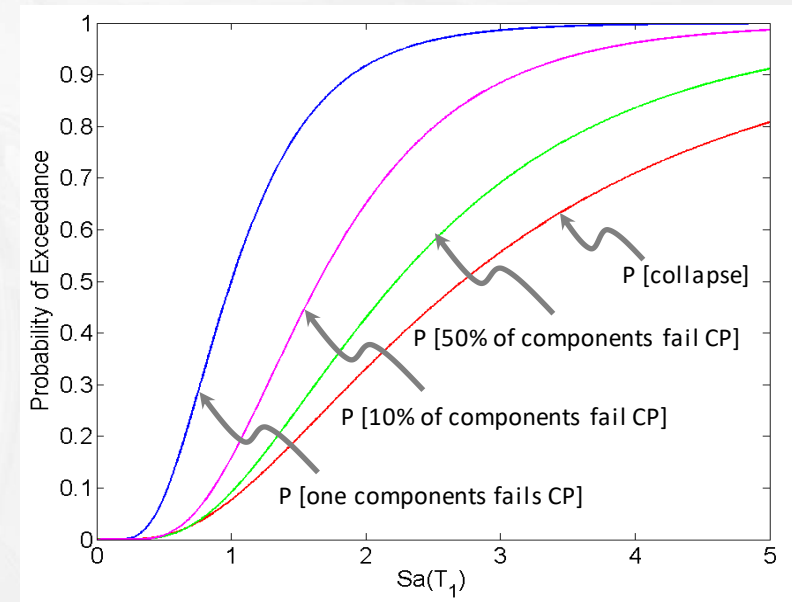
Assess the Global Performance

- Knowing P [collapse] | MCE_R would identify the expected performance of the buildings with respect to the target performance in ASCE 7.
- Linking the component level performance to the system level performance, i.e. global collapse to ASCE 41 definition of collapse.
