UHPC for repair of steel piles

Dr. Mohamed ElGawady

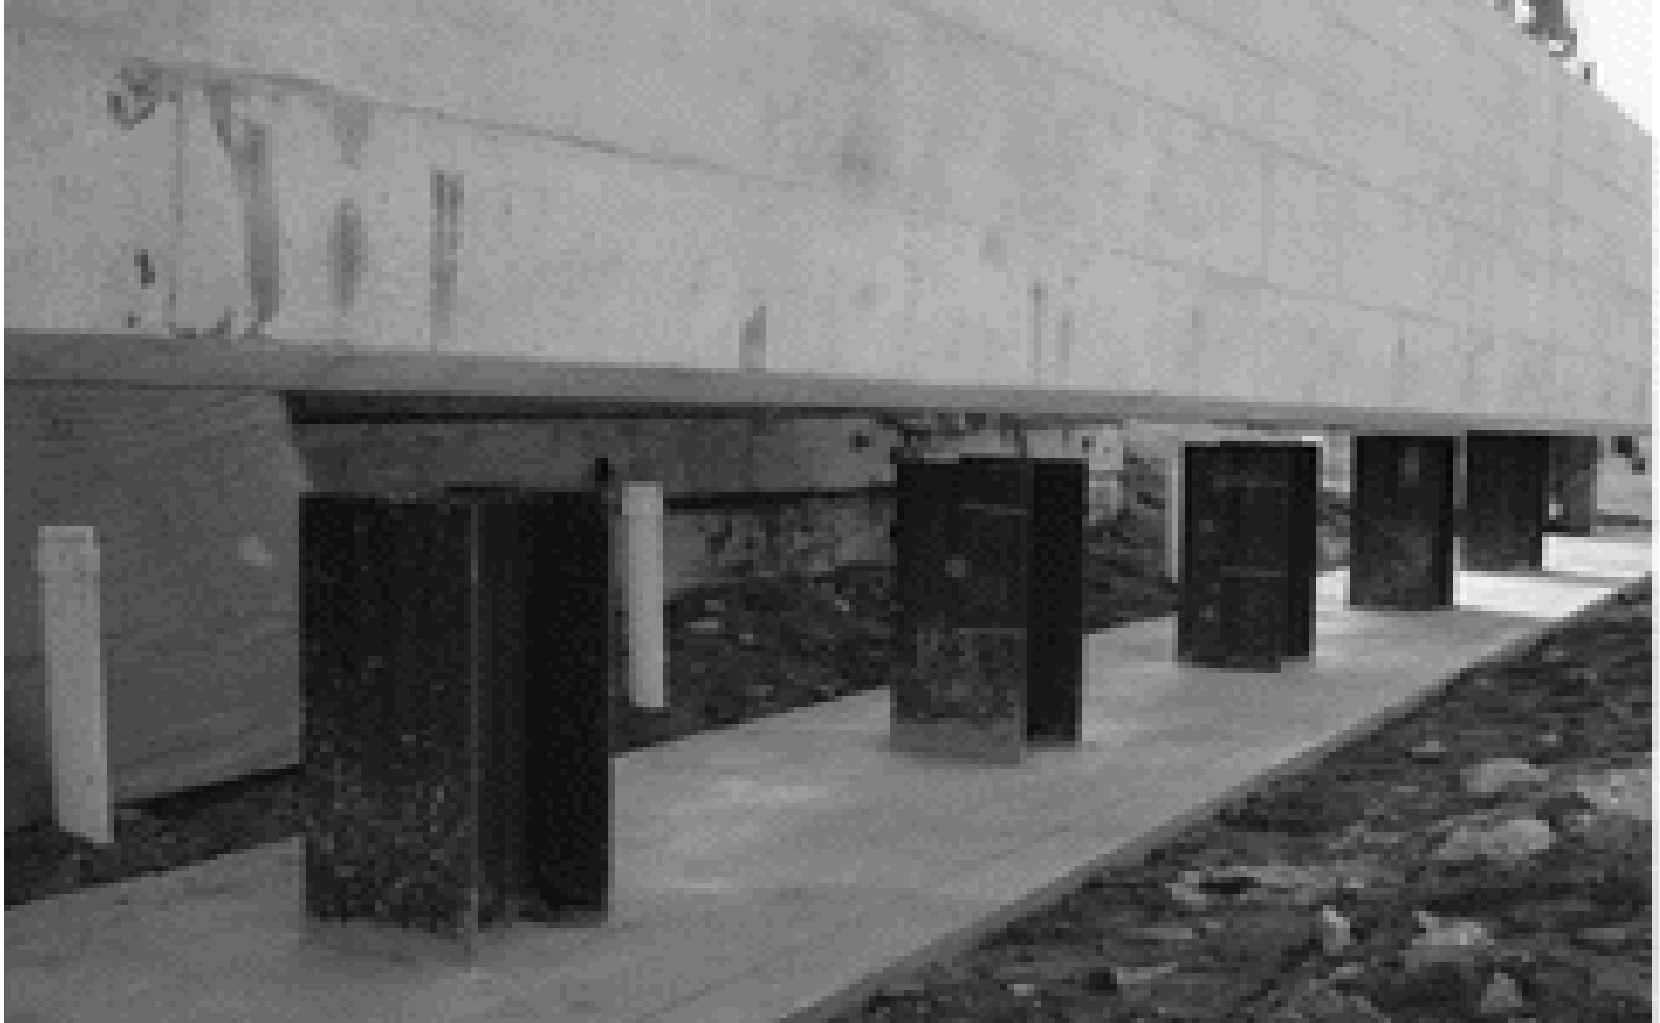
Steel HP piles used for abutment foundations

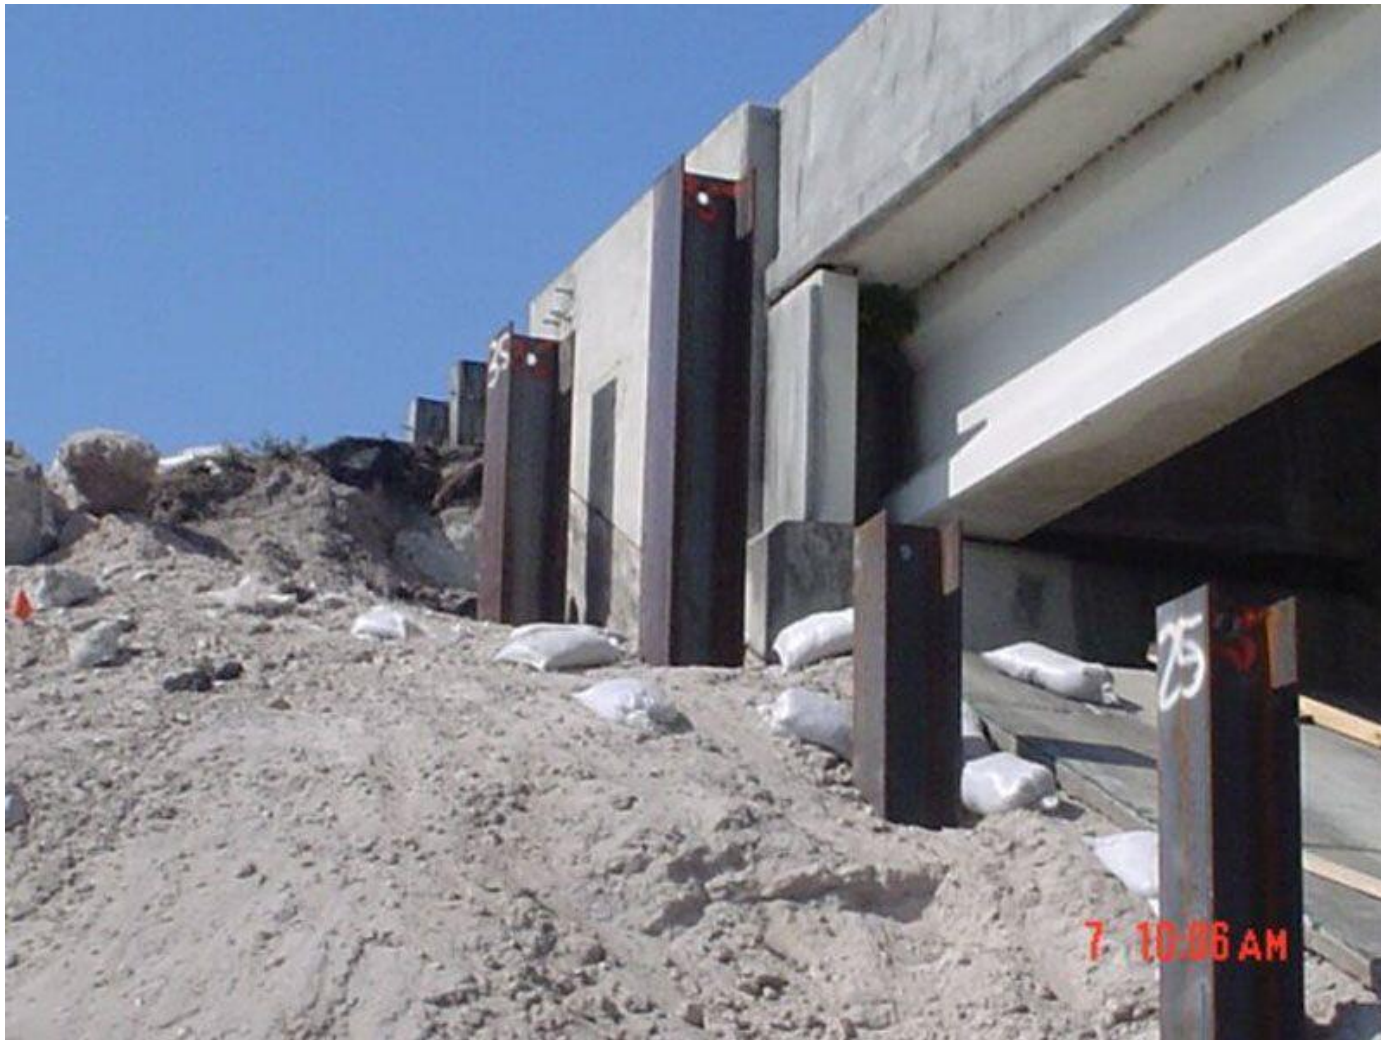
Steel HP piles used in conjunction with sheet piles

(FL Turnpike – Deerfield Beach)

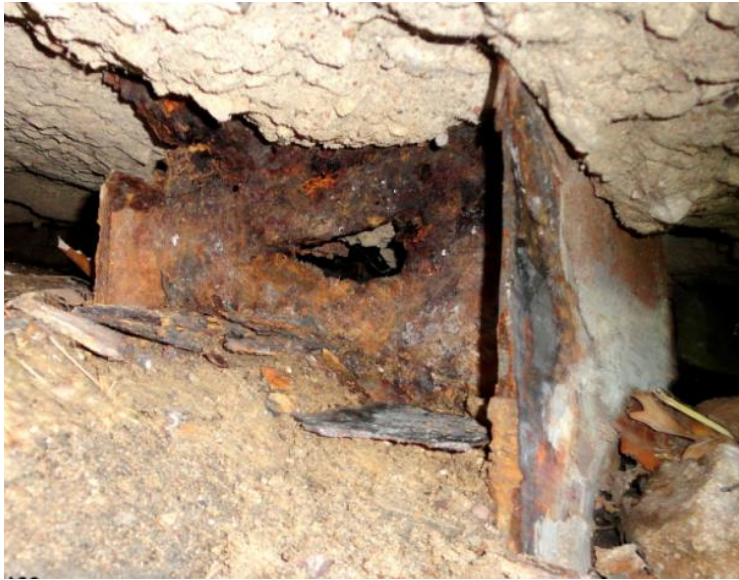
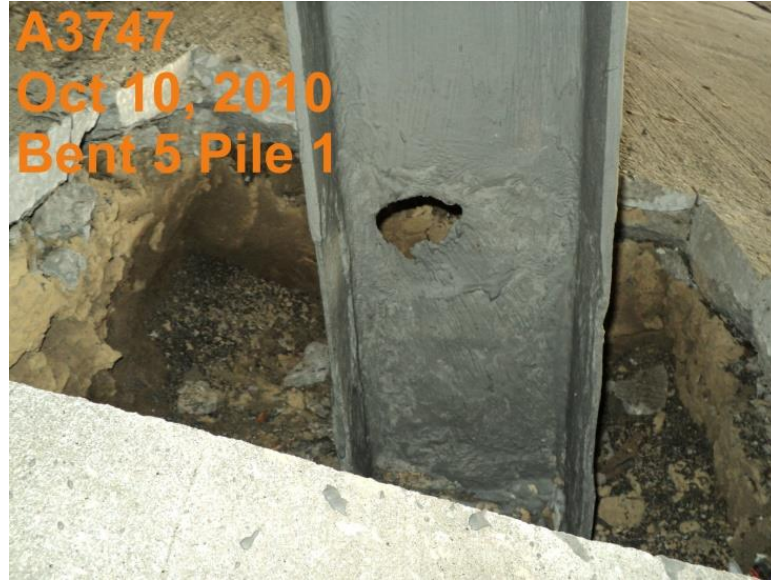
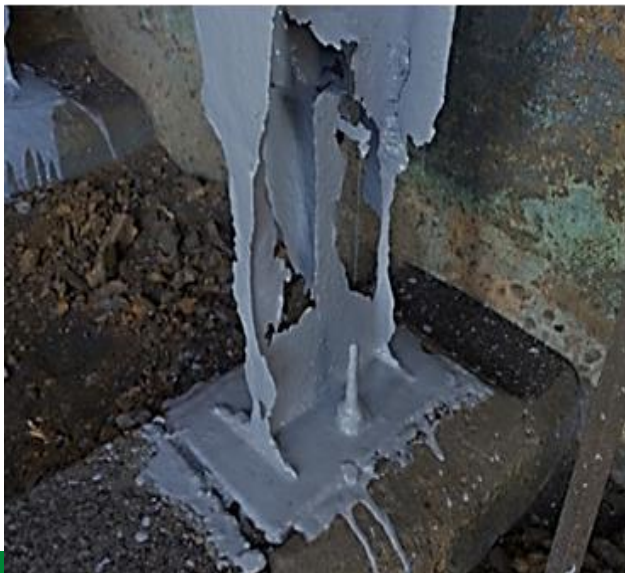
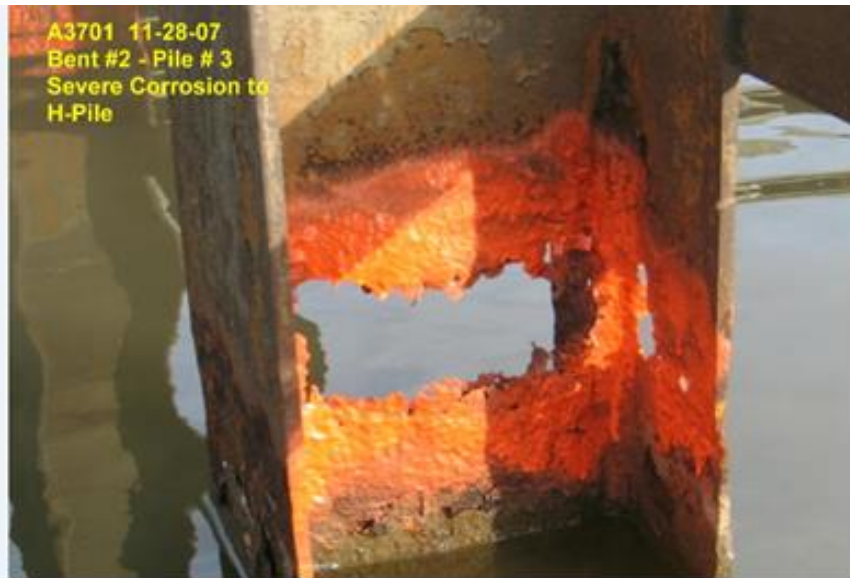
Corroded Piles

- 700 bridges need pile maintenance
- 300 have pile section loss (80 severe to limit loads)

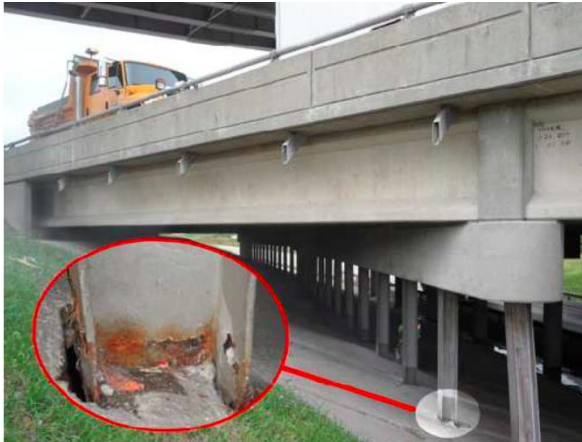
One of the 49 Corrosion-damaged piles in I-70/I-270 interchange (St. Louis, MO) that were repaired with this technique

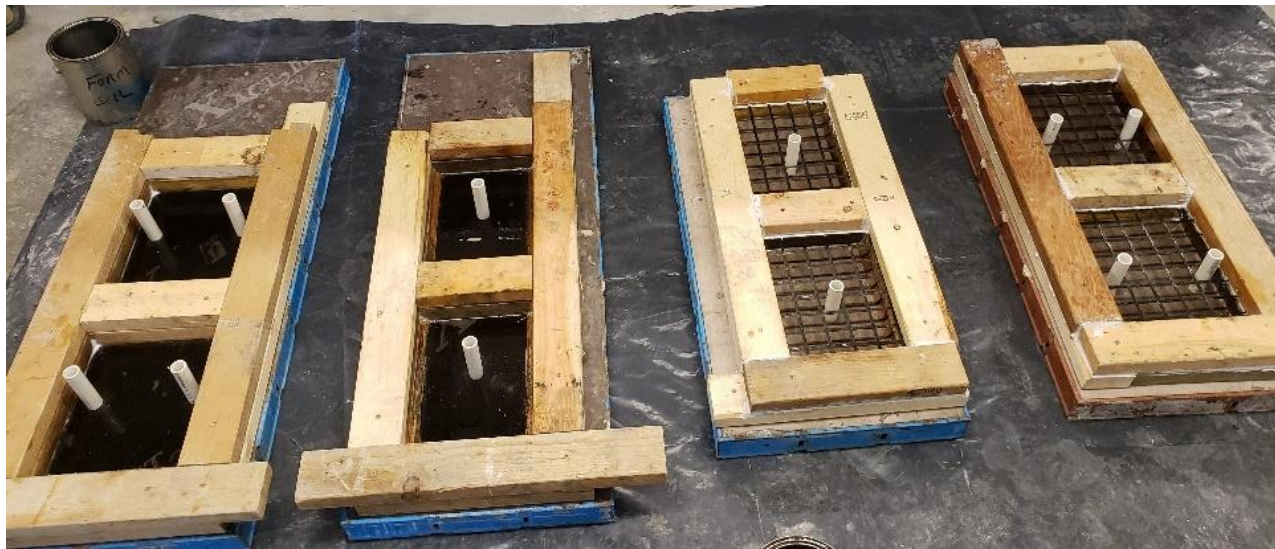
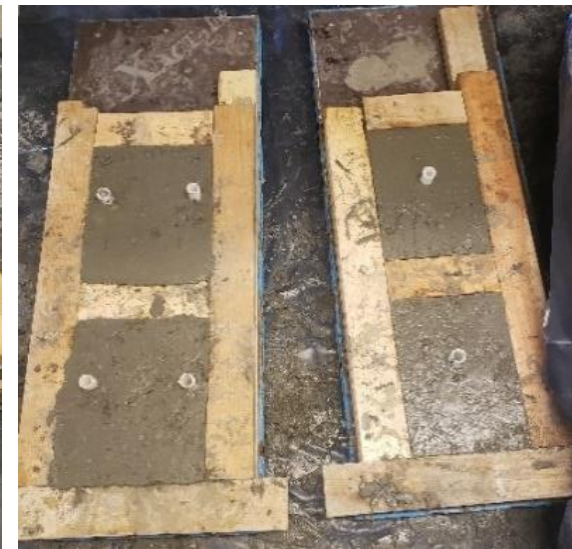
w/c*	Cement Type III	Slag	Fine Sand	HRWR	Water	Steel Fiber
0.2	945 (1,593)	220 (371)	1,008 (1,699)	43.8 (73.8)	200 (337)	157 (265)

kg/m³ (lb/yd³)

- UHPC was developed using locally available material in Missouri
- UHPC plates were able to provide the full strength of H-piles
