Load Test of a Precast Concrete Tub Stadium Riser and Bond Testing of #20 Bar

Wiss, Janney, Elstner Associates, Inc.

The Project

Corpus Christi Harbor Bridge Project

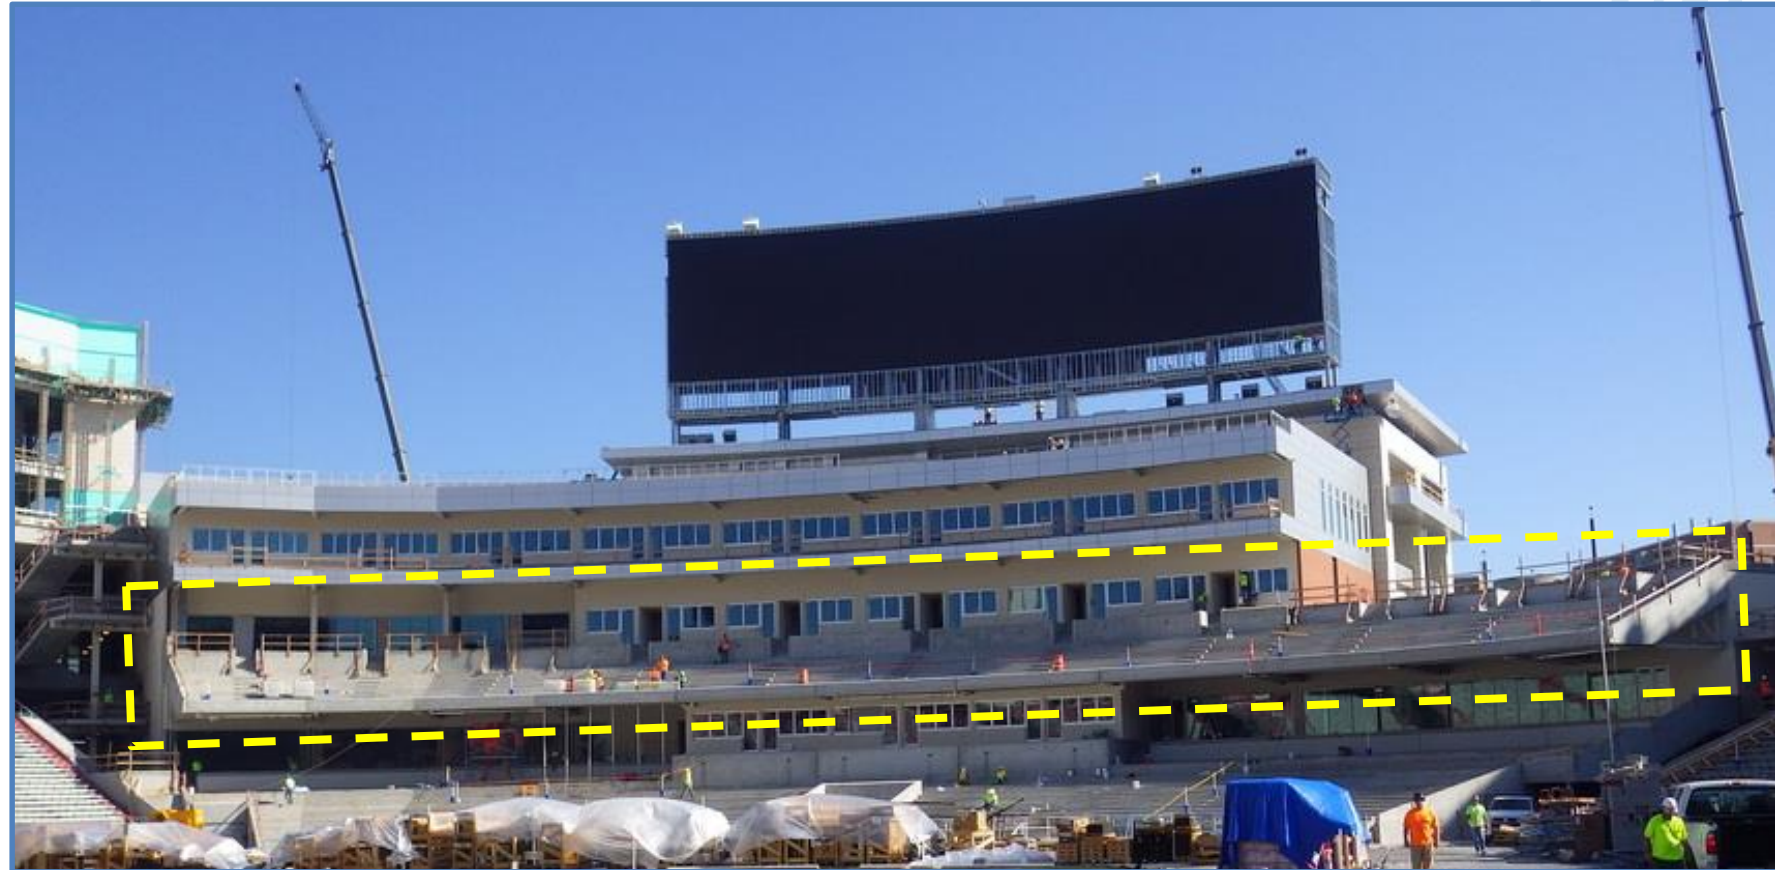
- Expansion at a collegiate football stadium
- Mezzanine club level in endzone
 - Cantilevering precast concrete tub riser
 - Supported by steel truss

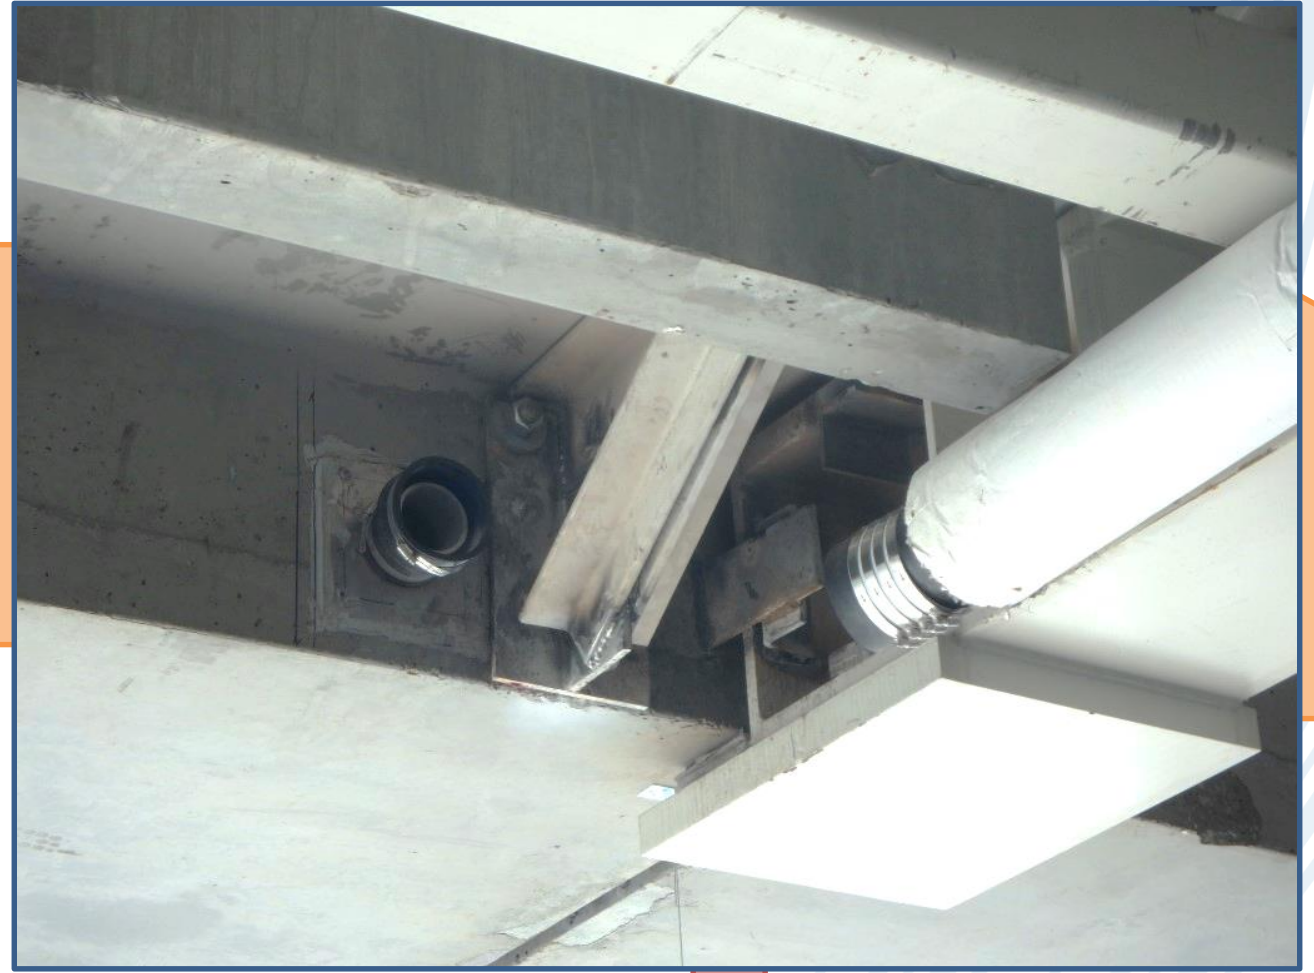
Retrofit and Load Test

- Bending response
 - Longitudinal
 - Transverse cantilever
 - Torsional

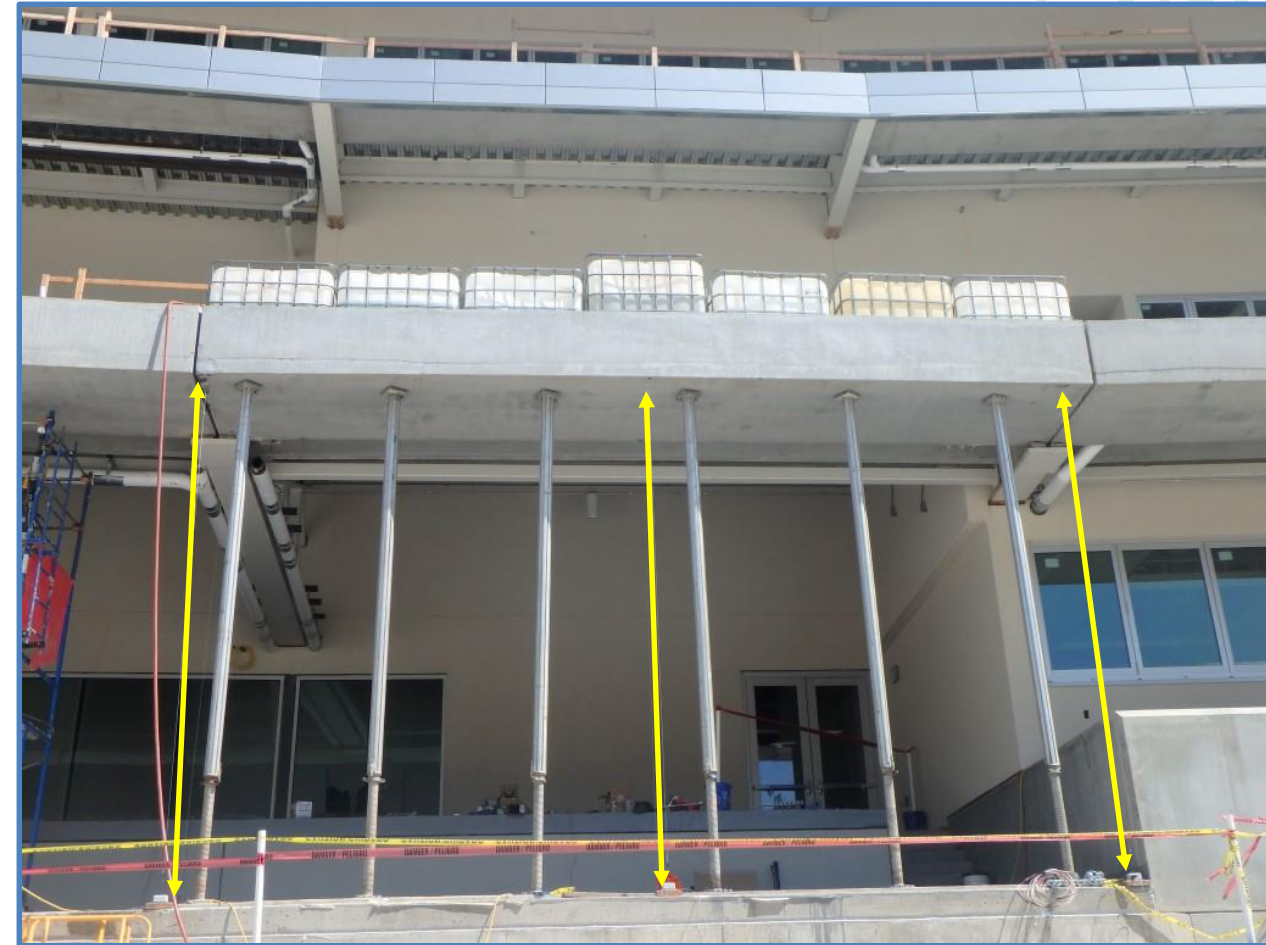
Load Test per ACI 318-11

- Load cantilever portion
- Design live load = 100 psf
- Total test load = 150 psf
- Use industrial totes for loading
 - 30 inches of water
- Load
 - Four equal increments with 24-hr hold
 - Measure deflection with string potentiometer
 - Measure crack width

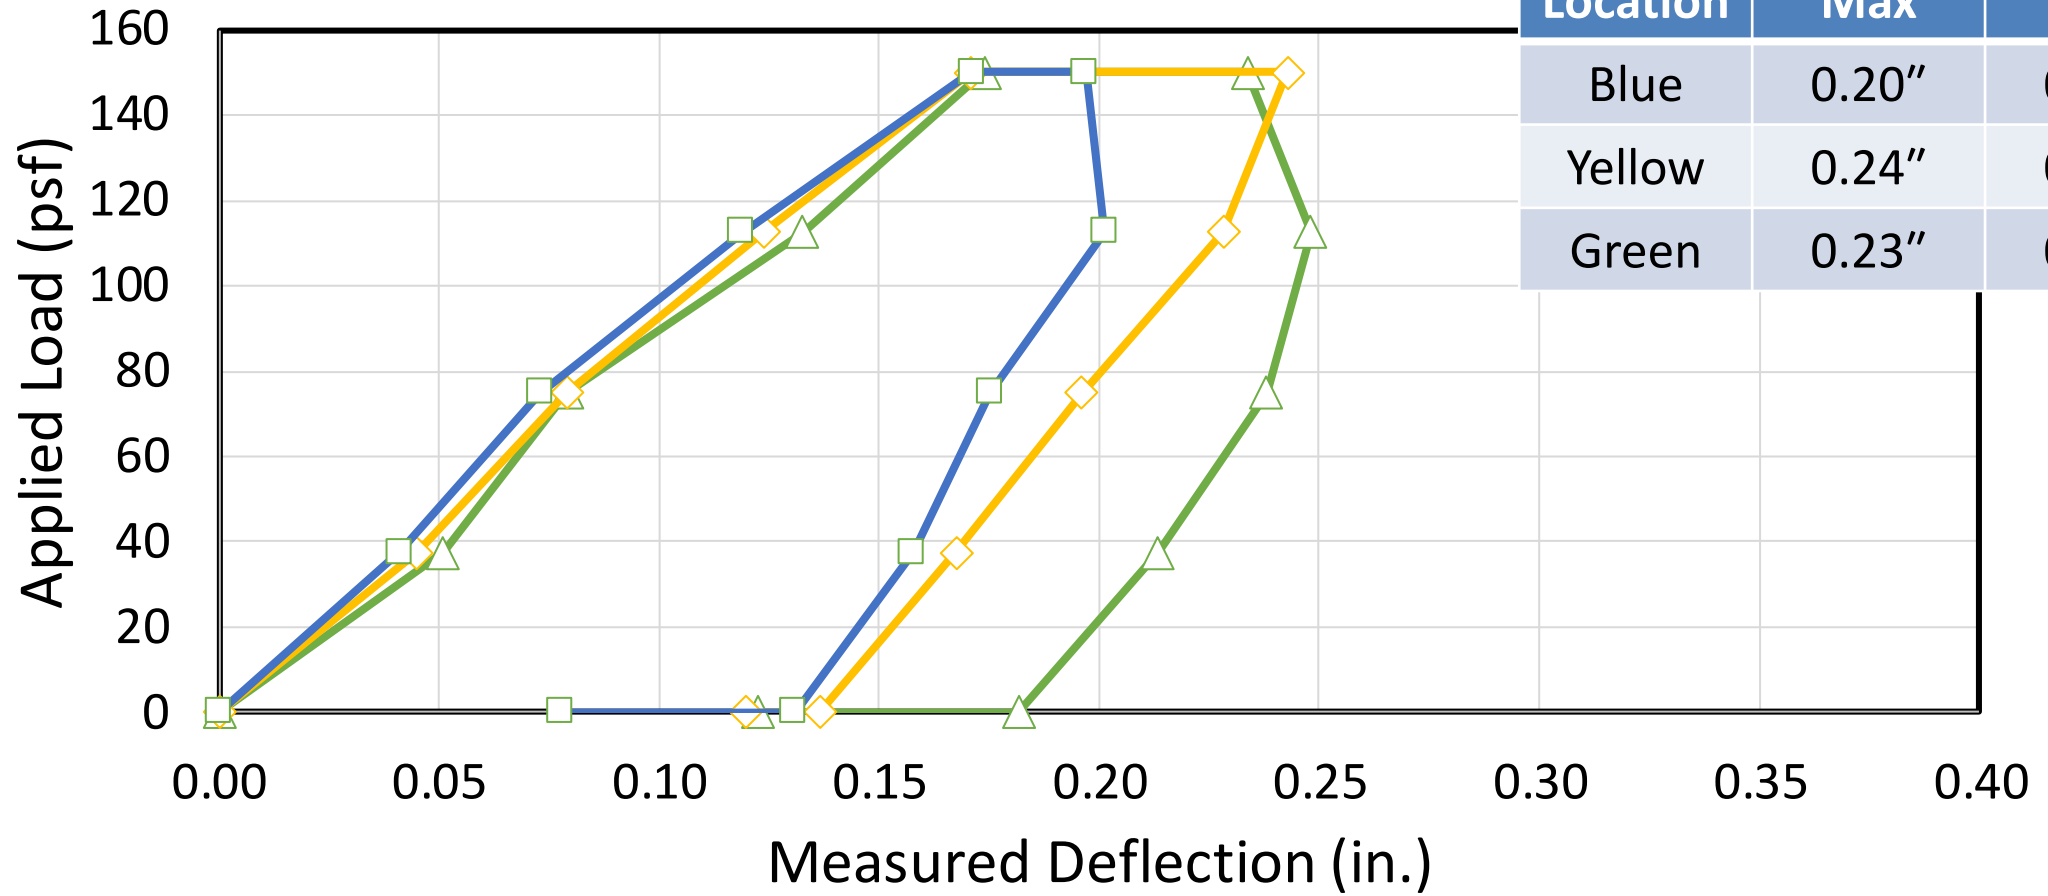
Relative Deflection

Location	Max	Final
Blue	0.20"	0.08"
Yellow	0.24"	0.12"
Green	0.23"	0.12"

Location	Max
Blue	0.20"
Yellow	0.25"
Green	0.25"

Location	Max/4	Final
Blue	0.05"	0.05"
Yellow	0.06"	0.06"
Green	0.06"	0.06"

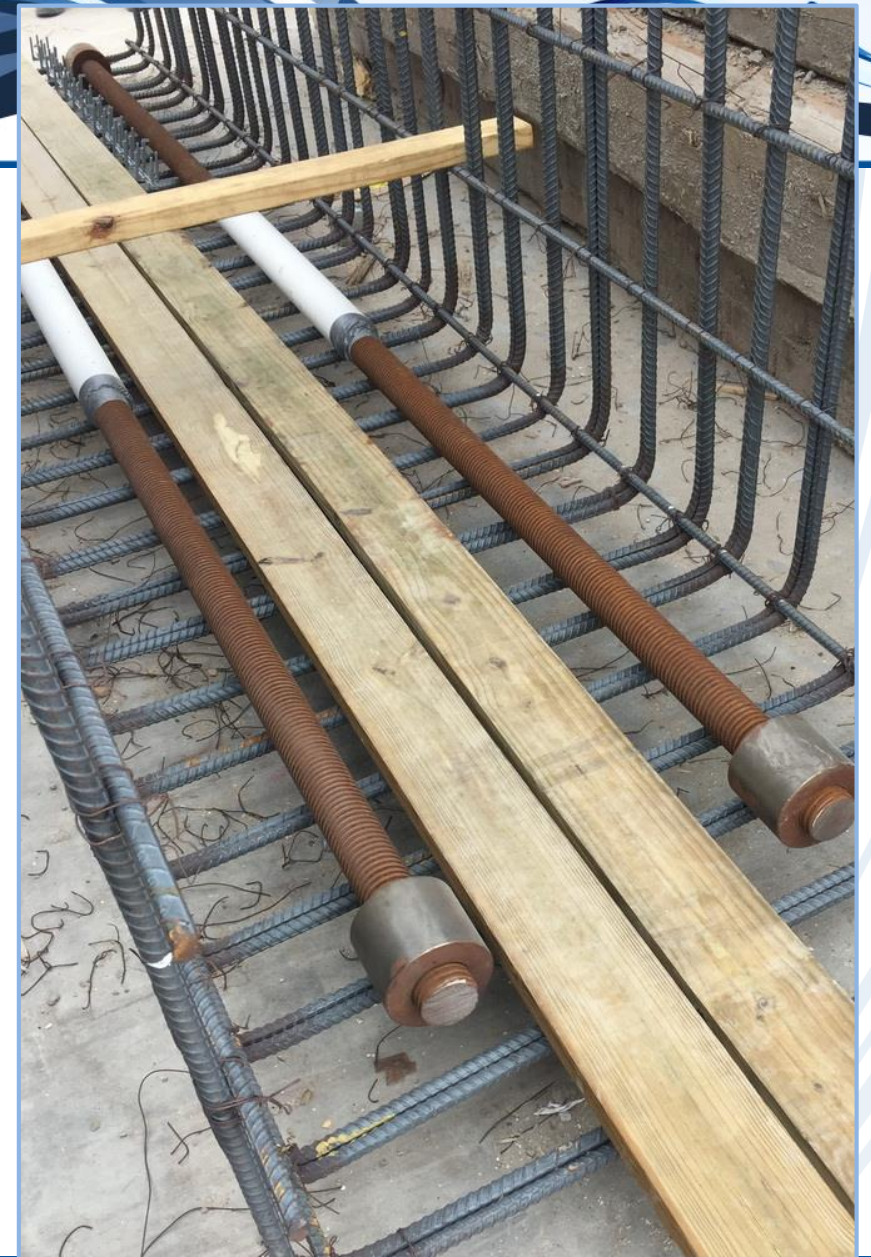
Fabricated Beams

- 6'-0" deep, 4'-0" wide, 15'-6.5" long
- Development length: 4'-8"

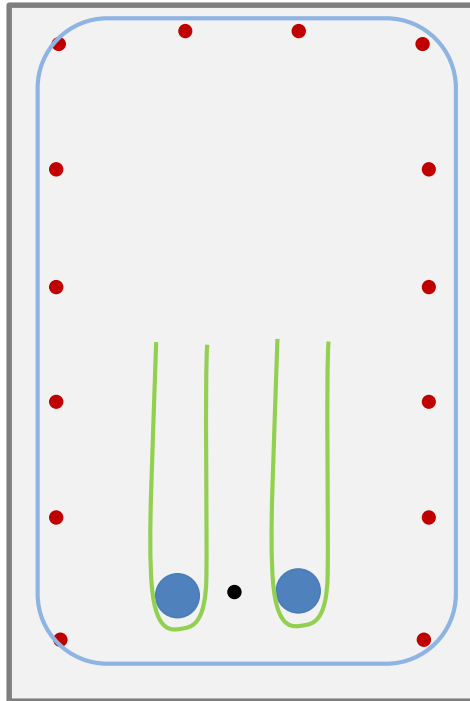
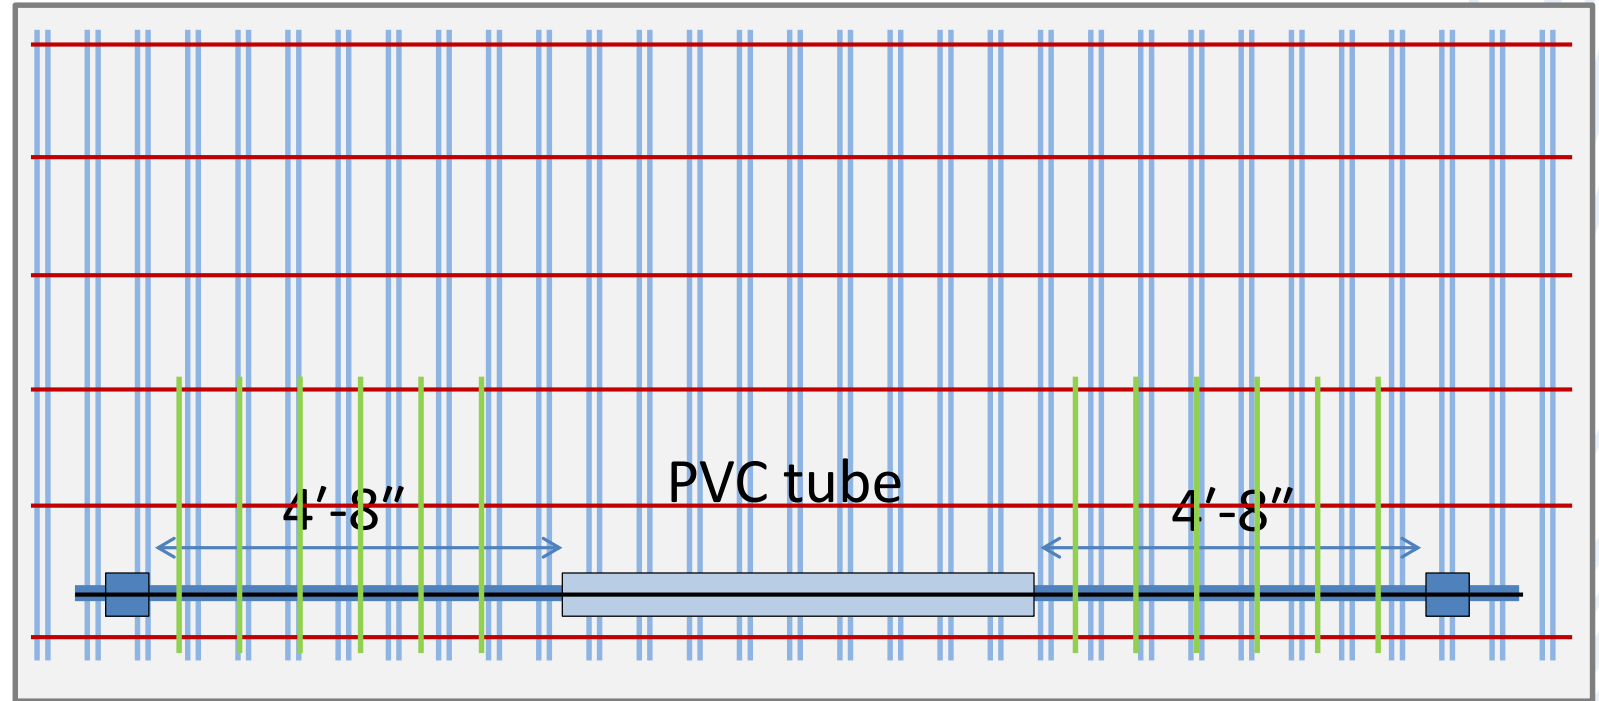
2#20s

1#5 (Grade 100)

14#5

2#6 @ 6" O.C.

#4 @ 9" O.C.

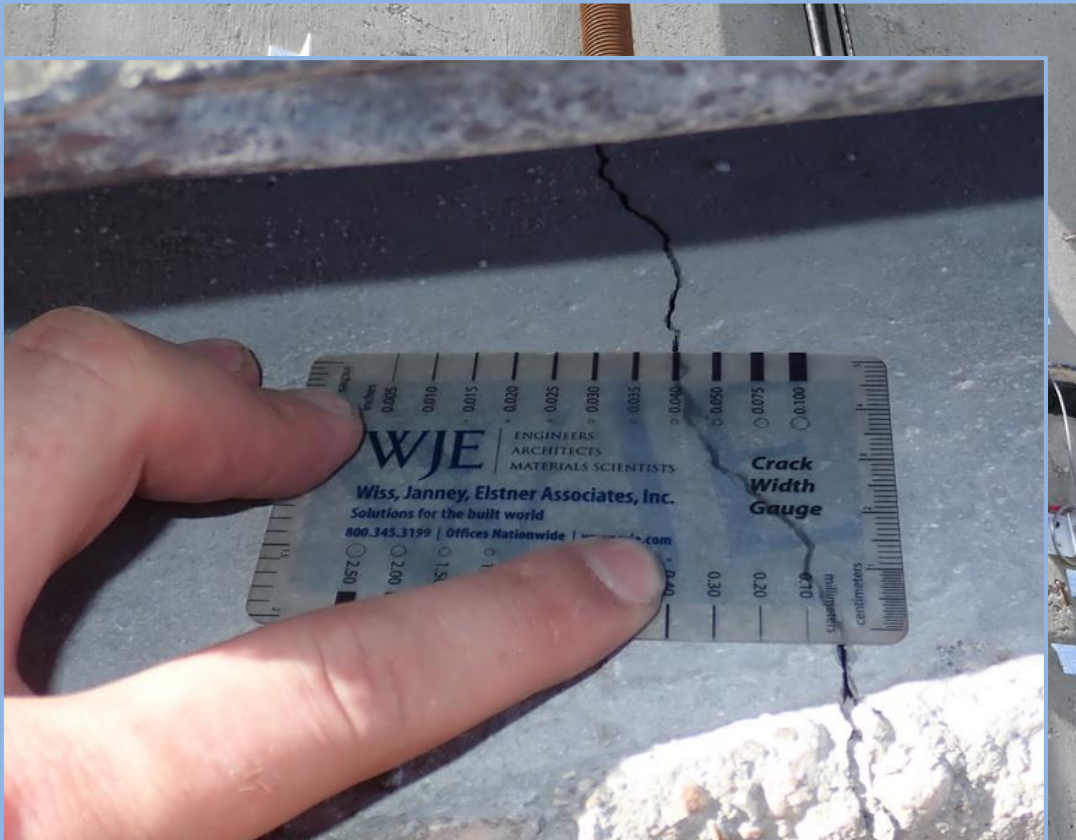
Condition of Beam

Residual Strain (external): $1,000 \mu\epsilon$
 $0.04'' \text{ crack} / 38'' \text{ gage} = 1,052 \mu\epsilon$

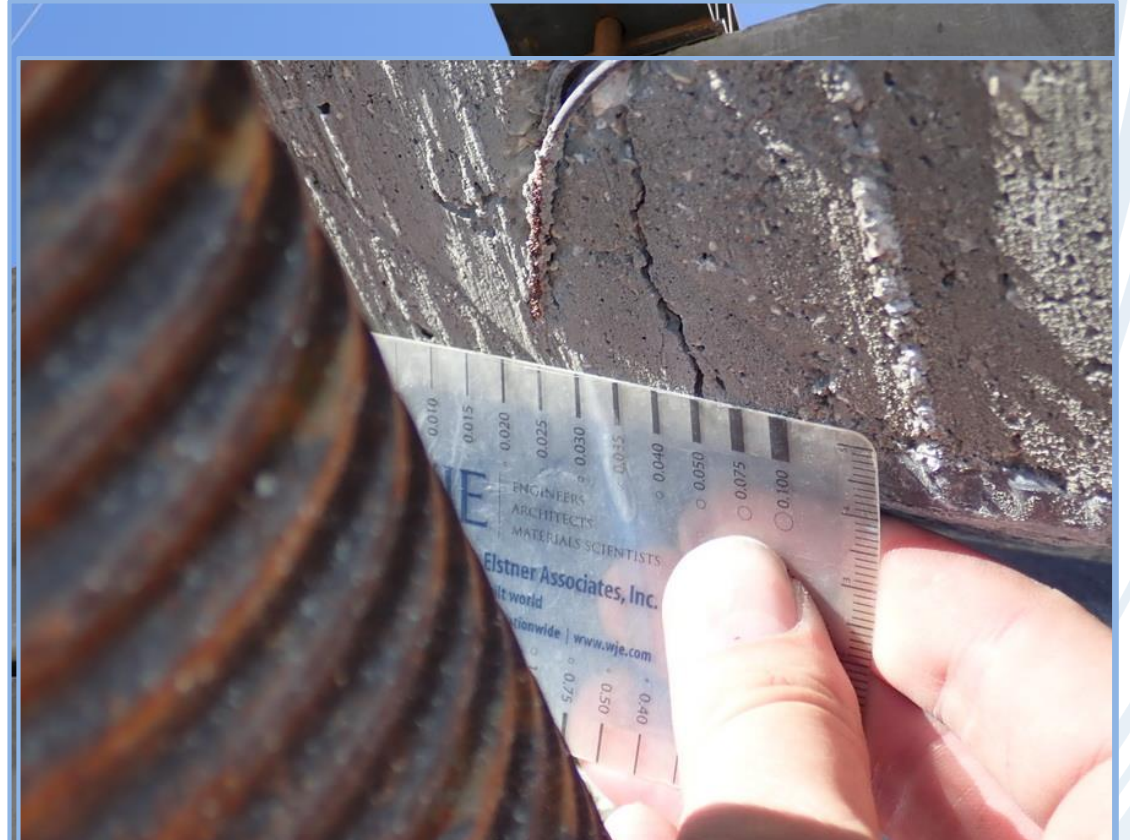
Residual Strain (external): $1,200 \mu\epsilon$
 $0.05'' \text{ crack} / 38.125'' \text{ gage} = 1,300 \mu\epsilon$
