# Performance of welded grid reinforcement as crack control in end zones of pretensioned bulb-tee beams

# Agenda

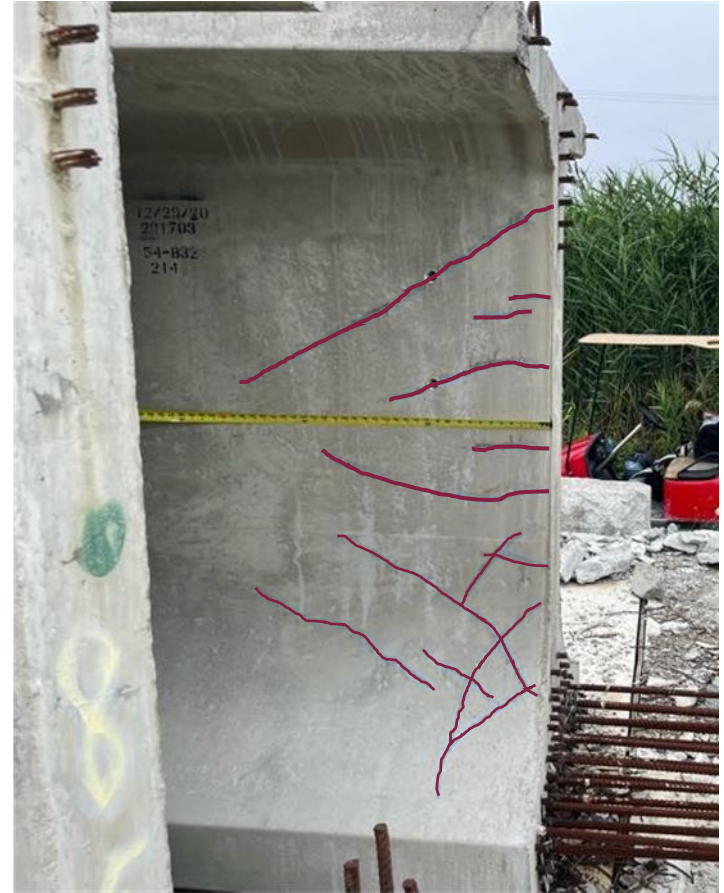
## PCBT End Zone Cracking

- During strand detensioning and beam lifting operations large transverse tensile stresses occur
- As a result, cracks often occur posing a durability concern
- Current design codes often do not adequately resist end zone cracking

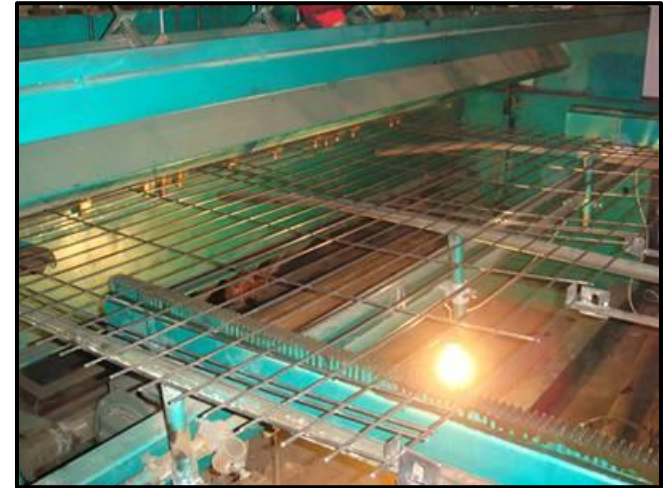
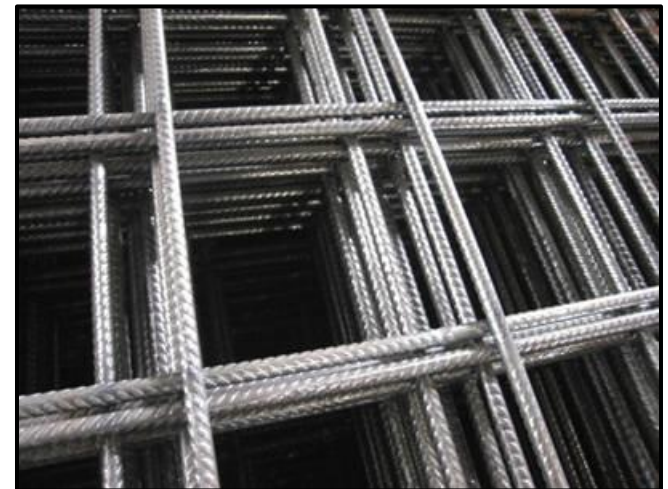
## Motivation - WGR

- Limited studies suggest that welded grid reinforcement (WGR) may control cracking better than tied reinforcement
- WGR can be made of deformed bars, with large diameter bars

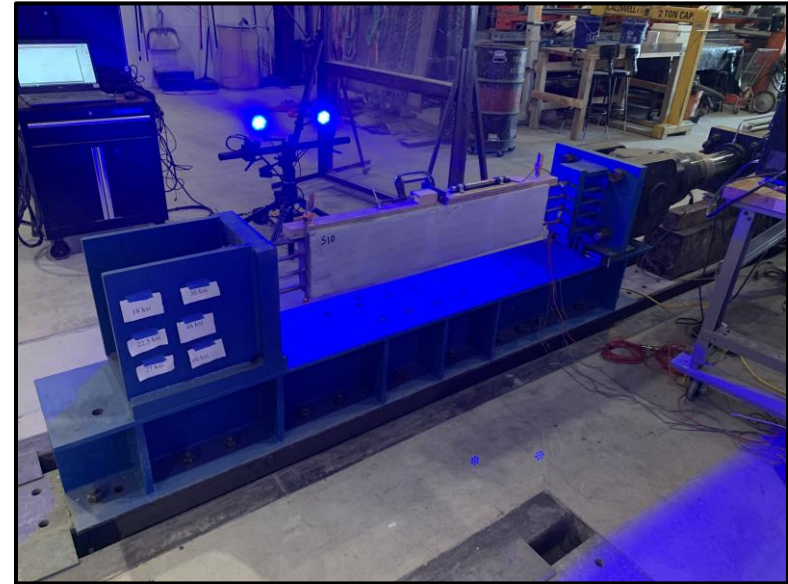
## Goals/Testing Setup

- Evaluate how the cracking behavior changes based on:
  - Cross wire spacing
  - Cross wire diameter
  - Longitudinal wire stress levels

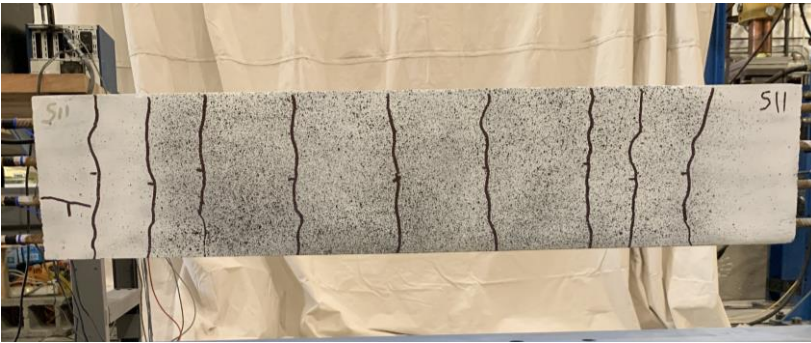
D4 @ 3"

## Results – photos of testing and preliminary takeaways

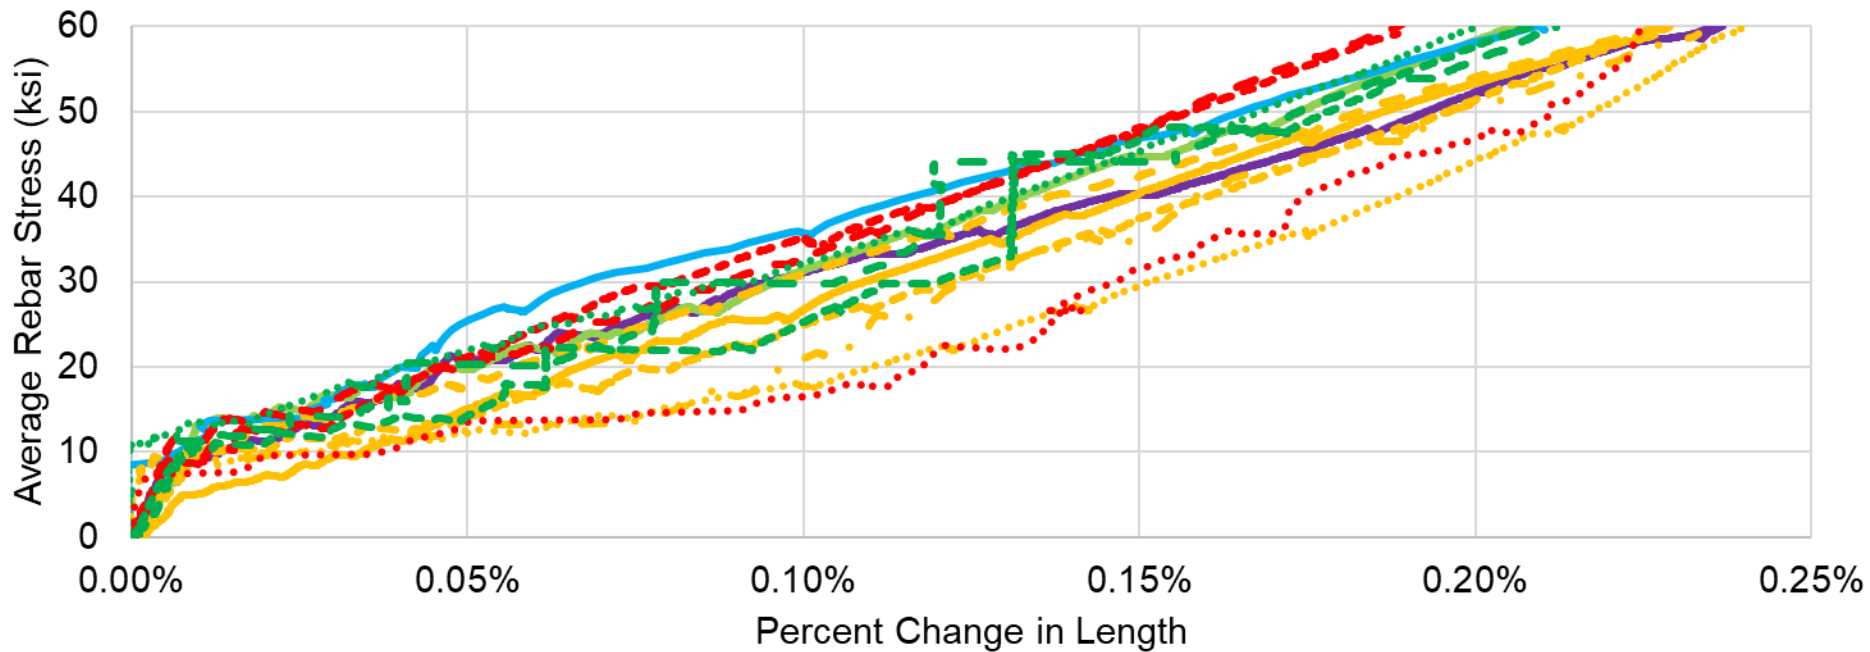
## Results – Length Change

Rebar Stress vs Percent Change in Length

- Rebar
- D10 @ 6 in. - tied
- D10 @ 12 in.
- D20 @ 6 in.
- D4 @ 6 in.
- WGR - no cross wires 1
- D10 @ 3 in.
- D10 @ 24 in.
- D20 @ 12 in.
- D4 @ 12 in.
- WGR - no cross wires 2
- D10 @ 6 in.
- D20 @ 3 in.
- D4 @ 3 in.

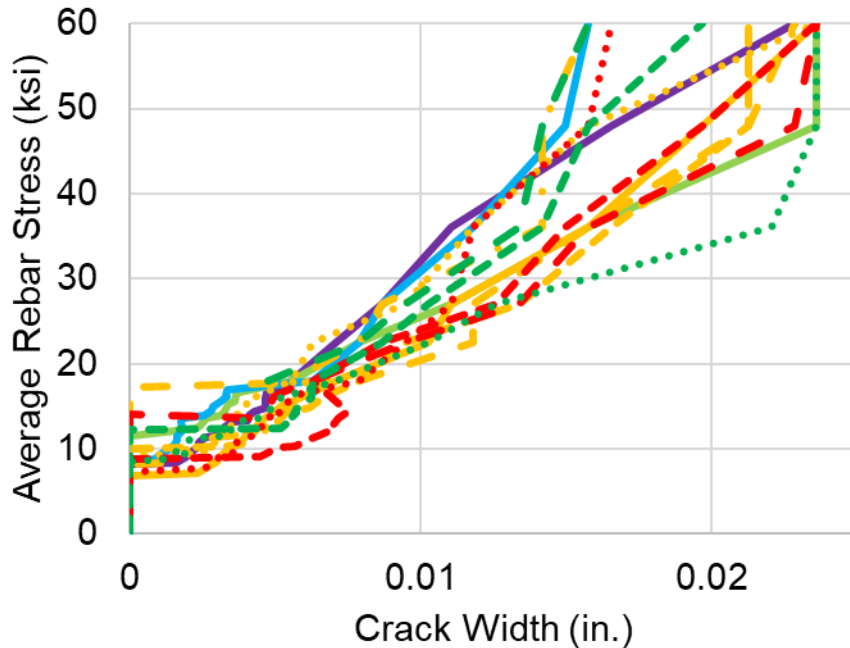
## Results – Crack Widths

Maximum Crack Widths

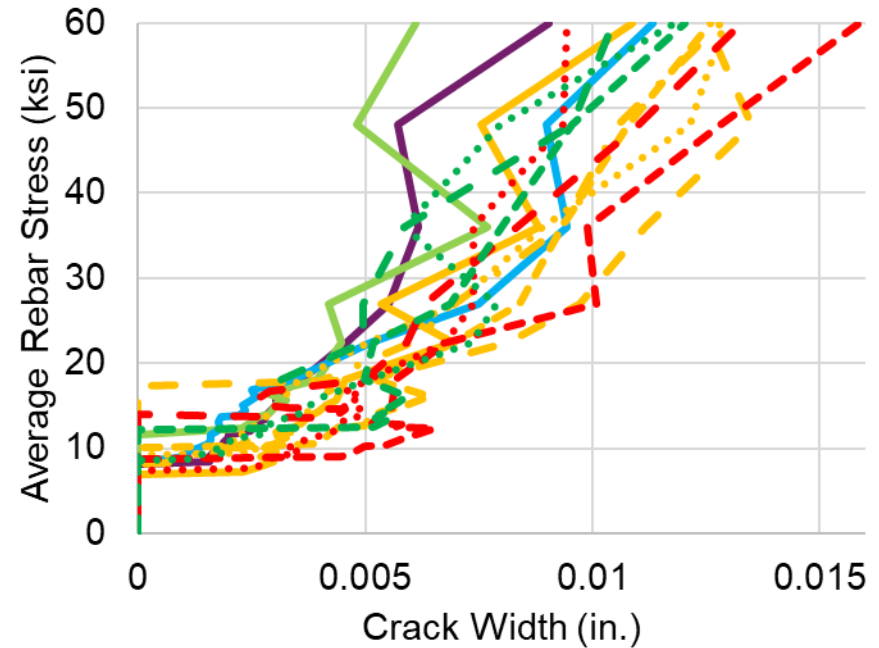
Average Crack Widths

| — Rebar | — WGR - no cross wires 1 | — WGR - no cross wires 2 |
| — D10 @ 6 in. - tied | ..... D10 @ 3 in. | — D10 @ 6 in. |
| — D10 @ 12 in. | — D10 @ 24 in. | ..... D20 @ 3 in. |
| — D20 @ 6 in. | — D20 @ 12 in. | ..... D4 @ 3 in. |
| — D4 @ 6 in. | — D4 @ 12 in. | |

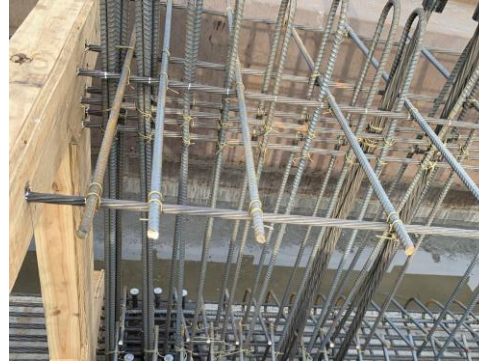
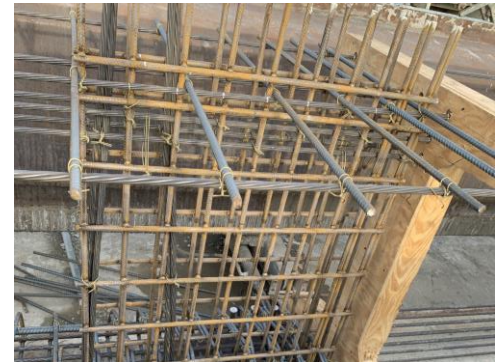
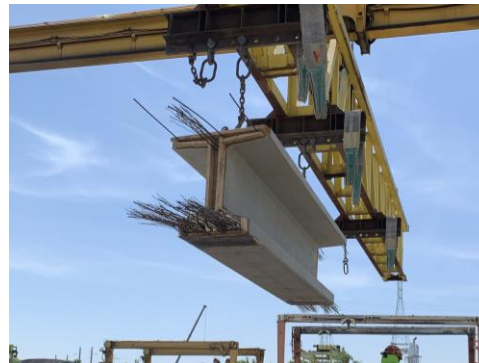
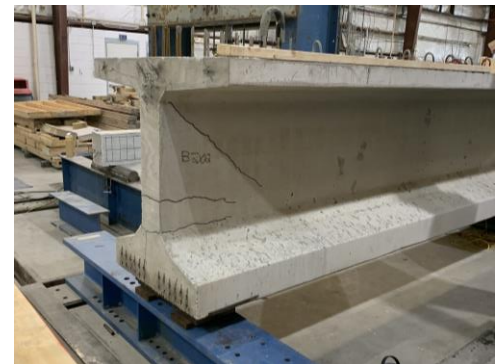
- Observe the cracking performance of PCBTs with varying levels of reinforcement in end regions
- Observe the cracking performance of PCBTs with rebar and WGR as end zone reinforcement and compare between the two

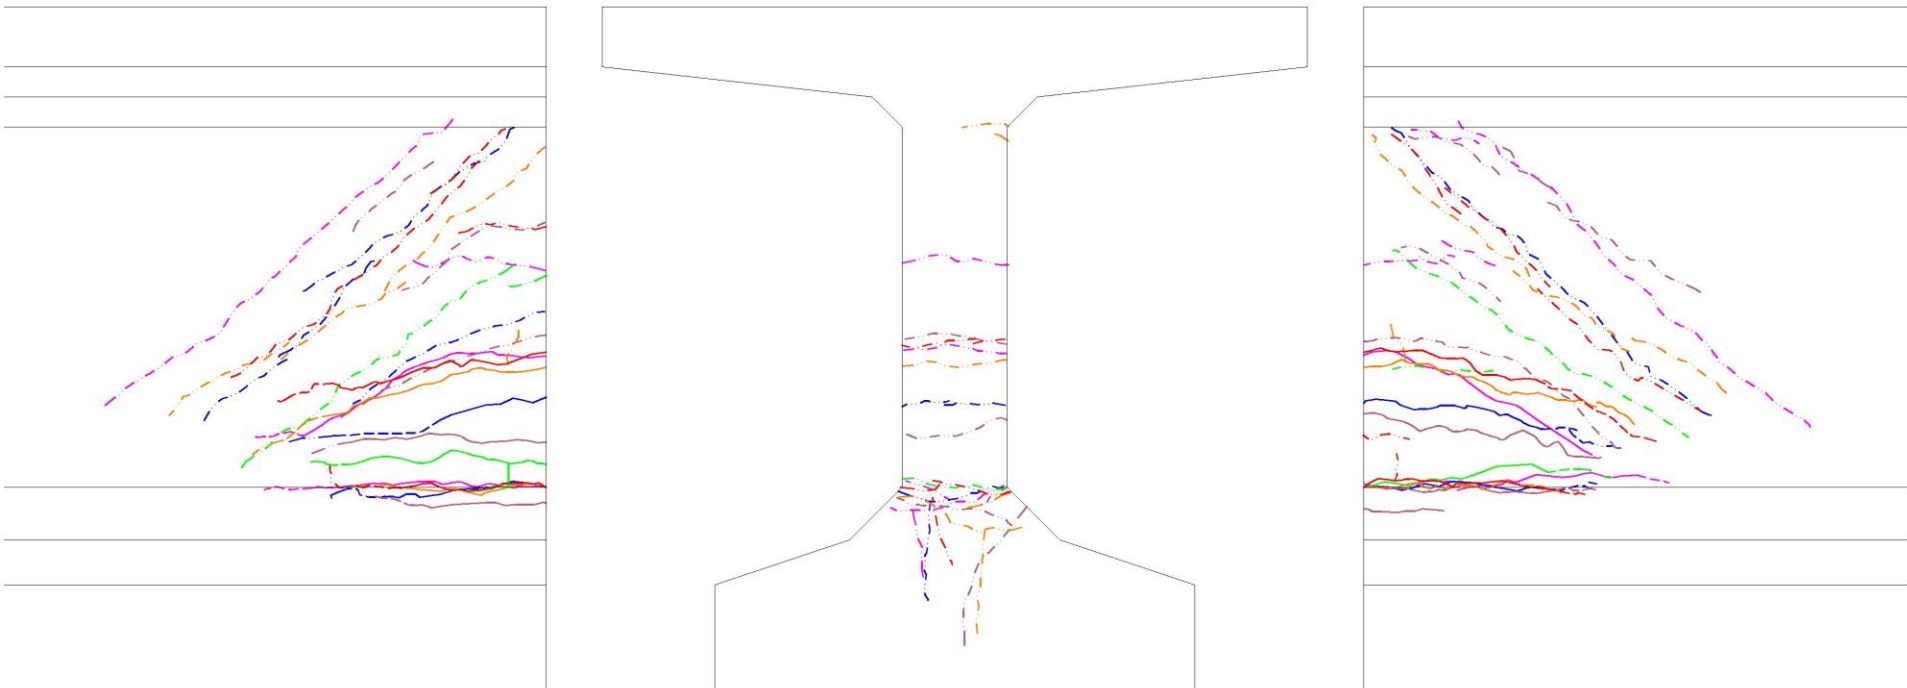
## Results – Cracking after delivery to Virginia Tech

18 ksi stirrups  
27 ksi stirrups  
36 ksi stirrups

18 ksi WGR and stirrups  
18 ksi WGR  
36 ksi WGR

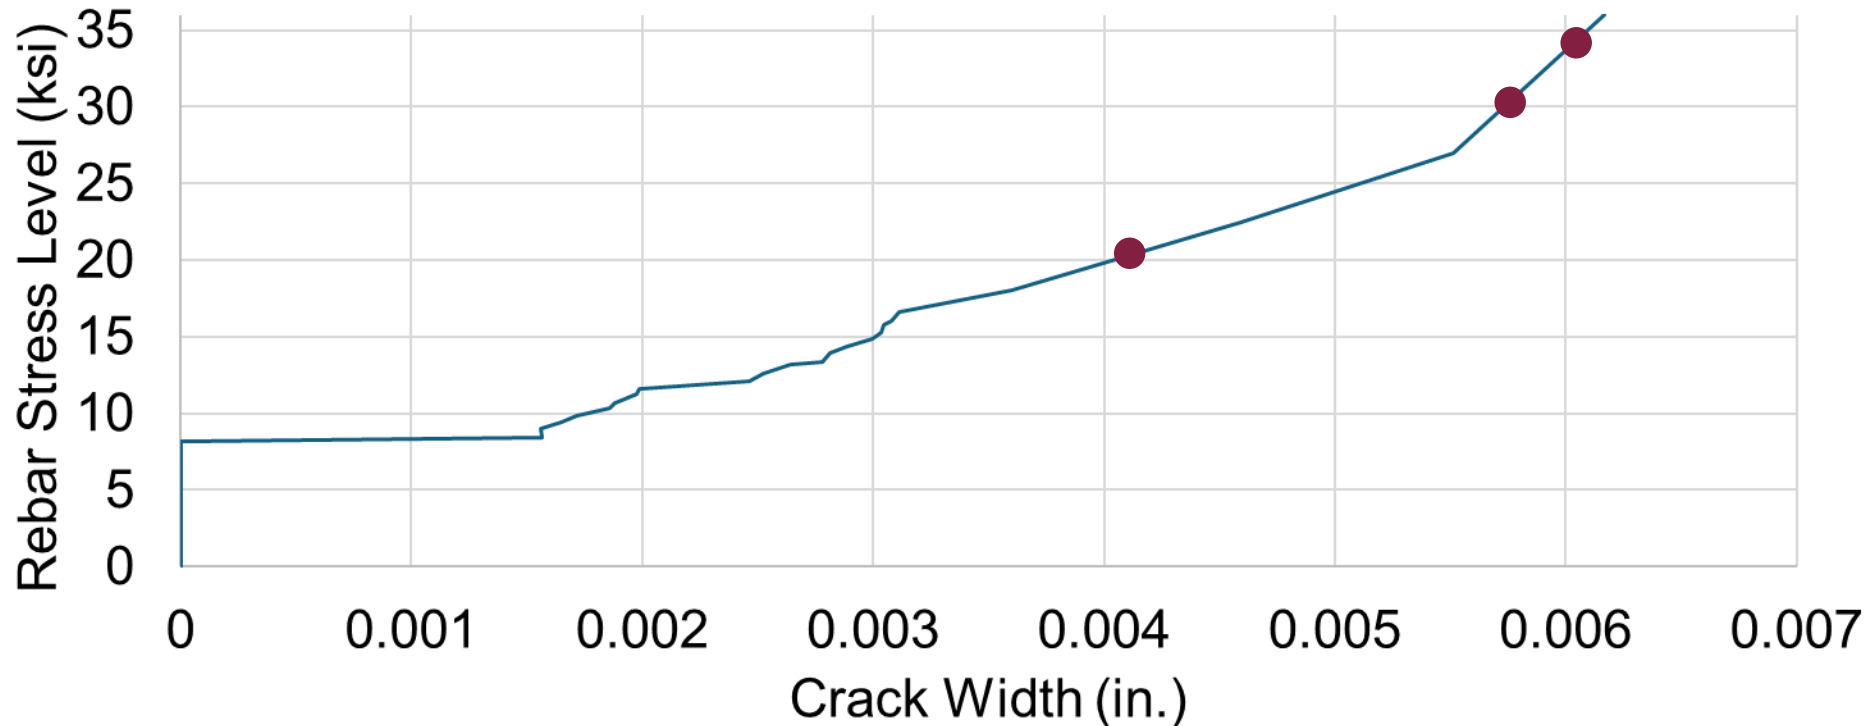
## Comparison of PCBT Cracking to Tensile Testing

Average Rebar Stress vs Average Crack Width from  
Tensile Testing

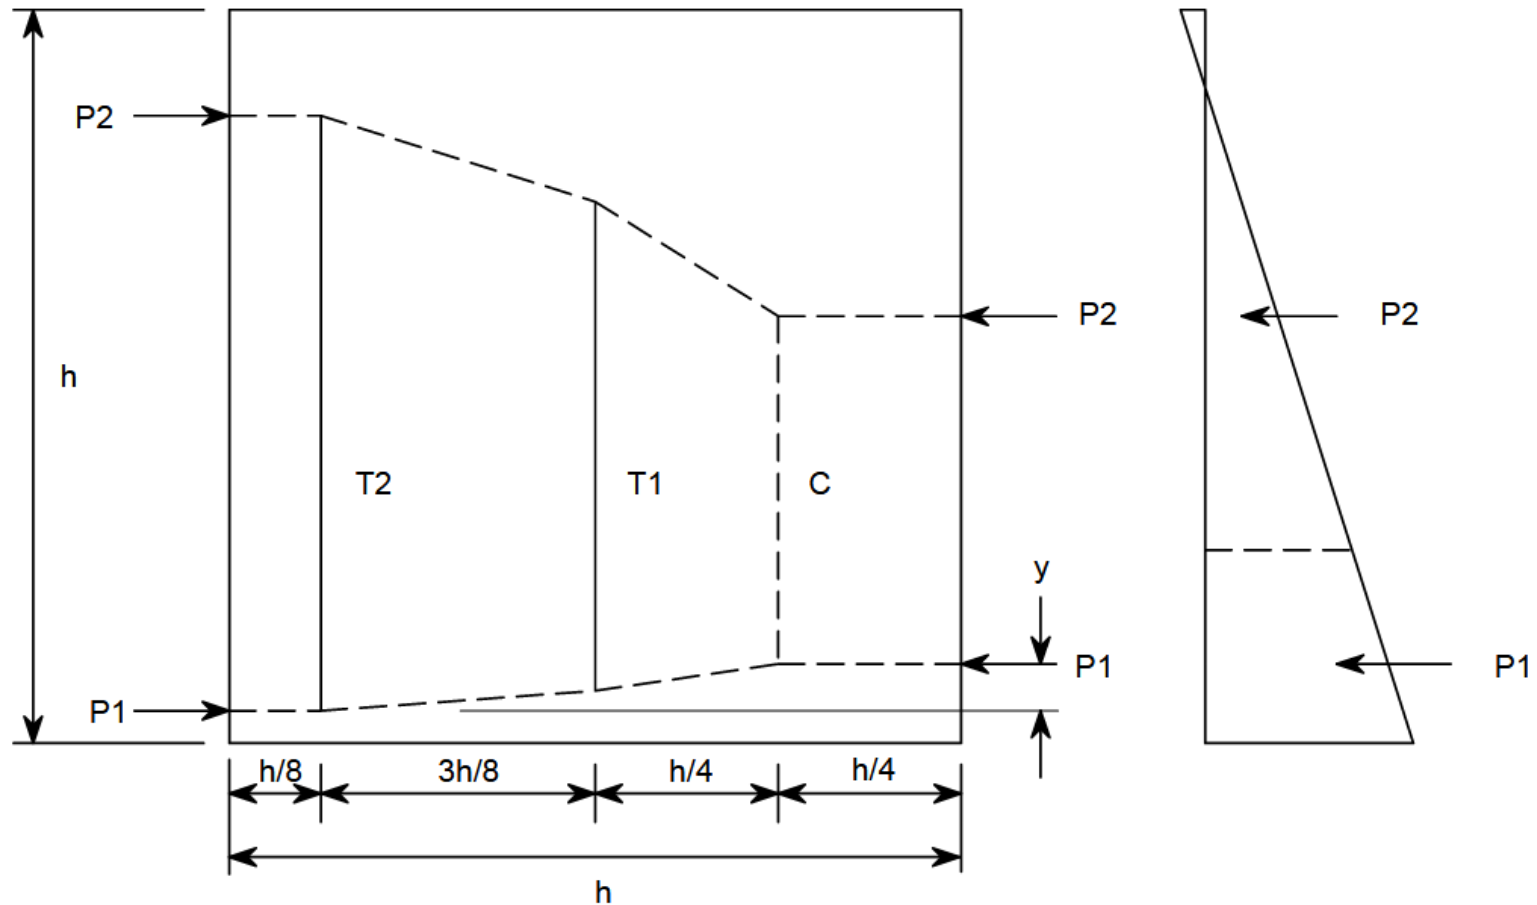
## Crispino *et al.*'s (2008) Strut and Tie Model
