Lessons from Post-tensioned Grouting Problems

Soundar Balakumaran
Virginia Transportation Research Council
Virginia Department of Transportation

*ACI Spring Convention 2024
New Orleans*

Lord Delaware and Eltham Bridges

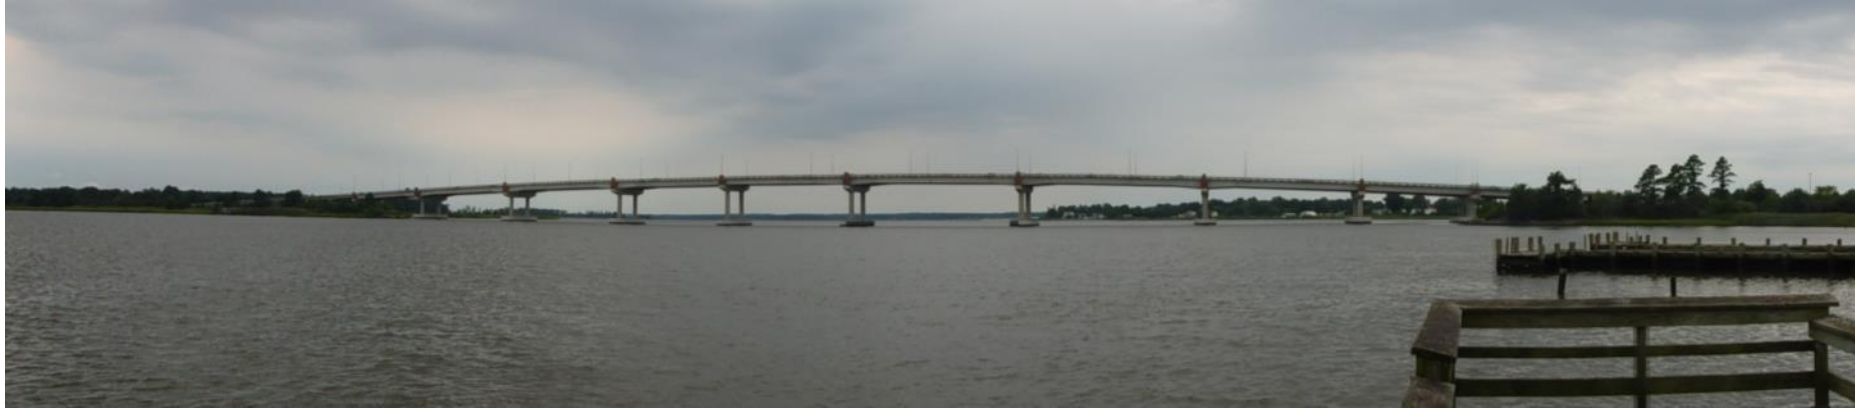
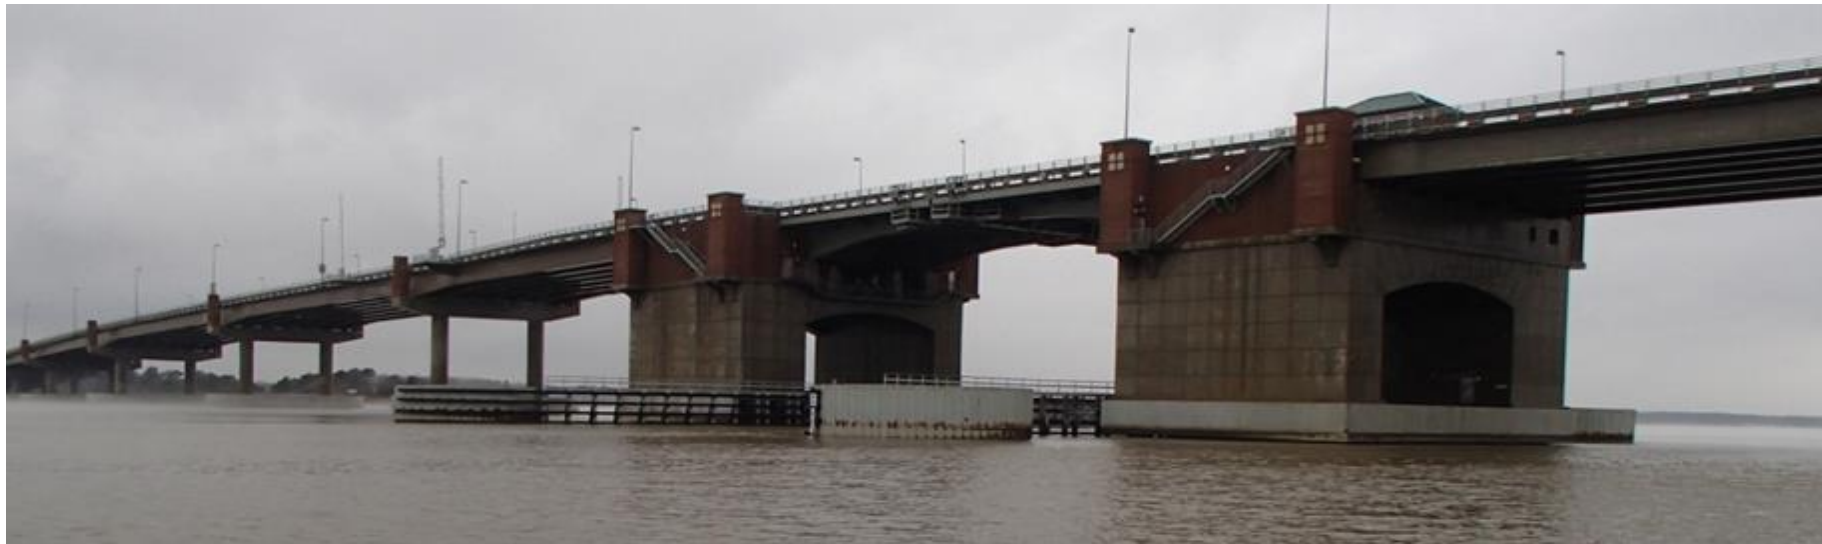
Post-tensioning Profile

Two sets of seven 4-span continuous post tensioned girders 880-ft long in each bridge (14 miles of PT duct)

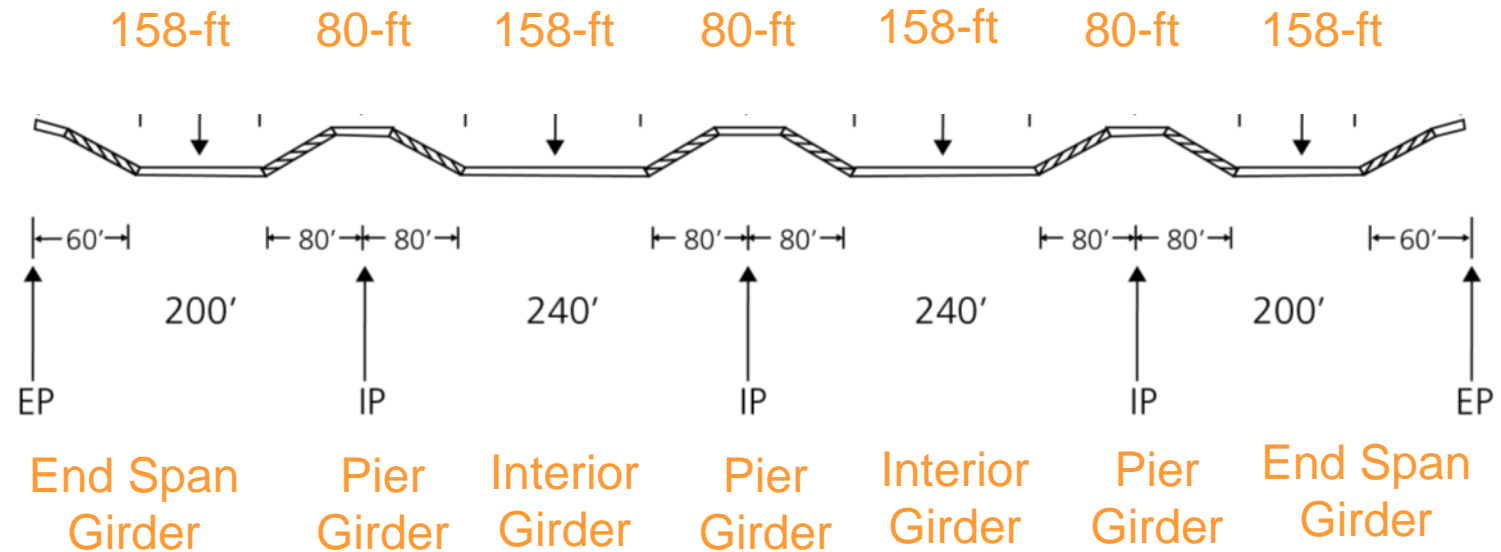
Girder Sections Showing PT Ducts

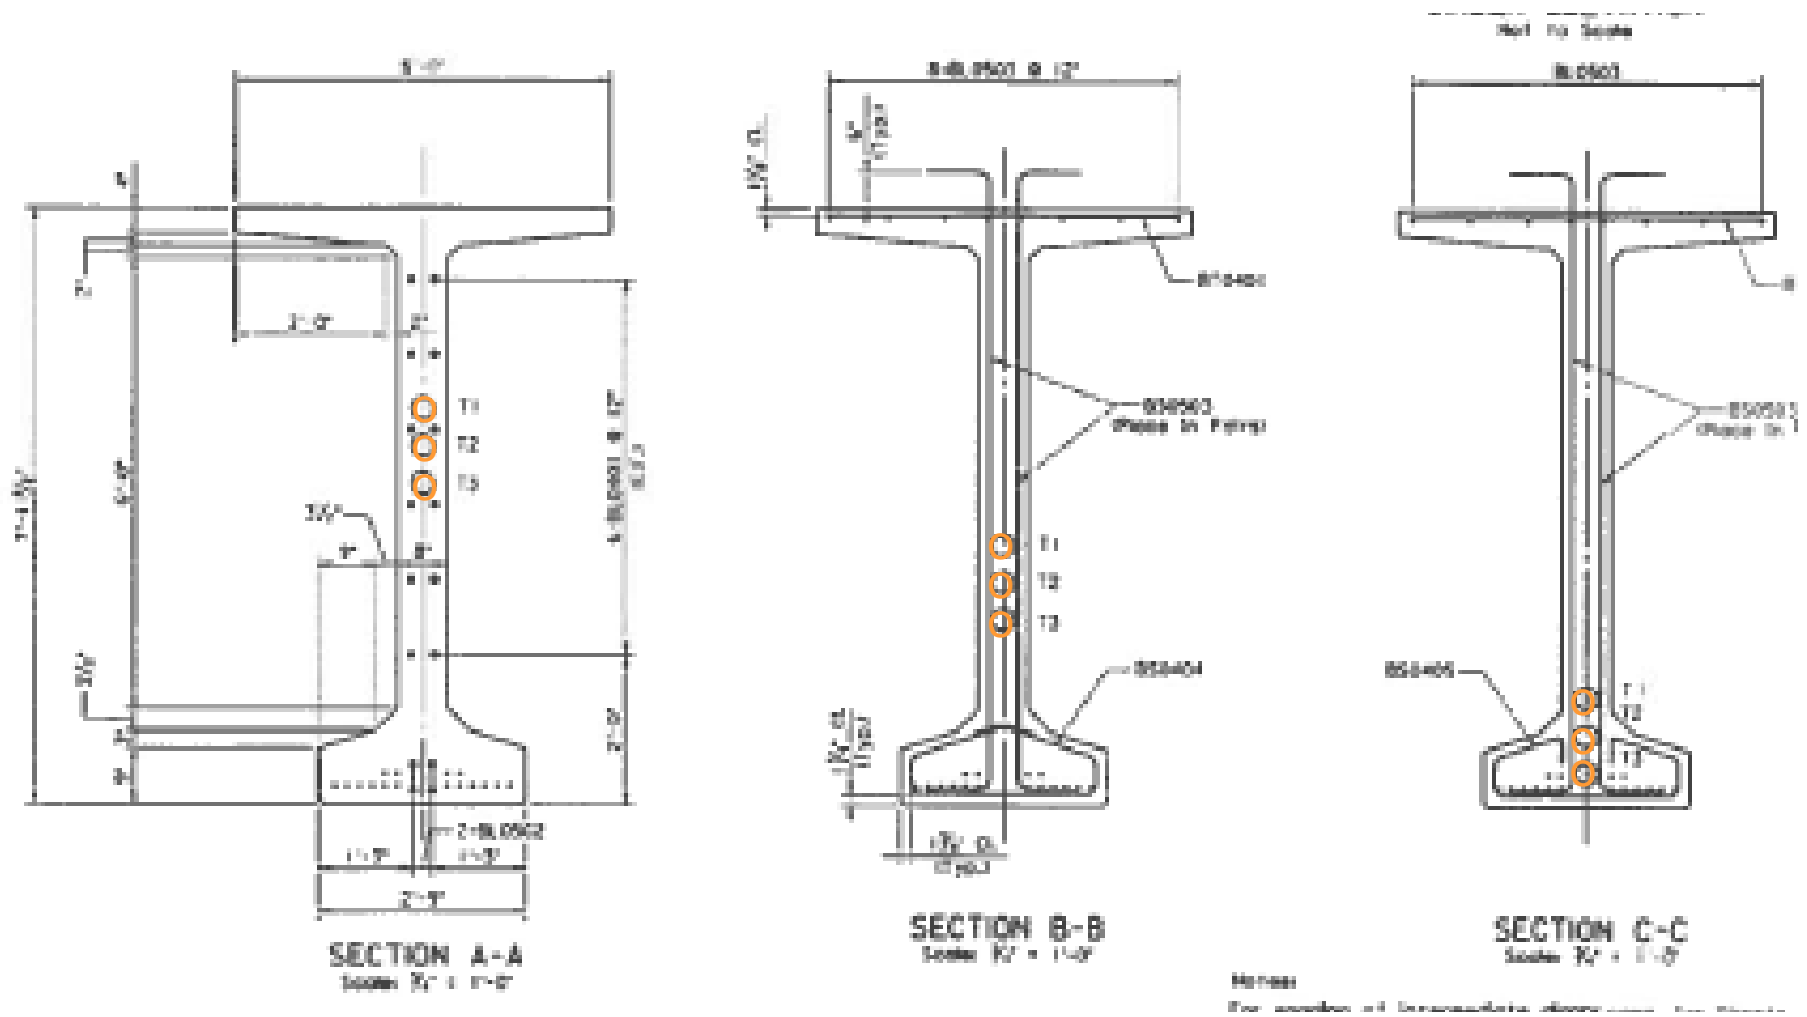
Spall in Web Adjacent to Tendon Duct

- A. Tendon grout may contain excess water, possibly more than twice the recommended amount of water.**
- B. Concrete spalled likely because the water in the duct expanded after being subjected to freezing conditions.**
- C. Tendon grout segregated in the duct with solid grout settling near the bottom PT profile, soft grout rising to the intermediate level sections and water and voids likely at the top profile over and near the piers.**

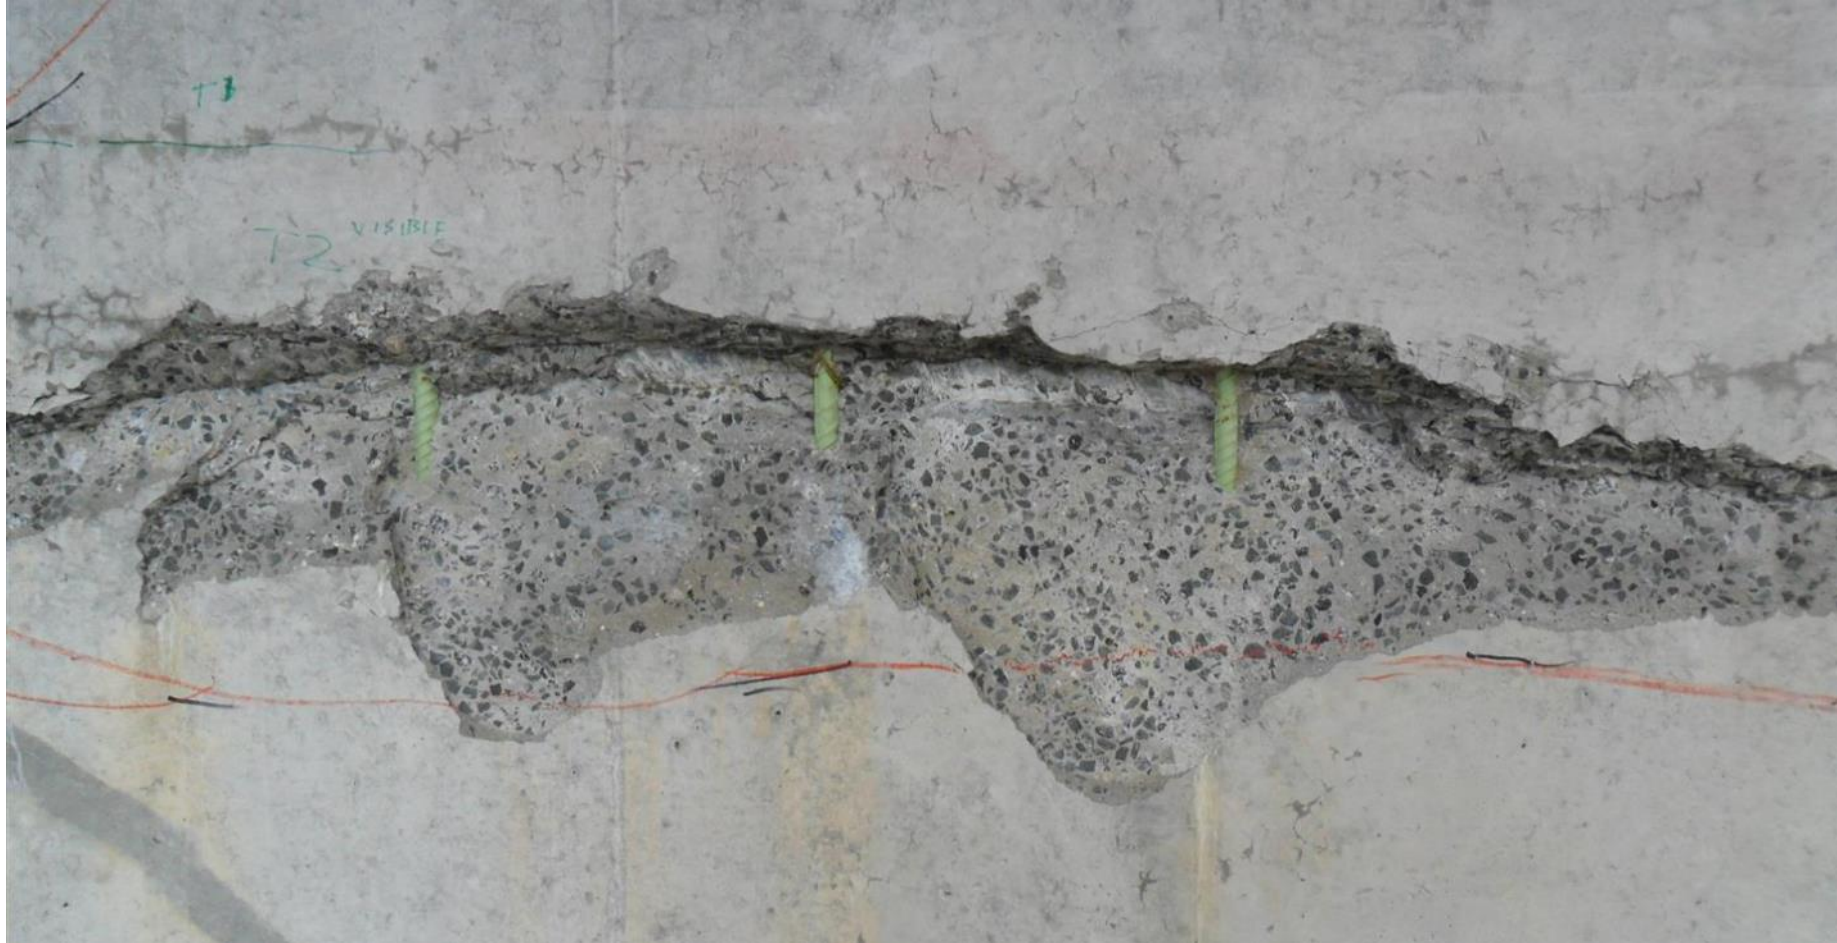
Cracks & Water Leaks at Closure Pour Joints

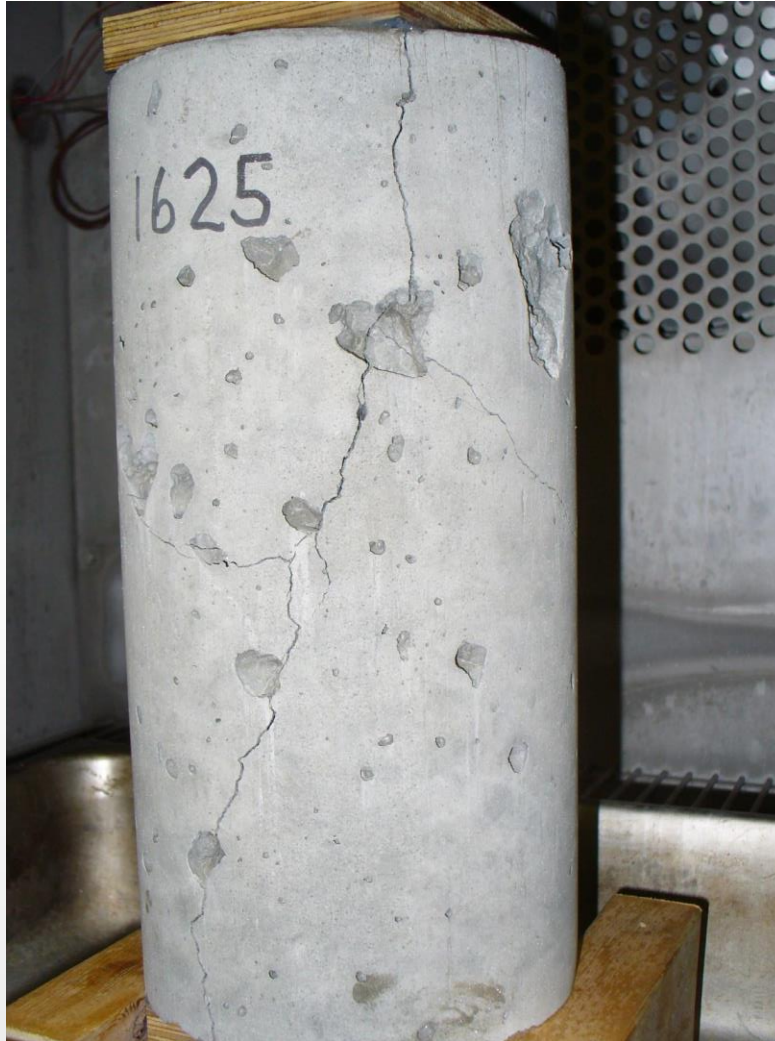
B. Simple Concrete Freeze Test

6x12 cylinder with
lightweight
concrete

3.5" conduit filled
with
water

Frozen overnight

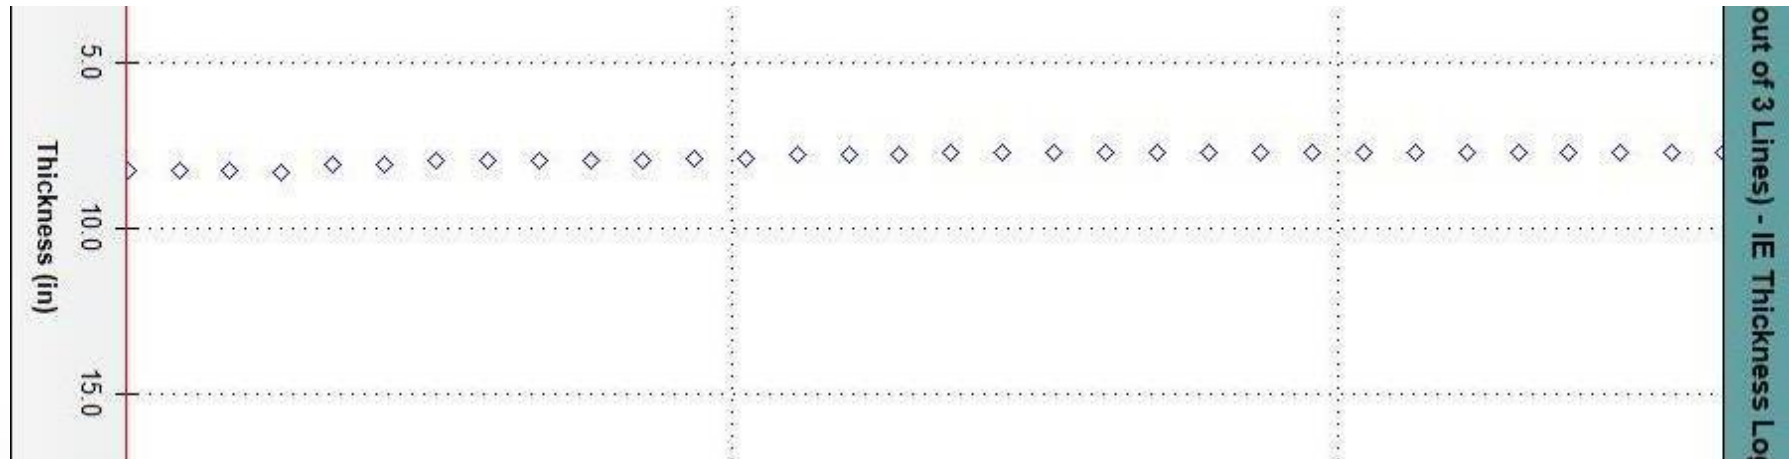
Indicating Hard Grout

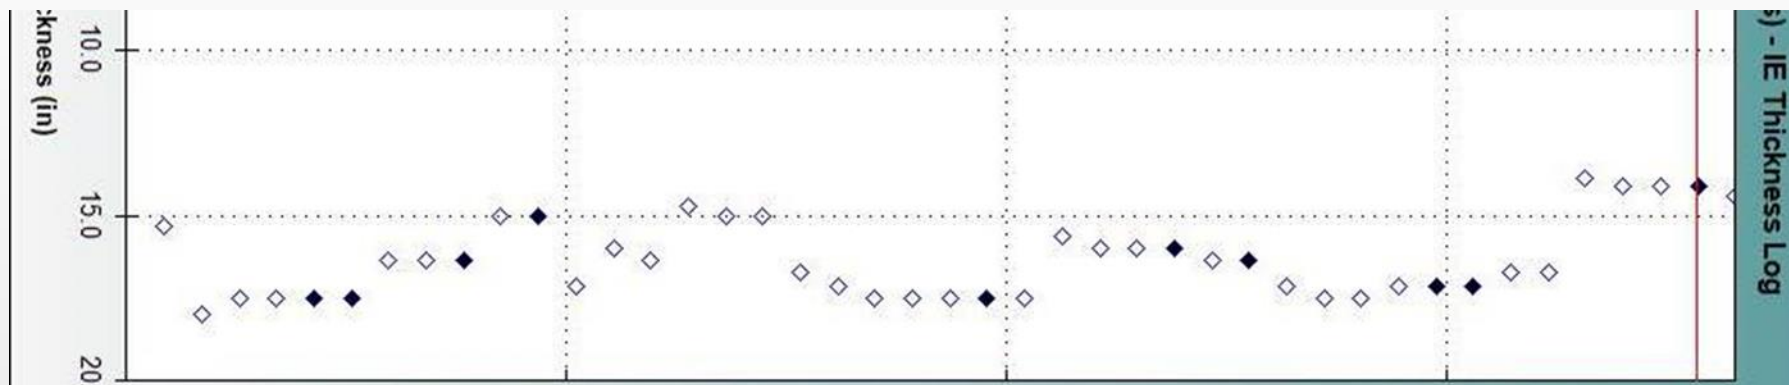
Indicating Water, Soft Grout or Void

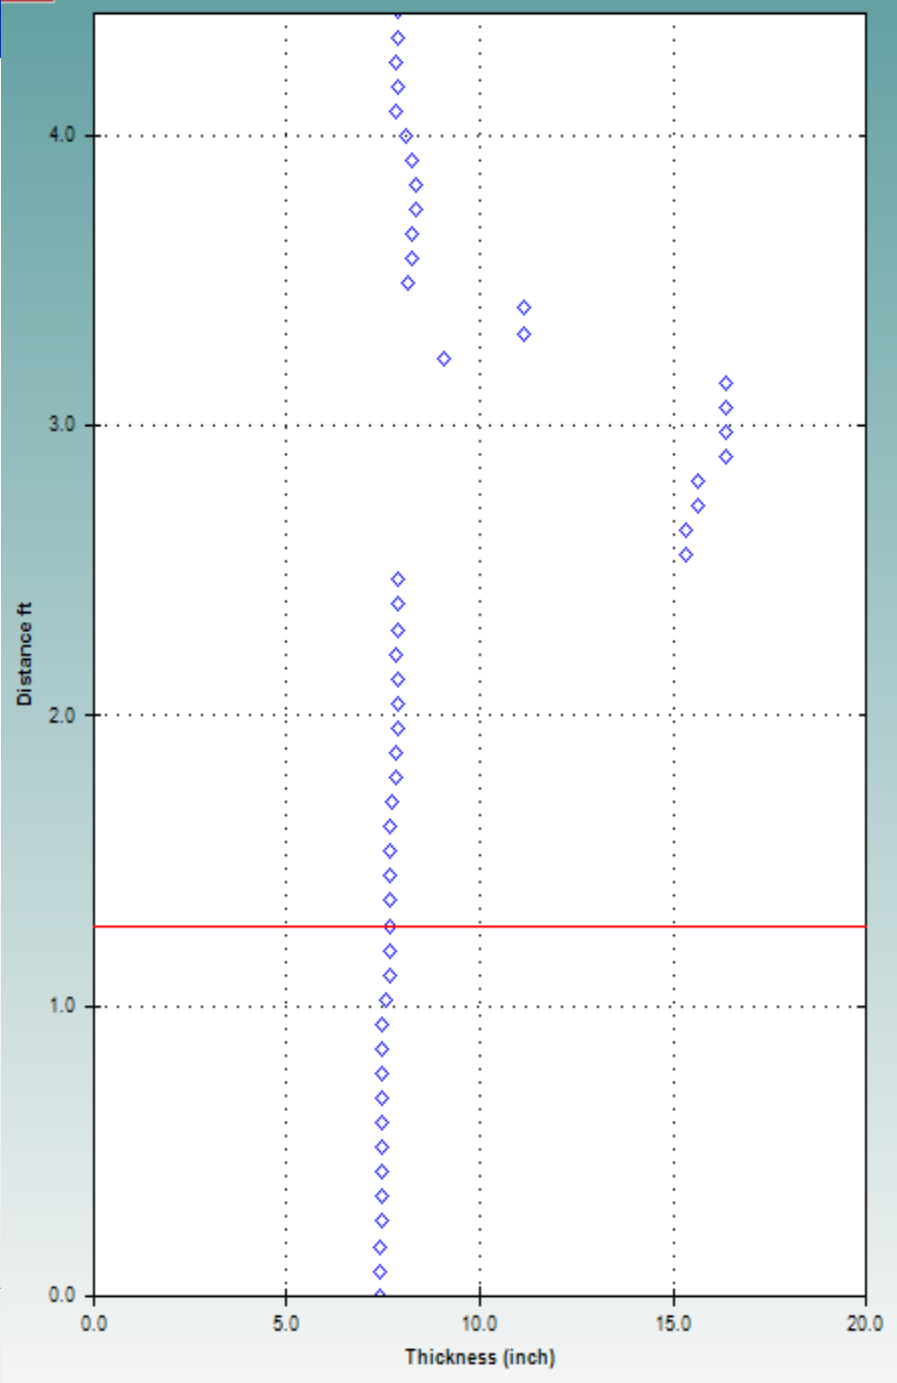
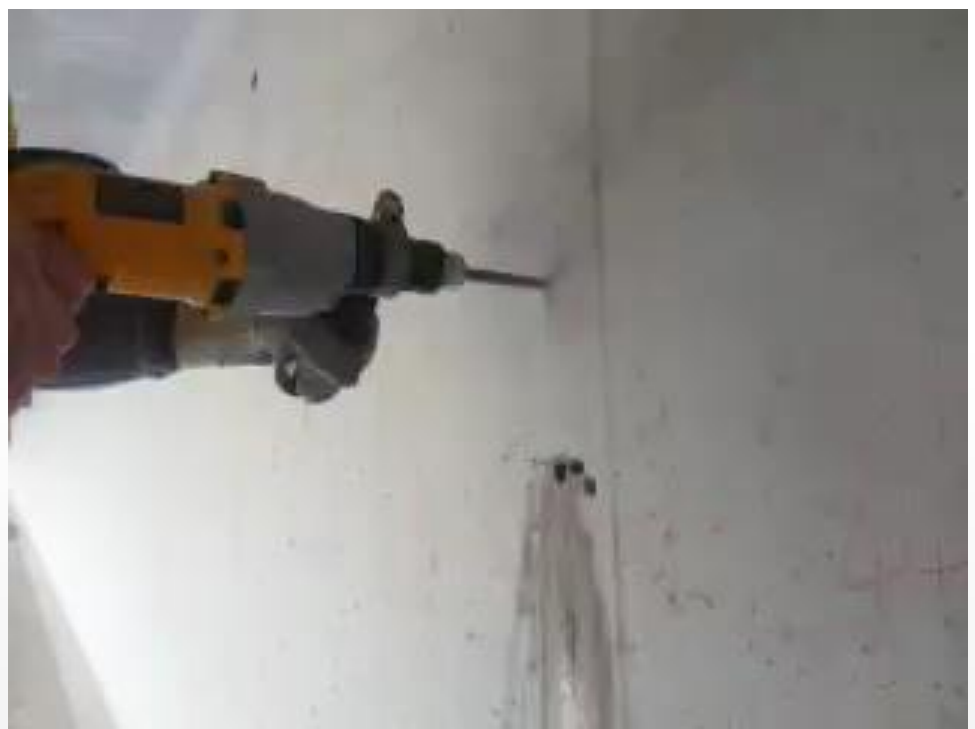
After air compression
45 ft. from Pier

- **Some interior girders had no cracks on the surface, but the ducts contained a lot of water indicating different temperature exposure.**
- **Lord Delaware Bridge appeared more predictable compared to Eltham Bridge**
- **Water in the ducts are probably from construction, because most air compression tests did not result in a leakage**

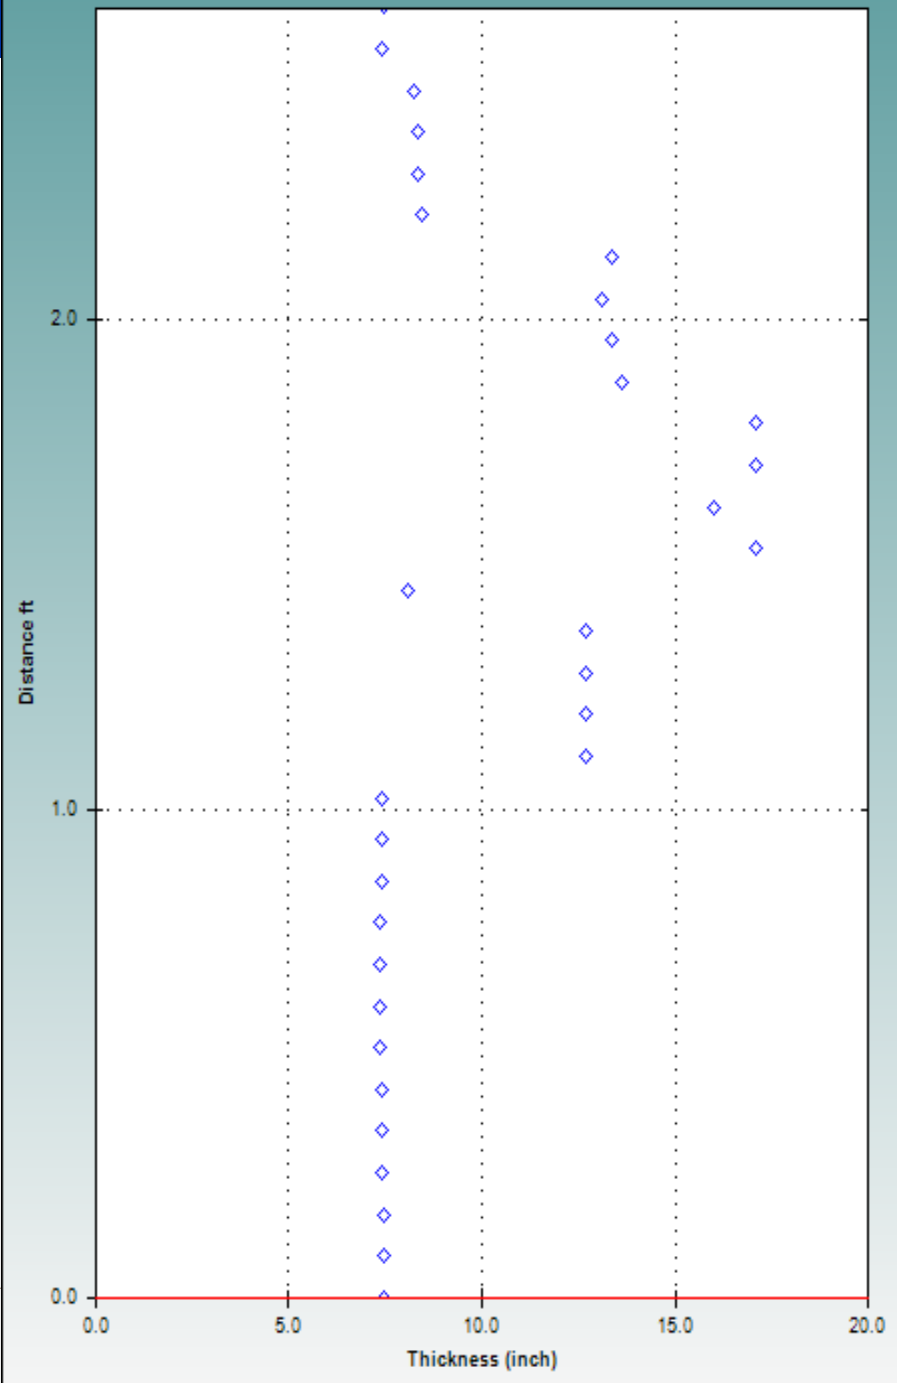
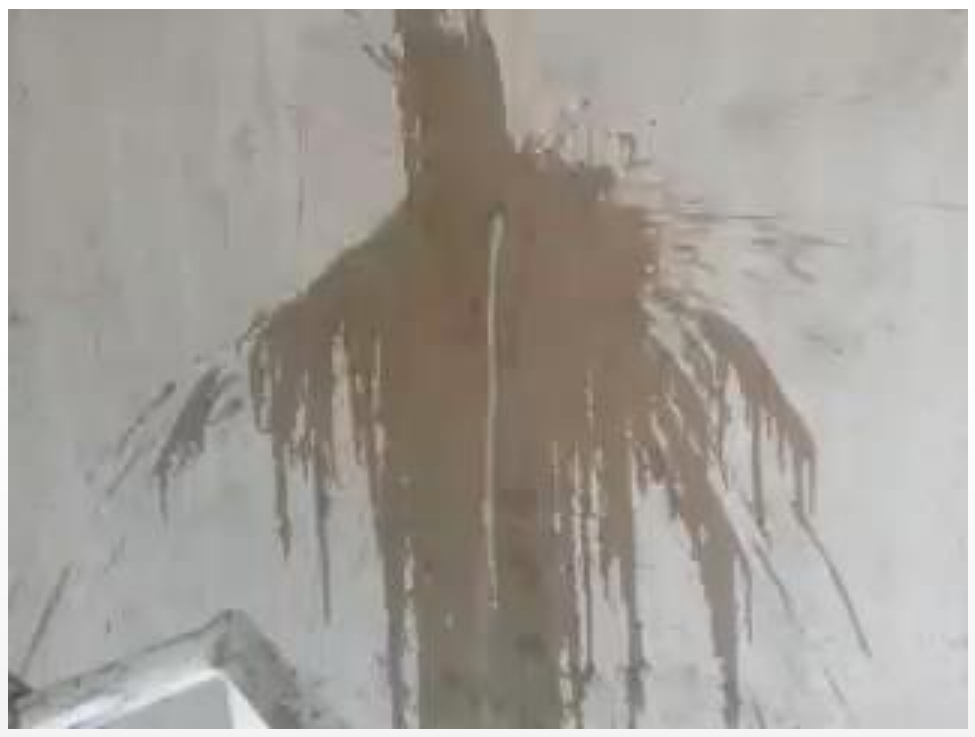
After air compression
35 ft. from Pier

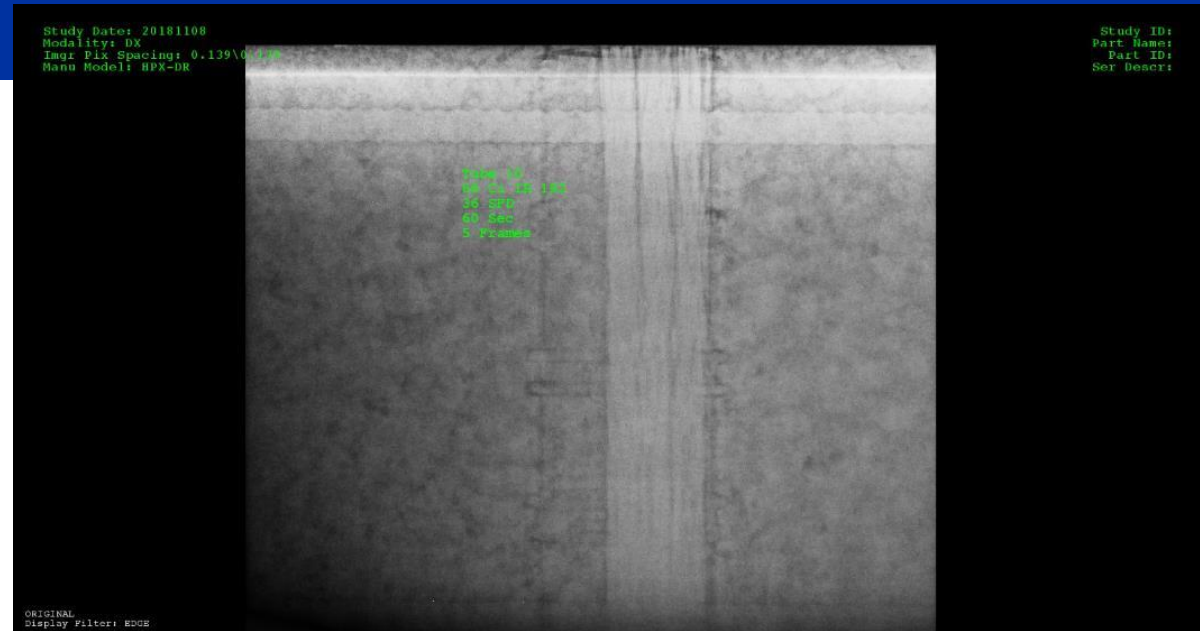
Digital Gammagraphy of Plastic Duct

Solid Grout

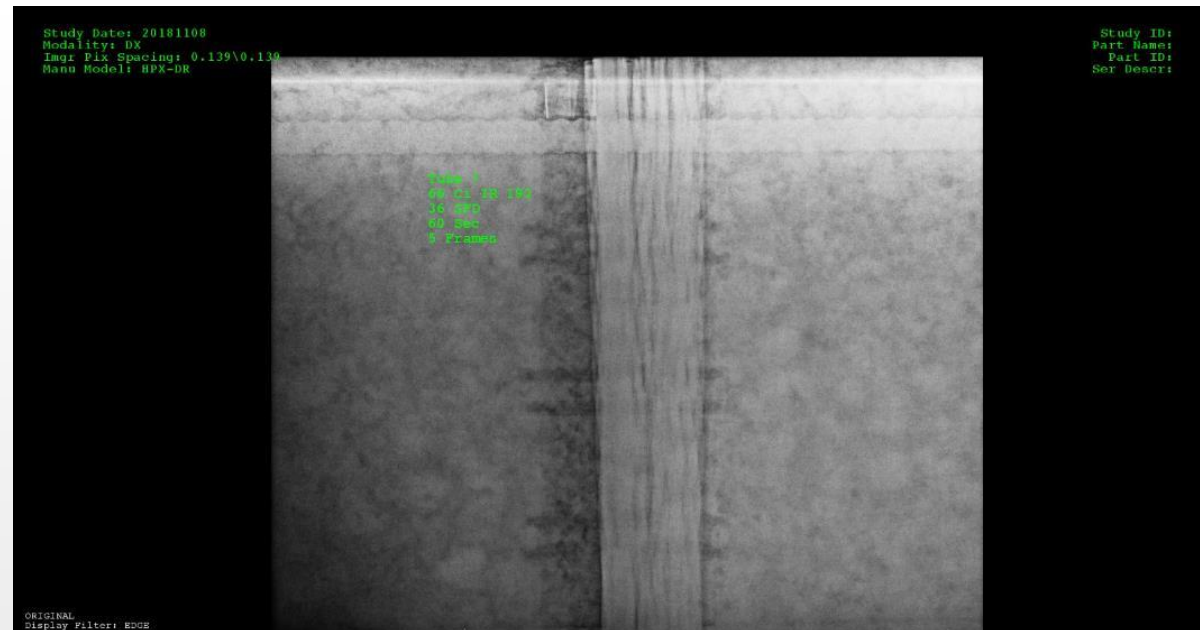
Empty Duct

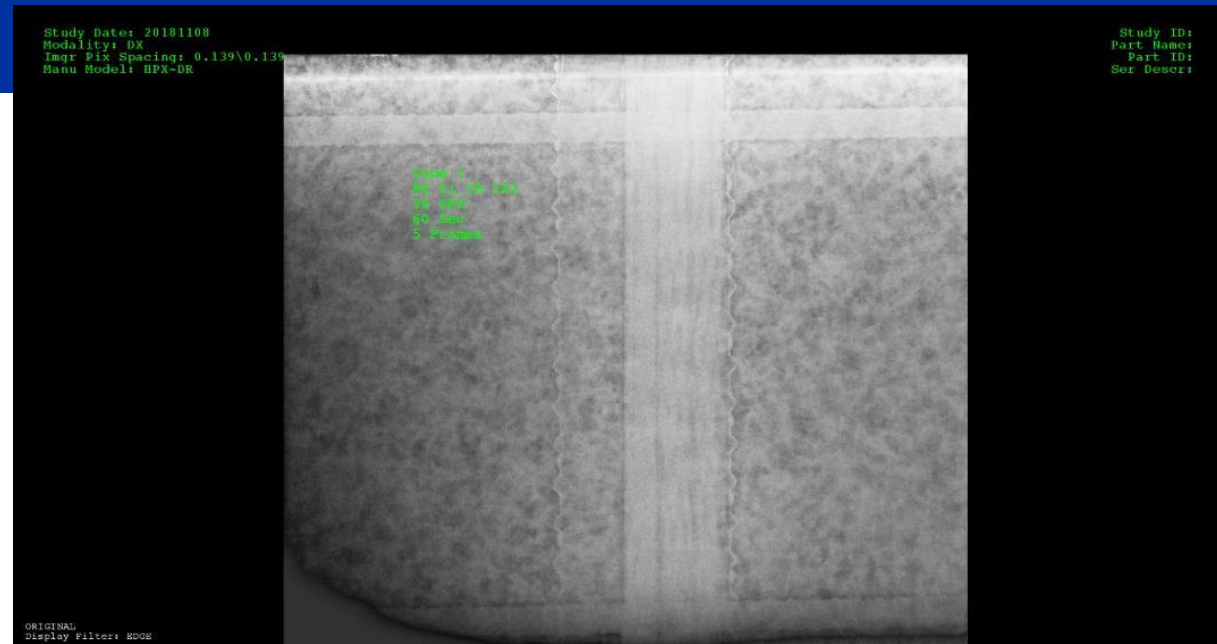
Digital Gammagraphy of Metallic Duct

Solid Grout

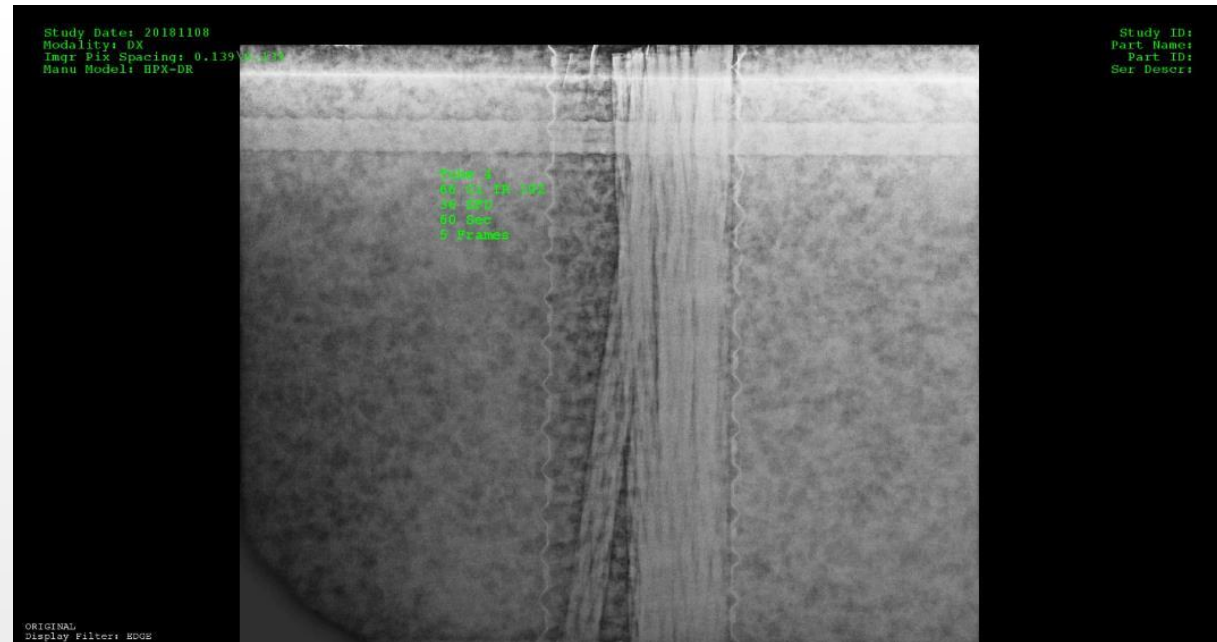
Empty Duct

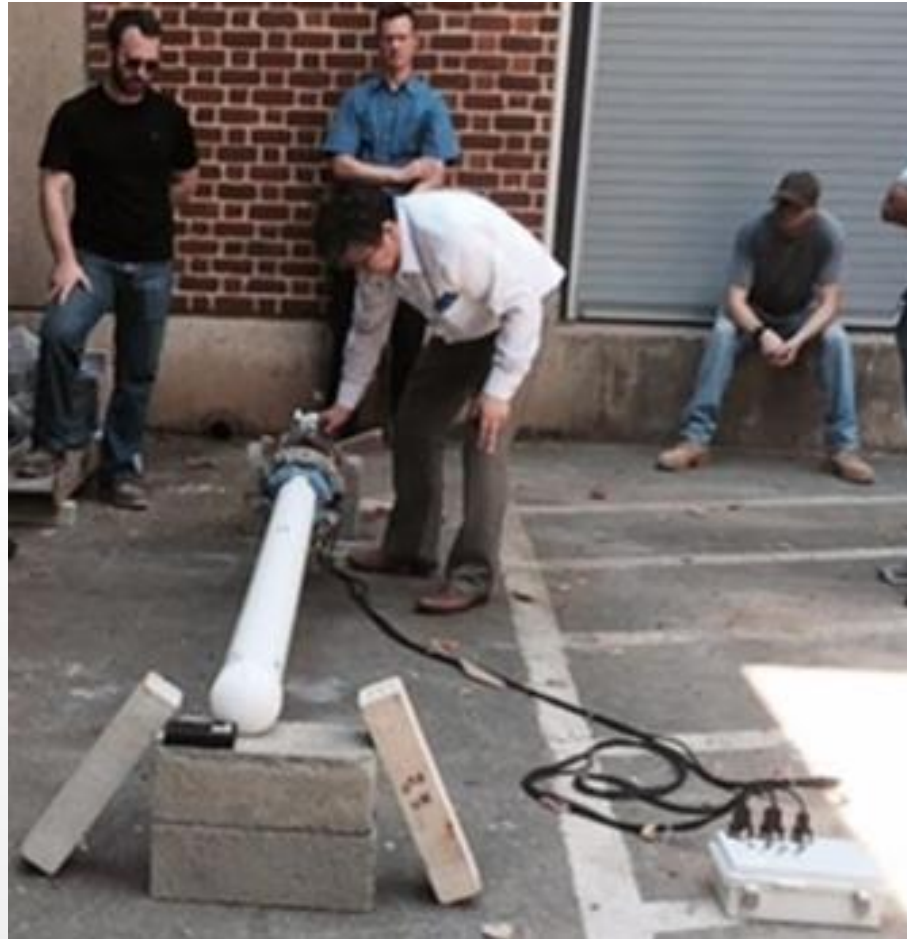
Magnetic Flux for External Ducts

- **Field evaluations are naturally triple-blinded.**
- **Recently, two separate instances of field evaluations using traditional NDE:**
 - an extensive consultant evaluation of PT tendon locations only matched 60% ground truth
 - Another small investigation had 50% match with the ground-truth
- **With Magnetic Flux, two consultants attempted their system on Michael's mockups:**
 - one consultant matched 100% of artificial defects, while another matched 60%.
