Development of a Crack-Resistant Rubber-Modified Cementitious Repair Material

From compatibility concepts to the field

by Alexander M. Vaysburd, Benoit Bissonnette, and Christopher D. Brown

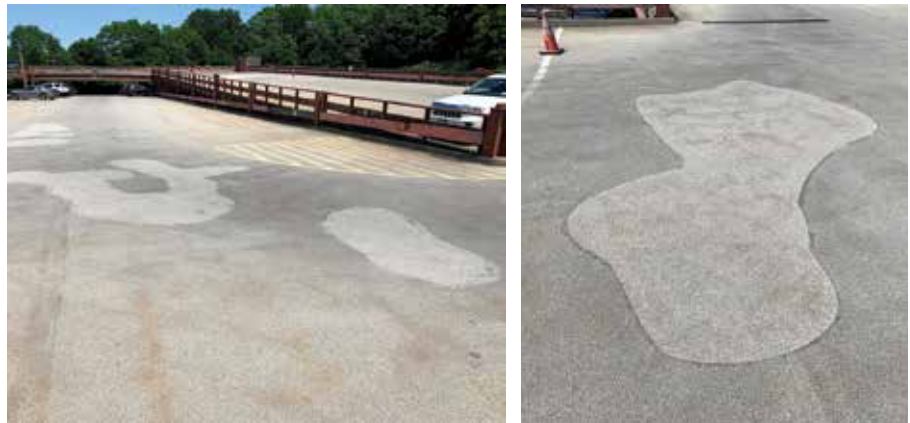
Fig. 7: A parking garage deck in Utica, NY, USA, repaired with the rubber-modified repair material, after 4 years in service

selected for its lower shrinkage-cracking sensitivity. The job involved patch repairs and then resealing of the exposed areas. As shown in Fig. 7, the patches had somewhat unusual geometries. The repairs were also shallow in some areas, and the exposed reinforcement was generally not undercut. Even so, no debonding, cracking, or bond line shrinkage have been observed after 4 years in service.

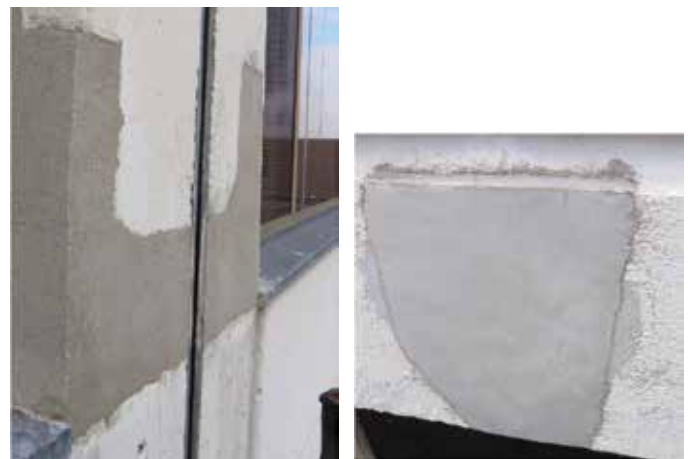
Fig. 8: Restoration of a 40-story reinforced concrete building in Philadelphia, PA, USA, in 2016. Spalled areas were repaired with a rubber-modified repair material. Repairs were to be subsequently covered with a polymer coating

that of the parent concrete, and the flexibility to use a single product in both manually applied, small patches (Fig. 8) and larger form-and-place applications. Once repairs were completed and cured, the structure was painted with an elastomeric coating. In both the vertical patches and formed elements, the material was applied successfully and performed quite satisfactorily, without reported cracking to this day.

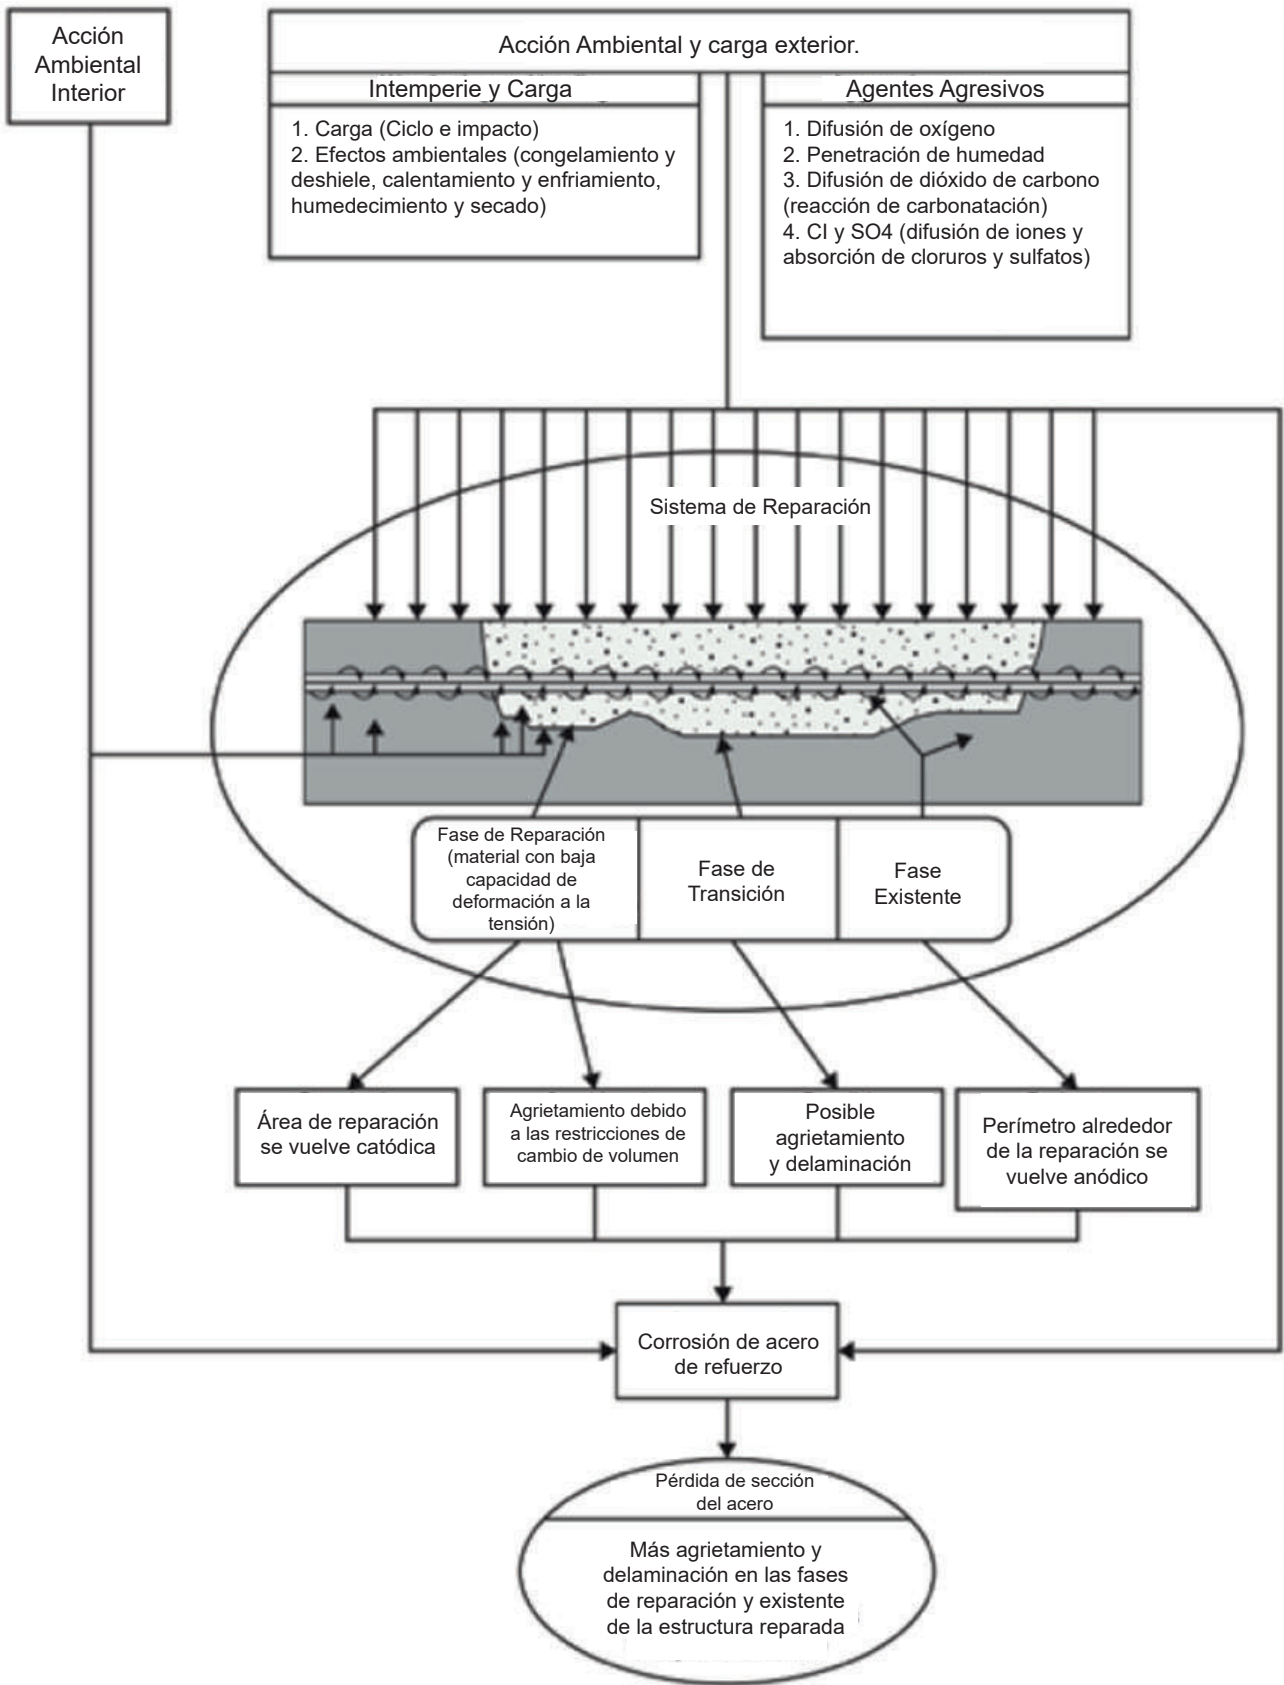
Fig.1: Modelo de falla de reparación causada por agrietamiento³

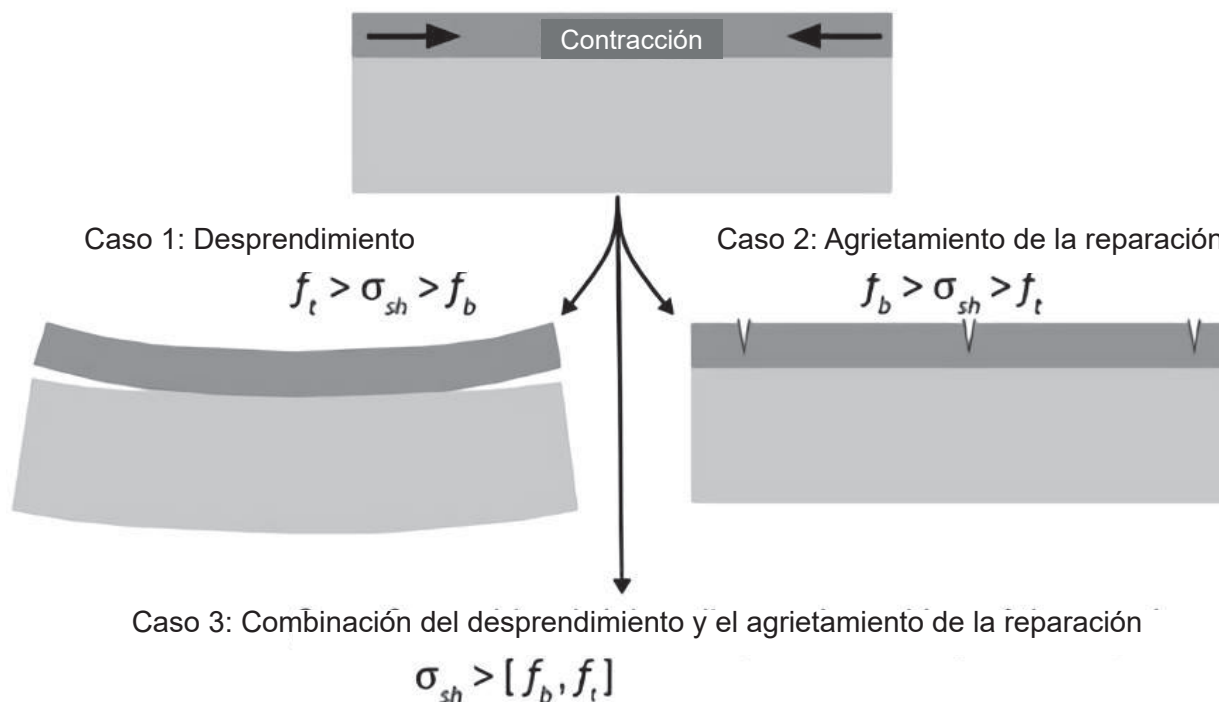
f_t = resistencia a tensión del material de reparación
 f_b = resistencia de adherencia a la tensión entre el material de reparación y el sustrato
 σ_{sh} = fuerza inducida de contracción

Fig.2: Mecanismos de daño en sistemas de reparación de concreto (adaptado de Luković et al.⁴)

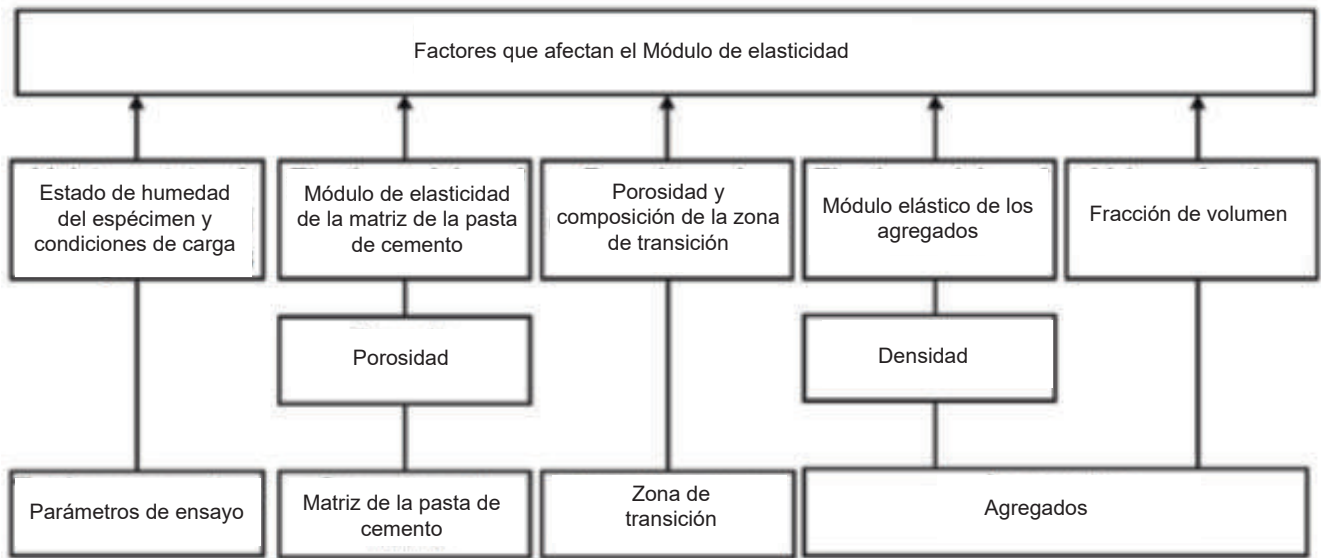
Fig.3: Resumen de los parámetros que influyen en el ME de los materiales a base de cemento⁵

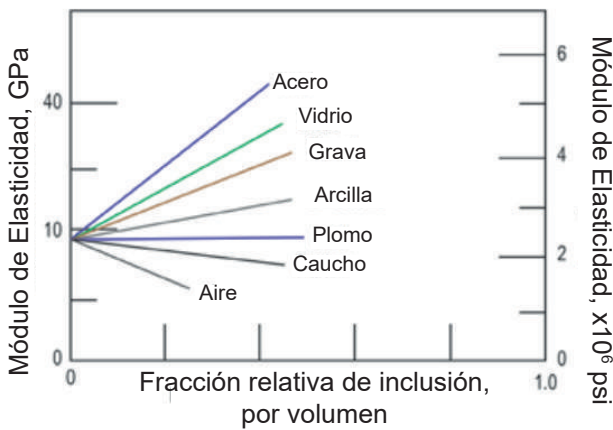
Fig.4: Efecto de varios materiales sobre el ME del concreto⁵

Cuando se usa para reemplazar agregados en materiales a base de cemento, las partículas de caucho inducen variaciones significativas en las propiedades del material. Numerosos estudios demuestran que el reemplazo parcial de agregados con caucho afecta negativamente las propiedades de resistencia de los compuestos a base de cemento de manera proporcional a la tasa de reemplazo.⁷ El reemplazo parcial de agregados también reduce el ME (Fig. 4).

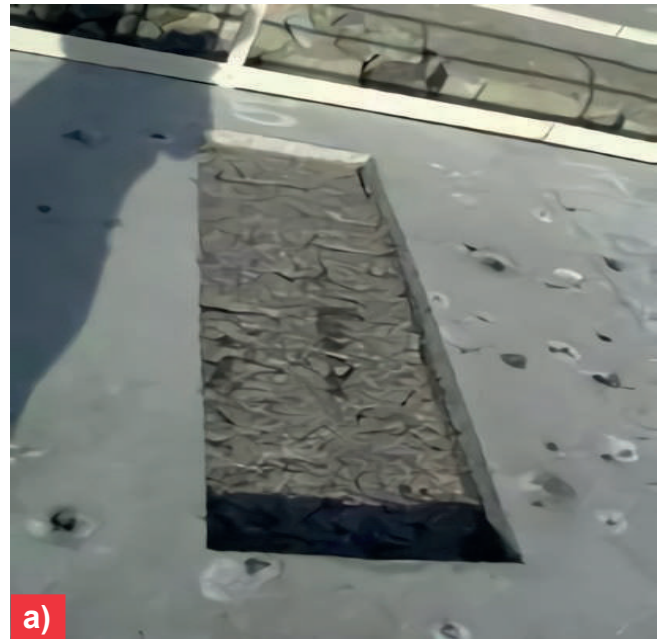
Fig.6: Áreas de reparación seleccionadas para experimentos en campo en las instalaciones de la Marina de los Estados Unidos de América en Port Hueneme, CA, E.U.A.: (a) horizontal, en el muelle, 1840 x 490 mm (73,5 x 19,5 pulg.) y 75 mm (3 pulg.) de profundidad; y (b) vertical, en una losa existente instalada en posición vertical junto al muelle seleccionado, 48 x 36 pulg.(1200 x 900 mm) y 3,5 pulg. (88 mm) de profundidad⁵

Las superficies de concreto preparadas de las cavidades se saturaron con agua durante 16 horas antes de las aplicaciones de reparación para producir condiciones de saturada superficialmente seca (SSS) en el momento de la colocación del material de reparación. Después de mezclar, el material de reparación se colocó en reparaciones horizontales usando una pala y en reparaciones verticales directamente desde baldes. Para ambos tipos de reparación, el material de reparación se consolidó utilizando un vibrador interno. La cimbra para la reparación vertical también se vibró con un vibrador externo. Las condiciones climáticas en el momento de la colocación fueron favorables a la contracción plástica con pleno sol, ráfagas de viento de hasta 21 mph (35 km/h) y una humedad relativa del 50%. Inmediatamente después del acabado, las reparaciones horizontales se cubrieron con tela de yute húmeda y plástico, y se curaron en húmedo durante 72 horas. Para las reparaciones verticales se realizó el curado con la cimbra durante una semana, rociando agua desde arriba dos veces durante las primeras 48 horas. Las reparaciones se controlaron para detectar grietas durante 10 meses y se hicieron sonar con un martillo para detectar huecos y delaminaciones. Durante el período de monitoreo, no se observaron grietas en ninguna de las reparaciones y el sondeo no reveló ningún vacío ni delaminación.

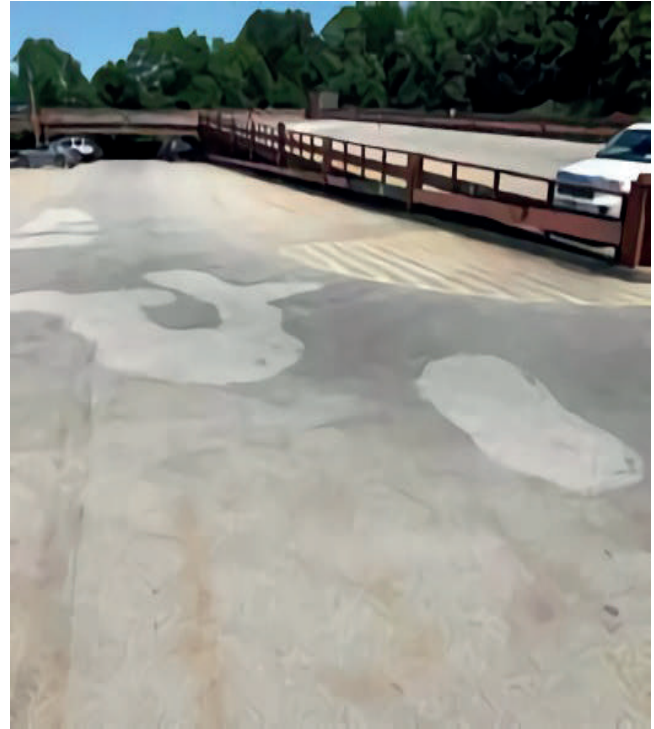
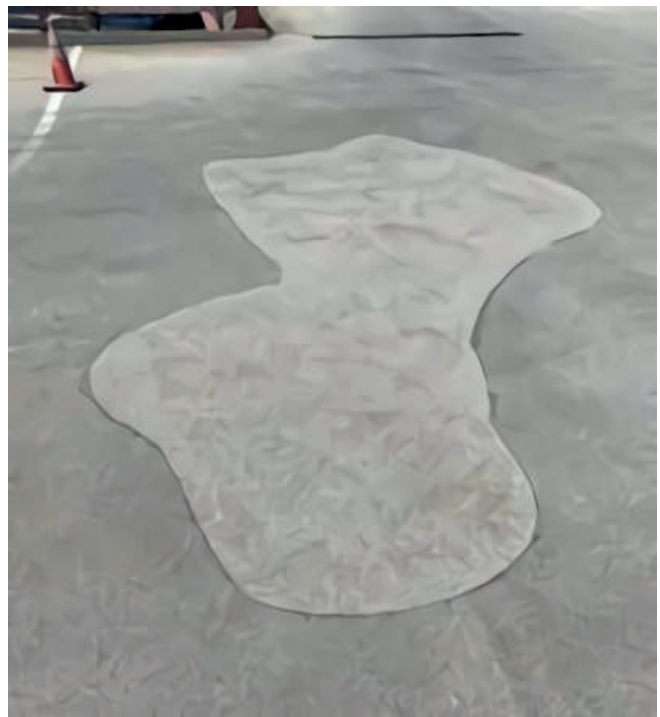
Fig.7: Una losa de estacionamiento en Utica, NY, E.U.A. reparada con el material de reparación modificado con caucho, después de 4 años en servicio

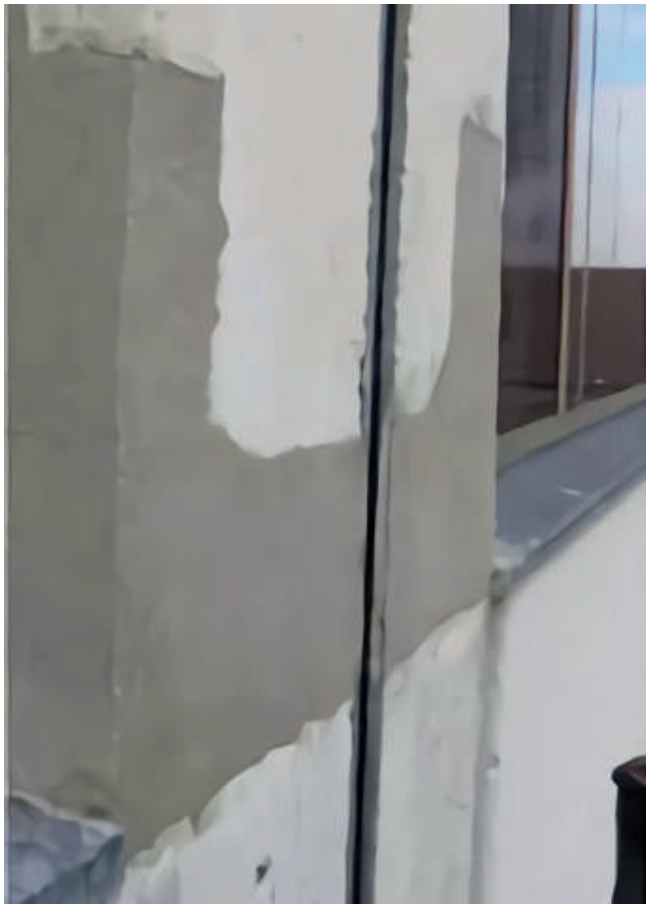
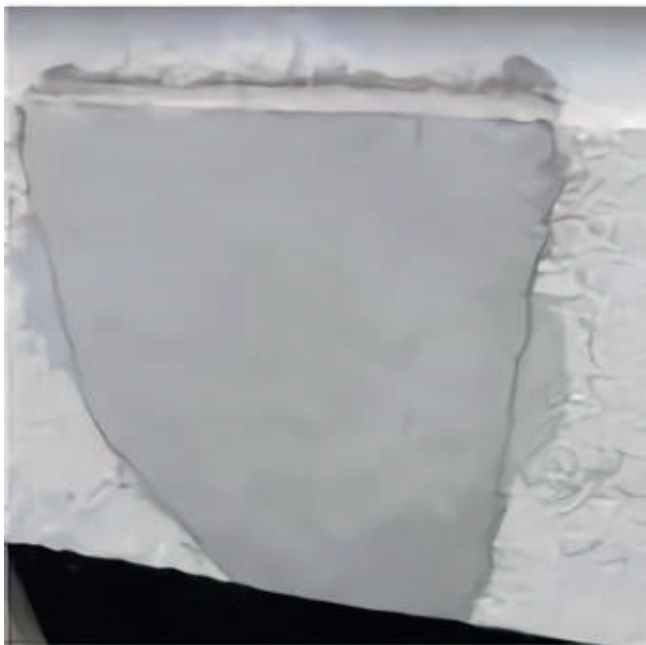
Fig. 8: Restauración de un edificio de concreto reforzado de 40 pisos en Filadelfia, PA, E.U.A. en 2016. Las áreas descascarado se repararon con un material de reparación modificado con caucho. Las reparaciones debían cubrirse posteriormente con una capa de polímero.

El segundo estudio de caso es la restauración de un edificio de oficinas de 500 pies (152 m) de altura y 40 pisos en Filadelfia, Pensilvania, E.U.A. en 2016. El edificio fue construido en 1974 y es el edificio de concreto reforzado más alto de la ciudad. El material a base de caucho se eligió para la aplicación horizontal, incluidas las reparaciones largas de forma y lugar en los parapetos, así como la aplicación vertical. Además de la baja sensibilidad al agrietamiento, los otros parámetros principales que influyeron en la selección del material por parte del especificador fueron la resistencia a la compresión, que tenía que coincidir con la del concreto base, y la flexibilidad para usar un solo producto en parches pequeños aplicados manualmente (Fig. 8) y aplicaciones más grandes de forma y lugar. Una vez que se completaron y curaron las reparaciones, la estructura se pintó con un revestimiento elastomérico. Tanto en los parches verticales como en los elementos formados, el material se aplicó con éxito y se desempeñó de manera bastante satisfactoria, sin que se haya reportado agrietamiento hasta el día de hoy.
