## Strut-and-Tie Models for the Design of Pile Caps: An Experimental Study

by Perry Adebar, Daniel Kuchma, and Michael P. Collins

*Describes the test results from six large pile caps that failed in two-way shear. ACI Building Code procedures for the shear design of pile caps are unable to predict the experimental results because the procedures neglect certain important parameters, such as the amount of longitudinal reinforcement, and overemphasize other parameters, such as the effective depth. Strut-and-tie models were found to describe more accurately the behavior of deep pile caps.*

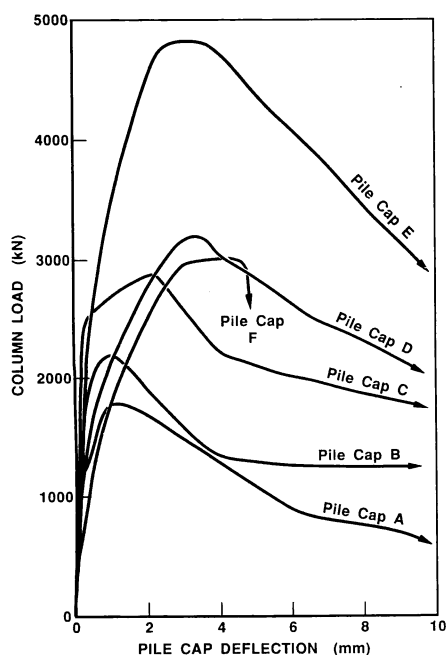
Fig. 5—Load-deflection relationships for the six test specimens (1 kN = 0.225 kips; 1 mm = 0.0394 in.)

The observed load-deflection relationships for the six specimens are shown in Fig. 5. The pile cap center deflection, load distribution among the piles, and reinforcing-bar strains, at both cracking load and ultimate load, are shown in Table 4. In Pile Caps A and B, which were lightly reinforced, the reinforcing strains increased very suddenly when the first crack formed. Both the strains immediately before and immediately after cracking are shown in the table.

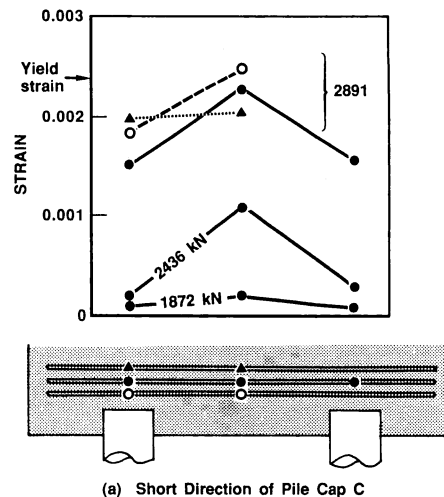
(a) Short Direction of Pile Cap C

(b) Long Direction of Pile Cap D

Fig. 11—Typical examples of longitudinal reinforcing strain variations measured at various column loads (1 kN = 0.225 kips)

In a member that resists shear by true “beam action,” the tension force in the longitudinal reinforcement changes along the beam to balance the applied bending moment, while the flexural lever arm remains relatively constant.<sup>14</sup> Alternatively, if the tension force remains constant, the flexural lever arm changes and the member acts as a tied arch with the shear being resisted by inclined compression, i.e., “strut action.” Fig. 11 shows typical examples of longitudinal reinforcing strain variations measured in the pile caps. While the sectional bending moment varies linearly from maximum at midspan to zero at the piles, the tensile force in the reinforcement varies much less. The measured tension in the reinforcement had its highest value at midspan, but the reinforcement over the piles still carried up to 75 percent of this maximum tension. It is perhaps the main advantage of strut-and-tie models

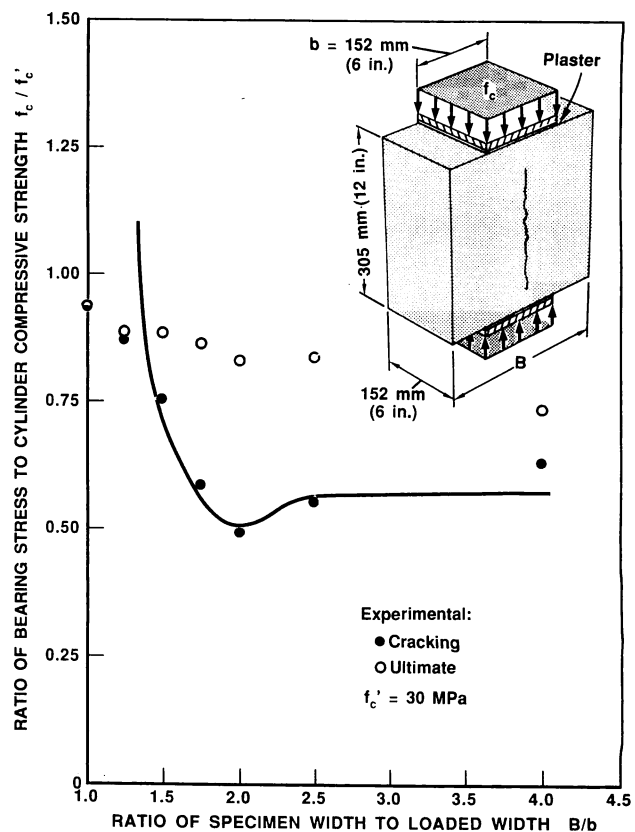
**Fig. 17—Simple tests to demonstrate the influence of transverse tension**

Rather than employing a refined strut-and-tie model, the simple truss model combined with an appropriate failure criterion for the compression strut can be used.<sup>1</sup> Fig. 17 summarizes a series of simple tests conducted by the authors to demonstrate the influence of transverse tension on the failure of compression struts. Seven plain concrete specimens with constant height and thickness but with varying widths were loaded in uniaxial compression, using the same size loading plate in all cases. In all but the most narrow specimen, the compression spread out, causing transverse tension, which split the specimens. The measured cracking loads, expressed in terms of the bearing stress, are compared with an elastic finite element prediction. In making this prediction, cracking was assumed to occur

when the maximum tensile stress reached 3.3 MPa (1579 psi).

For these plane-stress specimens, the minimum bearing stress at cracking was approximately  $0.5f'_c$ , but in a pile cap the compressive stresses spread in two directions, reducing the transverse tension in any one direction. Chen<sup>16</sup> conducted a series of tests on variously sized concrete cylinders loaded in uniaxial compression through small round loading disks (double-punch test). In these tests the concrete cracked at a minimum bearing stress of  $1.5f'_c$ .

In the author's plane stress tests, the concrete continued to carry load after cracking (see Fig. 17), while in Chen's double-punch tests, failure was always coincident with cracking. In pile caps, the absence of reinforcement to control diagonal cracking allows the cracks that occur due to splitting of the struts to propagate quickly through the specimen. Depending on the geometry of the pile cap, the final kinematically feasible failure mechanism resembles either a one-way or two-way shear failure.
