The Erosion of Reinforced Concrete Walls by the Flow of Rainwater

Abstract: The action of rainwater on reinforced concrete walls has led to an erosion phenomenon. The erosion is very apparent when the walls are inclined. This phenomenon is studied on a real site characterized by different architectural forms. The site dates back to the seventies; it was designed by the architect, modeler of concrete, Oscar Nie Meyer. On this site, the erosion has damaged the cover of the reinforcements and reduced its depth. In this research work, a method of quantification of the erosion is developed. Using this method, the amount of mass loss by erosion was measured on imprints taken from the site. The results are expressed by the rate of mass loss by erosion; they are associated to the height and the inclination of the walls. Moreover, laboratory analysis was carried out on samples taken from the site. From this study, it is recommended to consider the erosion, in any building code, to determine the cover thickness.

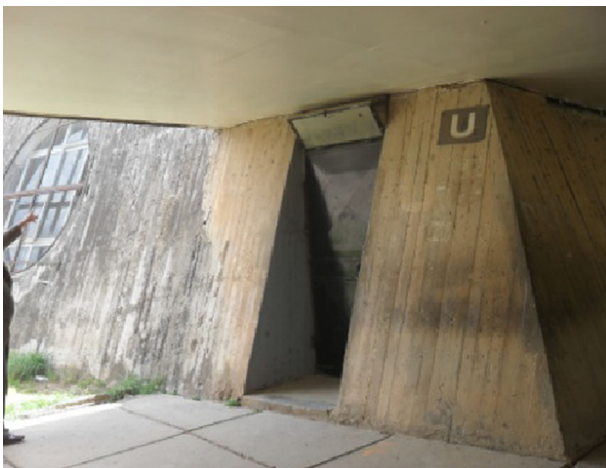
Fig. 1 Inclined wall intensely eroded.

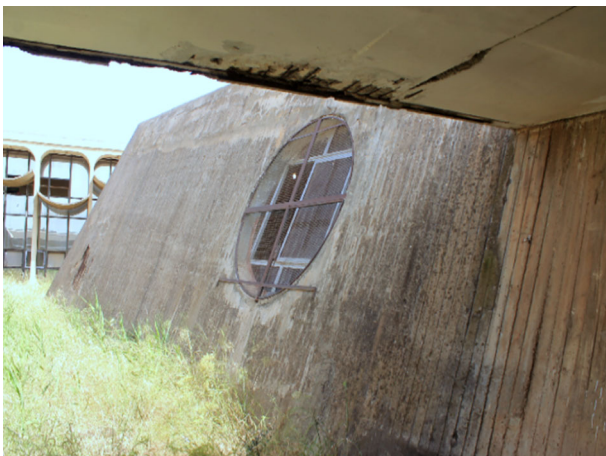
Fig. 2 The right side protected part, the left side exposed part.

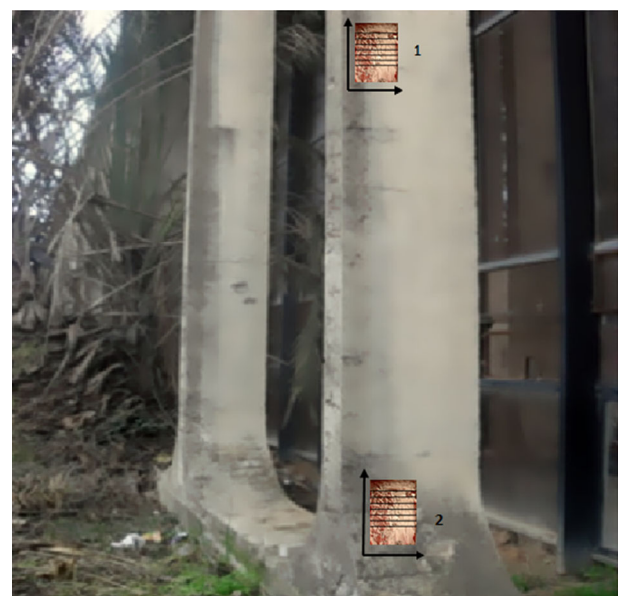
are seven buildings of this kind having 60 columns each. These elements are straight on first 5 m and inclined at the bottom. They have been subjected to the flow of rainwater on one side and protected on the other side (Fig. 4). The measurements were conducted on walls with a protected side (protected concrete) and another exposed to rain (eroded concrete) (Fig. 2). By this choice, the study concerns the same concrete that is poured at the same moment. Thus, it is the same element of the structure with and without erosion.

Fig. 4 The right side protected part, the left side exposed part of the straight wall.

Meros and Reros values presented in Table 1 were obtained in the x-direction of the imprint. They correspond to the position 1 of Fig. 4 (at $h = 6$ m).

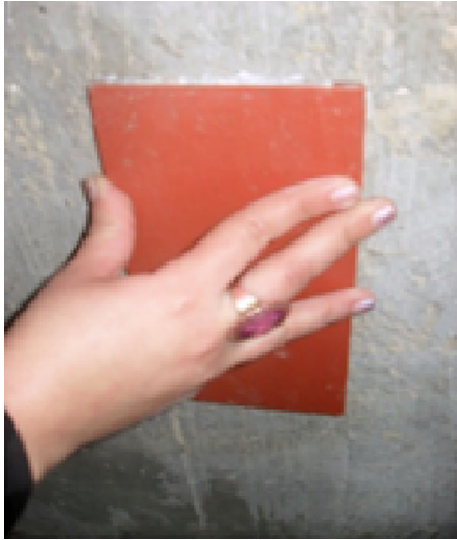
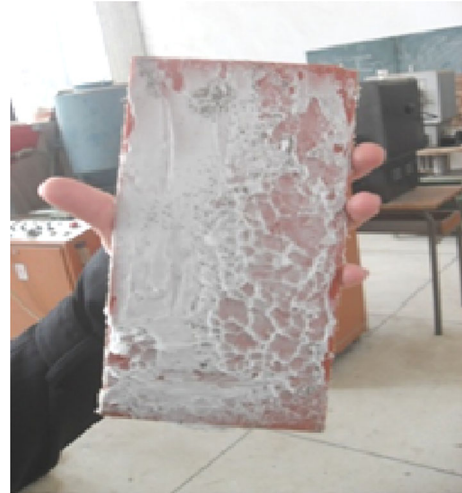
Fig. 5 Plate of the imprint against the wall.

Fig. 6 The imprint taken from the wall.

A silicone paste mixed with plaster was spread over a stable plate ($20 \times 10 \text{ cm}^2$). It was then plated against a part of the reinforced concrete wall during 2 min. Once removed, the imprint appears on the plate. The relief of the past expresses clearly the mass that is lost by erosion (Figs. 5 and 6). This experimental process was improved after several attempts of measurements. Using plates of $60 \times 40 \text{ cm}^2$ and adhesive silicone alone, the imprint did not appear on all the plate and the silicone became deformed. After several attempts, the plates were reduced to $20 \times 10 \text{ cm}^2$ and the paste to a of silicone-plaster mixture. The plaster was added to the silicone paste to reduce its deformability.

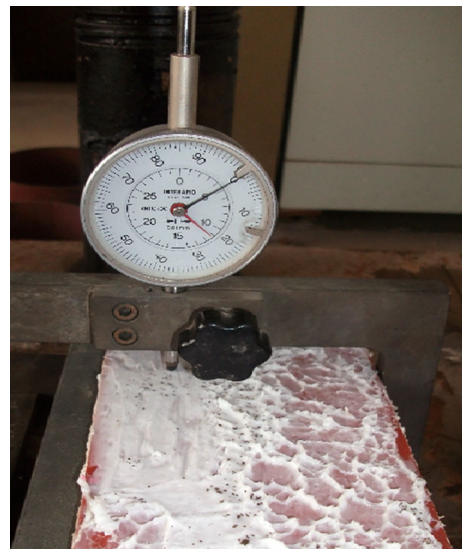
The depth of the mass taken away by the erosion is measured directly on the imprint with a displacement gauge. Measures are taken on several points crossing the studied surface according to two perpendicular axes with a step between 1.5 and 2 cm. (Figs. 7 and 8). The term “erosion depth” is used herein to indicate the thickness of the material taken away by erosion.

Fig. 7 Measuring device.

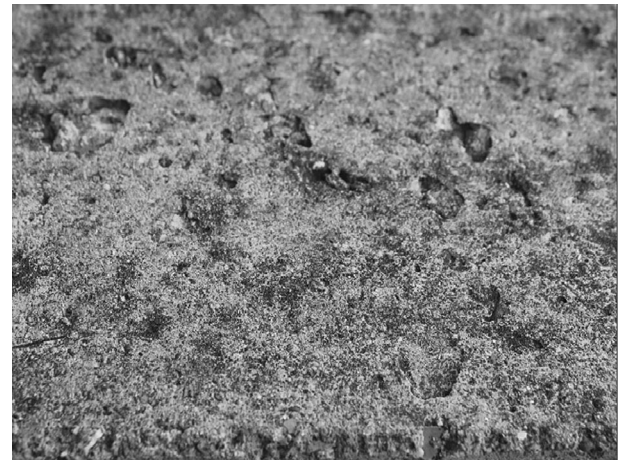
In order to identify the phenomenon of degradation and separate the chemical and dissolving effect from the mechanical effect, the rainwater is analyzed after passing over the wall. The results (Table 2) indicate that this water is hard and strongly ionized. A part of the damage was due to the action of the dissolving effect of rainwater. Moreover, the observation of the degraded surfaces by the naked eye (Fig. 14) and by using the microscope, shows the detachment of grains of various sizes. The observation of the analyzed rainwater shows the presence of particles.

Fig. 14 The detachment of grain of various sizes on the exposed concrete surface.

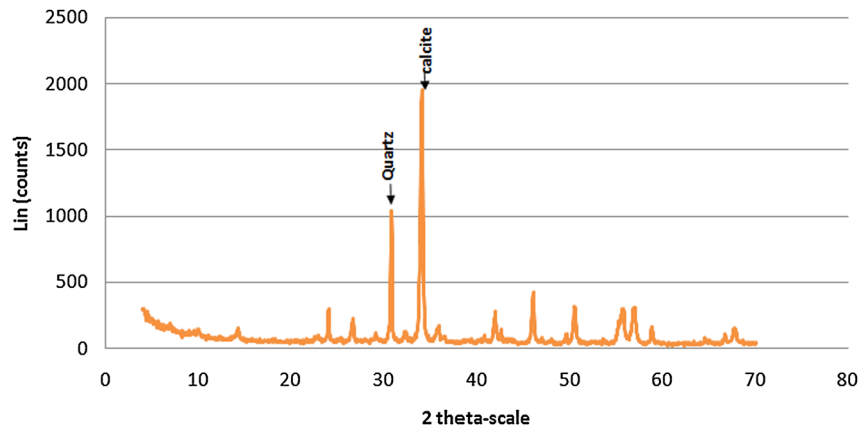
The X-ray diffraction applied on concrete debris collected in the two studied areas: protected (Fig. 15) and exposed (Fig. 16), indicates that there is a reduction of quartz peak about 26 % in the exposed area compared to the protected area.

Fig. 15 XRD spectrum-protected area.

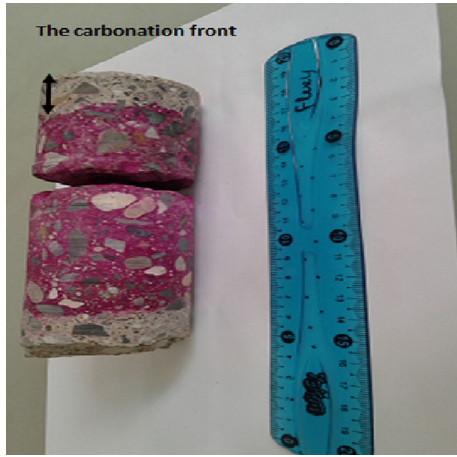
Concrete cores were taken to determine the carbonation depth of the two studied areas of concrete. The phenolphthalein indicates 2.5 and 2.1 cm carbonation depths respectively for the protected and exposed parts (Figs. 19 and 20).

Carbonation is more advanced in the case of protected areas than areas exposed to rainwater. This can be explained by the fact that the carbonation is slowed down by the saturation with water during the pluvial periods. When there is production of calcite, it is on the surface and hence

Fig. 19 The carbonation depth corresponding to the protected face.

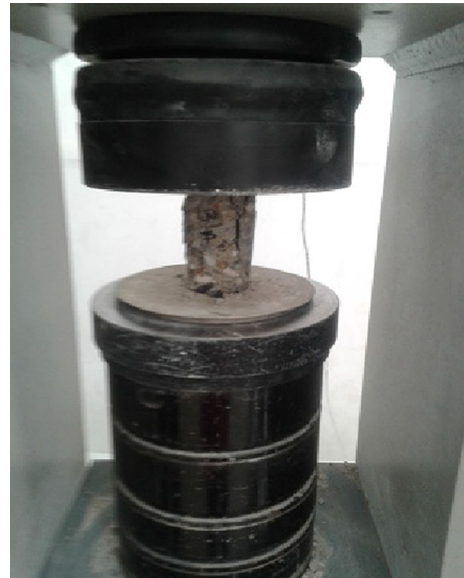
compressive strength was measured on the concrete corresponding to the two sides of the wall, the protected part and the exposed part using two methods. The first method is the destructive test; the compressive strength is measured by crushing cylindrical-concrete cores (Fig. 21) in a compression testing machine (Fig. 22). The second method is non-destructive testing by the determination of the rebound hammer (Fig. 23) and the measurement of the ultrasound velocity (Fig. 24 and Table 3)."

Fig. 22 Crushing core concrete.

The compressive strength obtained in the exposed face by crushing of the concrete core is lower than that of the protected part of concrete. This is due to two reasons:

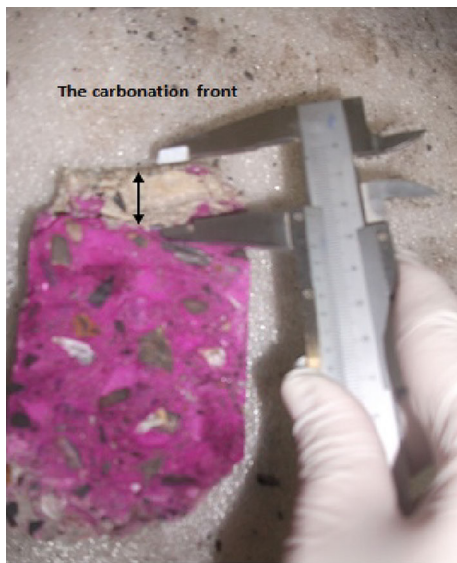
Fig. 20 The carbonation depth corresponding to the exposed and eroded face.

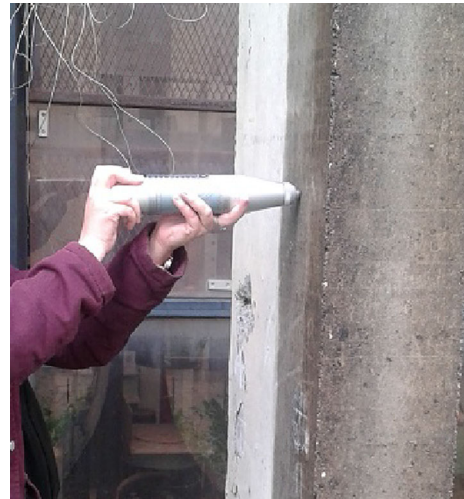
Fig. 23 Determination of the rebound.

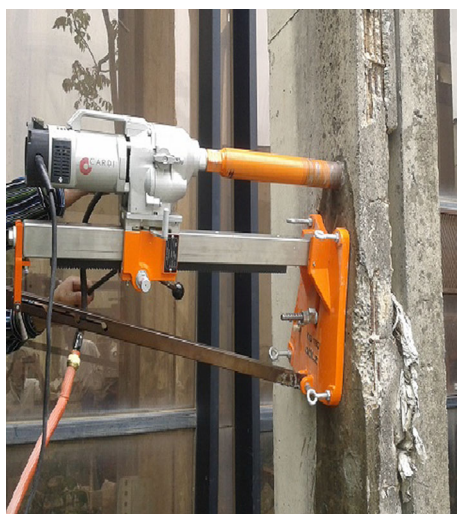
Fig. 21 Core drilling concrete.

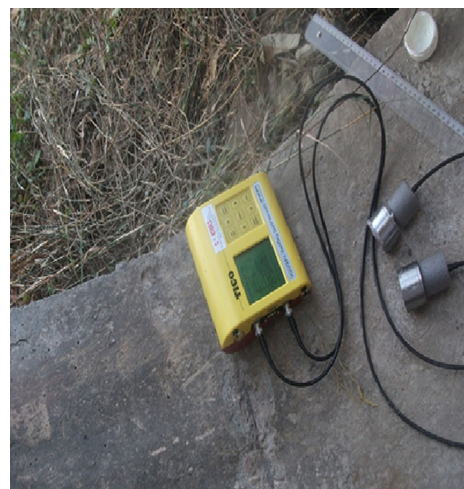
Fig. 24 Estimation of the ultrasound velocity.

Secondly, in the case of the exposed concrete, the layer of the calcite has been drained away by the erosion and hence does not lead to an increase in the density of the material. This explains the lower strengths of the eroded concrete. The results of ultrasound indicate a concrete with a low compressive strength (≤ 10 MPa according to Rilem) because the measurement was applied only on the surface.
