Belitic Calcium Sulfoaluminate Concrete Runway

Looking back after 23 years in service

by Omkar Deo, Neel Bhuskute, Eric Bescher, Naga Pavan Vaddey, and Jose Pacheco

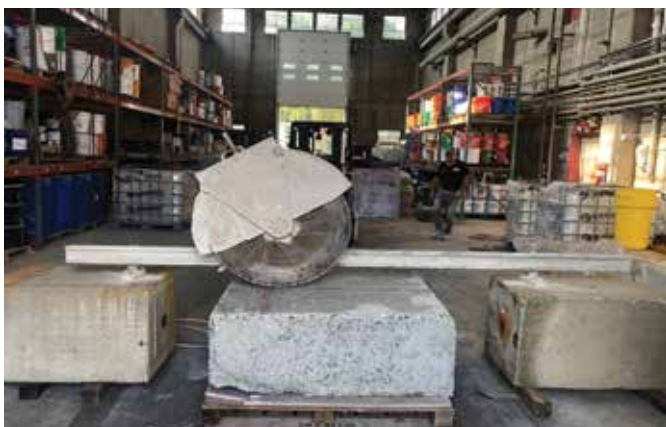
Fig. 2: BCSA runway slab sample is prepared for cutting at the CTLGroup’s laboratory

In the fall season of 2020, the slab section was delivered to the CTLGroup laboratory, where it was sawn per ASTM C42/C42M, “Standard Test Method for Obtaining and Testing Drilled Cores and Sawed Beams of Concrete,” using the equipment shown in Fig. 2. Concrete beams with a nominal dimension of 6 x 6 x 20 in. (150 x 150 x 510 mm) were extracted for fatigue and flexural strength testing from the upper and lower halves (~8.5 in. [216 mm] each) of the slab. This operation required precise sawing to maximize the number of specimens with the exact nominal dimensions as those used in the evaluation conducted in 1998. After extraction, the sawn beams were stored in saturated limewater until testing. In addition to sawn beams, core specimens were extracted and conditioned, also per ASTM C42/C42M. In addition to compressive strength tests, core specimens were used for pore solution analyses, carbonation depth evaluations, and petrographic evaluations (per ASTM C856/C856M, “Standard Practice for Petrographic Examination of Hardened Concrete”). Samples were also examined using a scanning electron microscope (SEM).

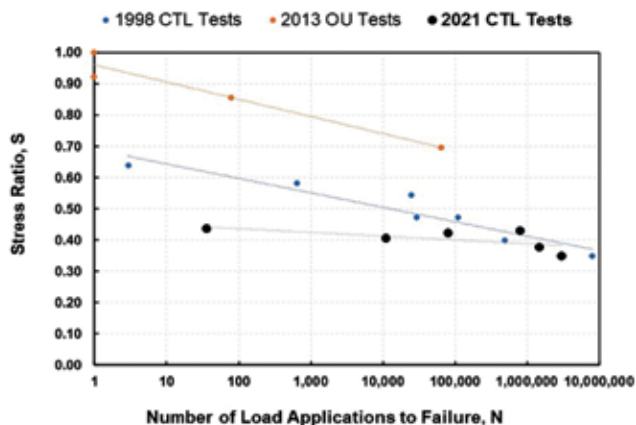
Fig. 4: A comparison of fatigue test results of BCSA concrete, including data from the slab sample taken from the Sea-Tac airport in 2021, the data obtained by the CTLGroup during the rehabilitation project, and data obtained in 2013 at the University of Oklahoma

In the same figure, a comparison is also made with similar tests carried out on the Sea-Tac slab specimens at CTLGroup and the University of Oklahoma in 1998 and 2013, respectively.

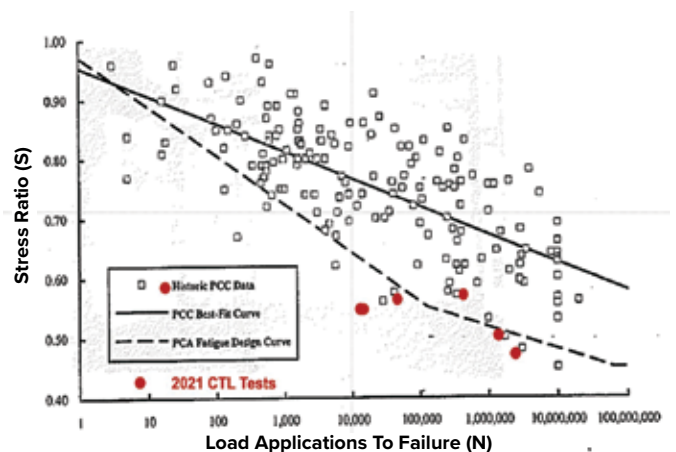
Fig. 5: The 2021 fatigue test data of the BCSA concrete slab from the Sea-Tac (red dots) in comparison to the PCA collected data

A comparison of the 2021 tests of BCSA specimens is also made with a comprehensive set of results compiled for PCCs by the Portland Cement Association (PCA). These results (see Fig. 5) indicate that the performance observed after 23 years of service correlates well with the PCA fatigue design curve. When the stress ratio was less than 0.55, load applications exceeding 1 million cycles were achieved, showing a marginal effect on fatigue performance after 23 years in service. Further, it should be noted that the BCSA specimens had already been subjected to many load cycles at the onset of each test, so the data points could be shifted to the right to reflect the actual performance.

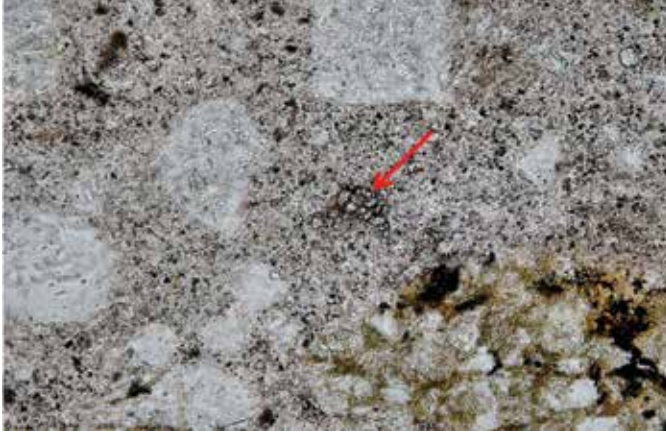
Fig. 6: Thin-section micrograph of hardened BCSA concrete, taken using a plain-polarized light source. The field of view is 0.03 in. (0.76 mm) across. Almost complete hydration is observed. The red arrow indicates a trace of residual calcium sulfoaluminate cement in the paste

Figure 6 shows the concrete micrograph from a core specimen examined per ASTM C856/C856M. The sampled concrete consisted of igneous rocks and fine-grained

sedimentary rocks. The calcium sulfoaluminate cement was found to be almost fully hydrated with minor trace amounts of unhydrated or partially hydrated cement grains (indicated with a red arrow in Fig. 6), which would most likely be the belite component. The carbonation depth was found to range between 0.4 and 0.6 in. (10 and 15 mm), as shown in Fig. 7. The estimated air content of the concrete was between 7 and 9%. The petrographic and SEM images showed no signs of ASR or ASR gel formation (see Fig. 8).

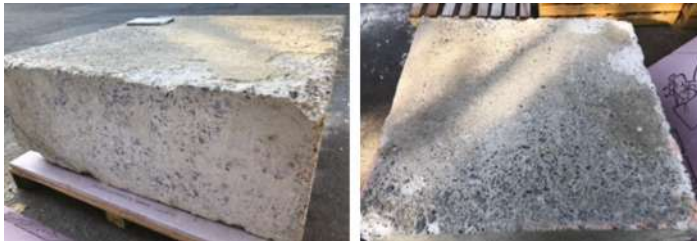
Fig. 1 Muestra de losa CBSA de la pista, tomada después de 23 años de servicio

Como parte de los proyectos de Reemplazo de Pavimentos de Aeropuertos e Infraestructuras Secundarias de la Autoridad de Puertos de Seattle para el 2020, se removió una losa de la vía de rodaje de 4 x 4 x 1.5 pies (1.22 x 1.22 x 0.45 metros) y fue sometida a pruebas en laboratorio. La superficie de rodaje mostraba un desgaste ligero a moderado (Fig. 1). En una cara de la sección de la losa se encontraron barras de refuerzo a una profundidad de 8 pulgadas (200 mm) y espaciadas a unas 13.5 pulgadas (345 mm).

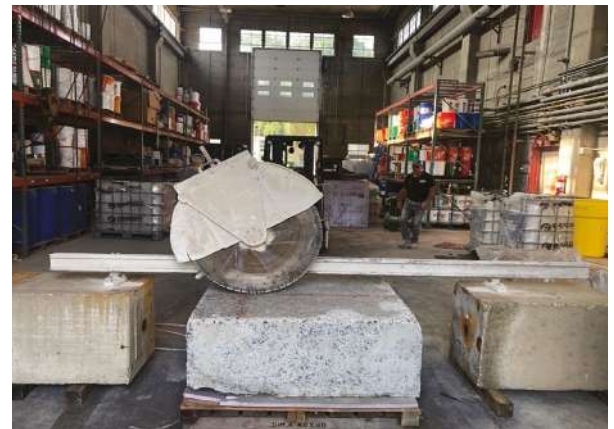
Fig. 2: Se prepara una muestra de losa CBSA para ser cortada en el laboratorio de CTLGroup

En la temporada de otoño del 2020, la sección de la losa fue entregada al laboratorio de CTL Group, donde fue cortada de acuerdo a la ASTM C42/C42M, “Método de Prueba Estándar para Obtener y Ensayar Núcleos de Concreto Taladrados y Vigas de Concreto Cortadas”, utilizando el equipo mostrado en la Fig. 2. Se extrajo vigas de concreto a un tamaño nominal de 6 x 6 x 20 pulgadas de la parte superior e inferior de la losa (~8.5 pulgadas [216 mm] cada una) para realizar pruebas de fatiga y de esfuerzo en flexión. Esta operación requirió de unos cortes precisos para maximizar la cantidad de especímenes con las dimensiones nominales exactas como aquellas que se usaron en la evaluación realizada en 1998. Luego de ser cortadas, las vigas se acondicionaron en un baño de agua de cal saturada hasta que fueron utilizadas para las pruebas. Además de las vigas cortadas, se extrajeron núcleos de concreto y fueron acondicionados según la ASTM C42/C42M. Adicional a las pruebas de resistencia a la compresión, los núcleos fueron utilizados para análisis de la solución de poros, evaluación de profundidad de carbonatación, y evaluación petrográfica (según la ASTM C856/C856M, “Práctica Estándar para Examinación Petrográfica de Concreto Endurecido”). Las muestras también fueron examinadas utilizando microscopía electrónica de barrido (SEM).

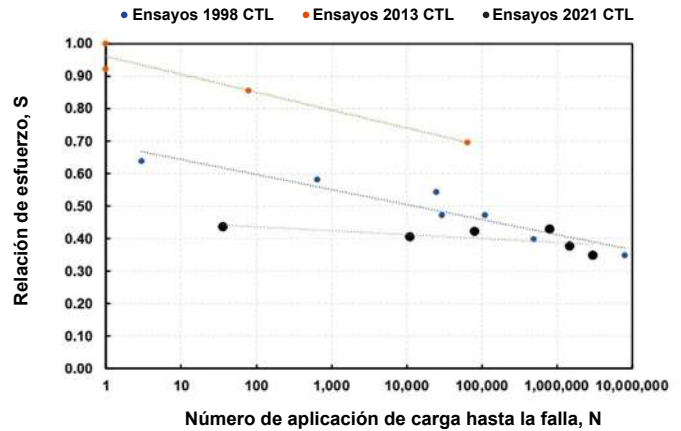
Fig. 4: Una comparación de los resultados de las pruebas de fatiga del concreto CBSA, incluyendo los datos de la muestra de losa tomada del aeropuerto Sea-Tac en 2021, los datos obtenidos por CTLGroup durante el proyecto de rehabilitación y los datos obtenidos en 2013 en la Universidad de Oklahoma

En la misma figura, se hace una comparación con ensayos similares obtenidos de los especímenes de las losas de Sea-Tac realizados en CTL Group y la Universidad de Oklahoma en 1998 y 2013 respectivamente.

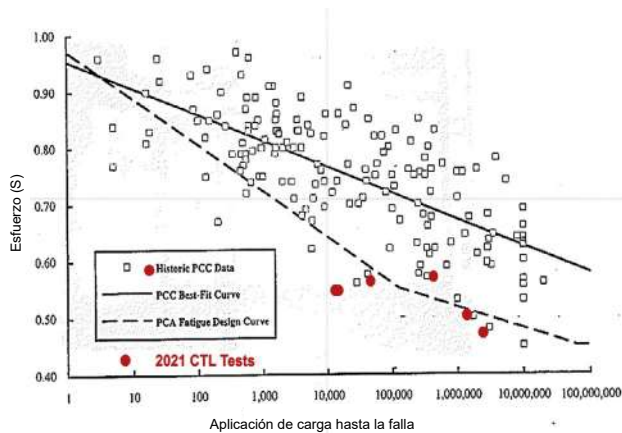
Fig. 5: Los datos de prueba de fatiga de 2021 de la losa de concreto CBSA del Sea-Tac (puntos rojos) en comparación con los datos recopilados por la PCA

De igual manera, se hace una comparativa de las pruebas de concreto CBSA realizadas en el 2021 y el compendio de resultados obtenidos por la Asociación de Portland Cement (PCA por sus siglas en inglés). Estos resultados (véase la Fig. 5) indican que el desempeño observado luego de 23 años en servicio se correlaciona bien con la curva de diseño de la fatiga de la PCA. Cuando la relación de esfuerzo era menor de 0.55, se lograba exceder 1 millón de ciclos de aplicación de cargas, mostrando un efecto marginal del rendimiento de fatiga luego de 23 años en servicio. No obstante, se debe hacer una nota sobre los especímenes de CBSA los cuales ya habían sido sometidos a muchos ciclos de carga al inicio de cada prueba, por lo que los datos podrían desplazarse a la derecha para reflejar el desempeño real.

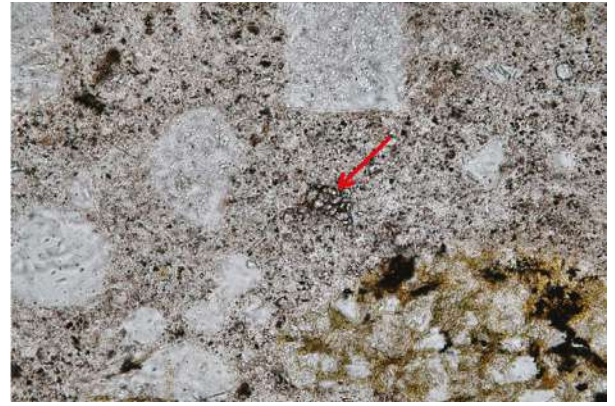
Fig. 6: Micrografía de sección delgada de hormigón CBSA endurecido, tomada utilizando una fuente de luz de polarización simple. El campo de visión es de 0.03 pulgadas (0.76 mm) de ancho. Se observa una hidratación casi completa. La flecha roja indica un rastro de cemento sulfoaluminato de calcio residual en la pasta

La Figura 6 muestra la micrografía de un núcleo de concreto según el ASTM C856/C856M. La muestra de concreto consiste en roca ígnea y rocas sedimentarias de grano fino. El cemento de sulfoaluminato de calcio mostró estar completamente hidratado con bajas cantidades de partículas no hidratadas o parcialmente hidratadas (indicado por una flecha roja en la Fig. 6), que muy probable sería el componente belita. La profundidad de carbonatación se mantuvo entre 0.4 y 0.6 pulgadas (10 y 15 mm), según se muestra en la Fig. 7. El contenido de aire estimado del concreto fue entre 7 y 9%. Las imágenes petrográficas y SEM no mostraron señal de ASR o formación de gel ASR (véase Fig. 8).
