# GFRP Reinforced Concrete Slabs under Restrained Shrinkage

by Bryan E. Barragan, Antonio Mudadu, Giuseppe Tiberti, and Giovanni A. Plizzari

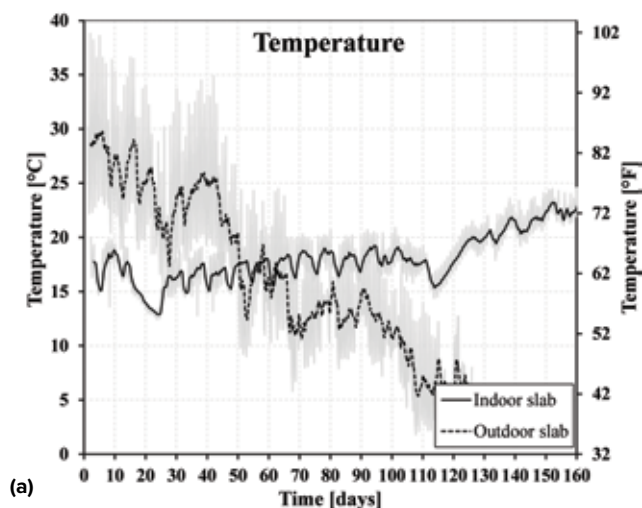
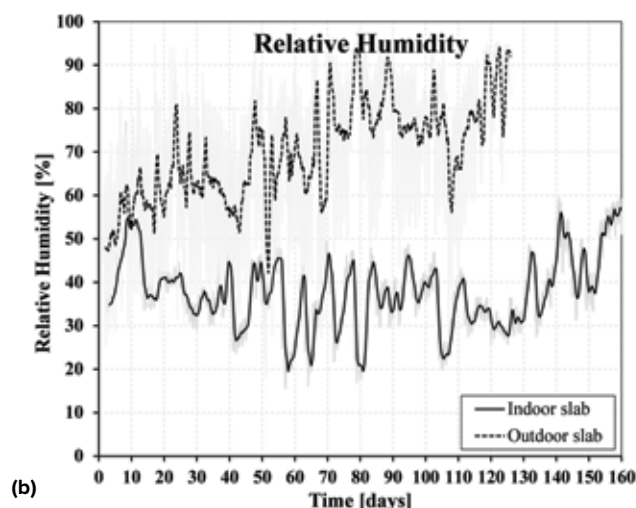
**Fig. 2: Exposure conditions for indoor and outdoor slabs: (a) temperature; and (b) relative humidity**

[6 x 12 in.] cylinders and 25 MPa [3600 psi] when measured in 150 mm cubes) typically used in floor applications was supplied by a local ready mixed concrete company. Mixture proportions are presented in Table 1. Concrete was placed using a bucket for the internal slabs and pumped for the external slabs. For all slabs, concrete was evenly spread by screeding and consolidated using a needle vibrator. The slab top surface was troweled to achieve a smooth finish (Fig. 1(b)). To simulate a more severe condition, no curing was implemented on the surface of the slab; only the bleed water kept the surface wet during the initial hours after concrete placement. Ambient temperature and relative humidity were measured continuously for the duration of the tests (see Fig. 2).

While indoor slabs were cast inside the laboratory for testing materials and structures at the University of Brescia, Brescia, Italy, in a relatively dry laboratory environment, outdoor slabs were cast under severe summer conditions (with temperatures higher than 35°C [95°F]) and remained exposed until the end of the following winter. As can be seen in Fig. 2(a), the average indoor temperature was 18°C (64°F), with a small overall daily variation of ±6°C (11°F), while the average outdoor temperature was 17°C (63°F), with an overall daily variation of ±15°C (27°F). The average relative humidity for the indoor slabs was 37% (ranging from 16 to 58%), whereas for the outdoor slabs it was 70% (ranging from 18 to 96%), as shown in Fig. 2(b). Indoor and outdoor slabs were exposed (not protected) during the entire duration of the test.

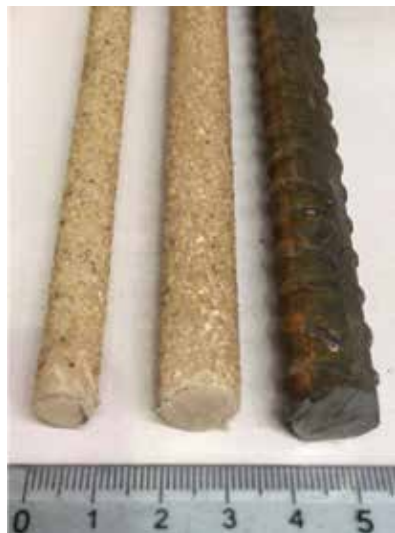
Fig. 3: Bar types used in the study, from left: No. 3 and No. 4 GFRP bars and No. 4 steel bar

Figure 3 shows the steel and GFRP bars used in the study. The No. 4 steel bars were standard Grade B400S (Grade 60)

with a yield strength of 400 MPa (58 ksi) and modulus of elasticity of 210 GPa (30,500 ksi). The No. 3 and No. 4 GFRP bars (PINKBAR® from Owens Corning®) met ASTM D7957/ D7957M-17,<sup>6</sup> with a tensile strength of 981 and 910 MPa (142 and 132 ksi), respectively, and a modulus of elasticity of 46.9 GPa (6800 ksi).

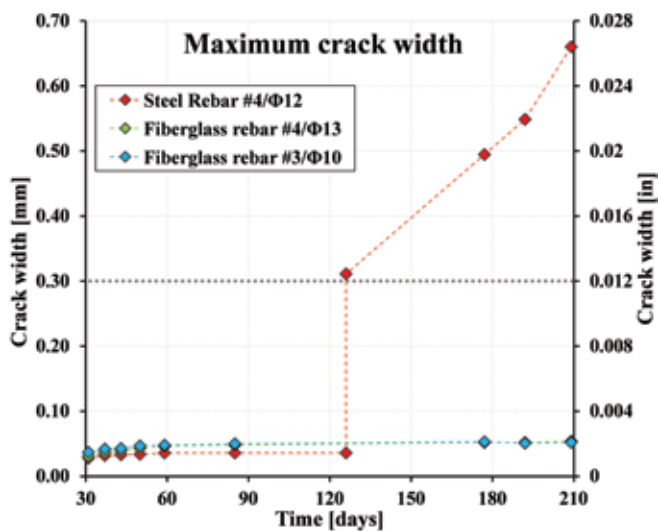
Fig. 6: Maximum crack widths for indoor slabs

Figure 6 shows the maximum crack widths observed for indoor slabs; it can be seen that the microcrack widths slowly increased up to 90 days in all slabs, after which the opening rate significantly decreased or stopped. Crack openings in GFRP-reinforced slabs were well below 0.1 mm (0.004 in.). The same behavior was observed for the steel-reinforced

slabs, until a macrocrack appeared in this slab after 126 days, reaching an opening of more than 0.65 mm (0.025 in.) at 209 days. Figure 6 also shows the 0.3 mm (0.01 in.) reference crack width line, because microcracks below that value are generally acceptable in floor construction.

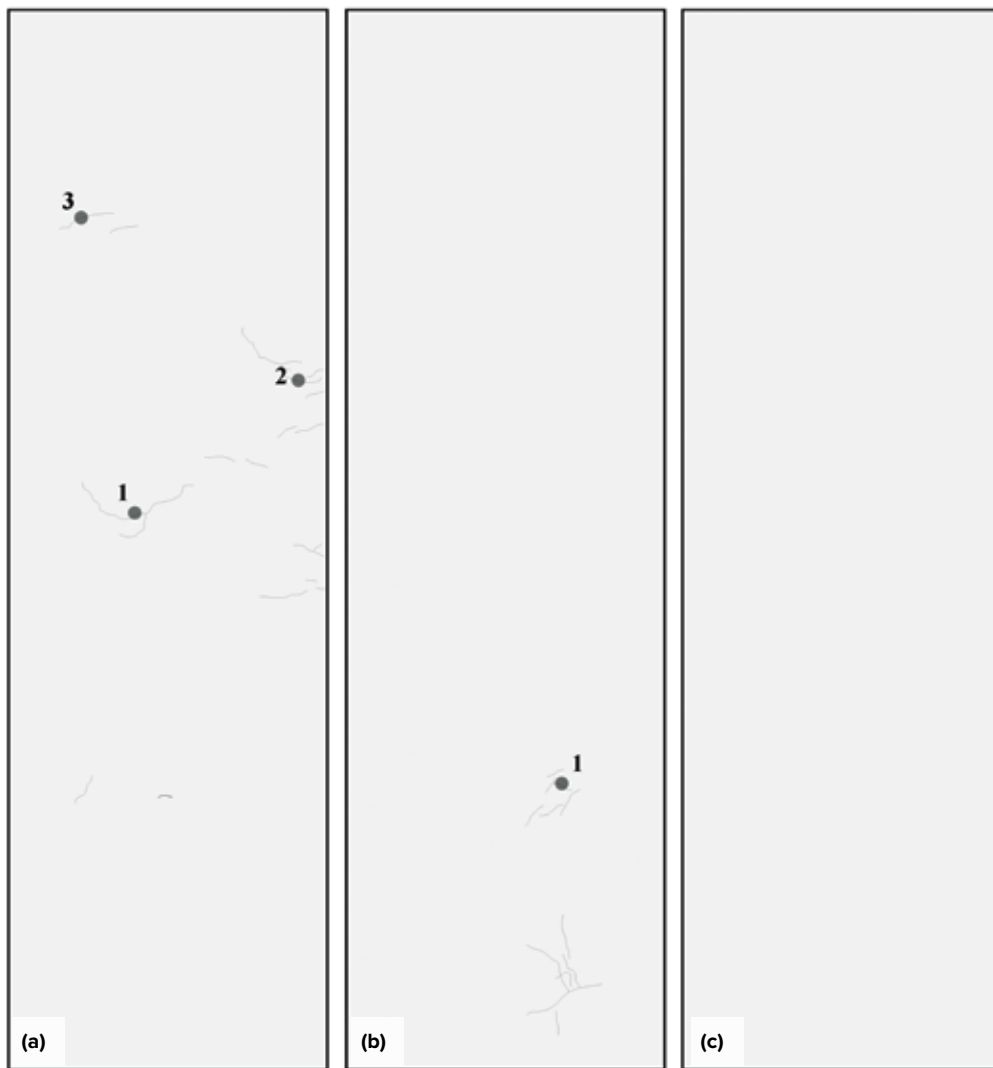
Fig. 7: Outdoor slabs crack pattern after 210 days: (a) No. 4 steel bars at 18 in. o.c.; (b) No. 4 GFRP bars at 18 in. o.c.; and (c) No. 3 GFRP bars at 18 in. o.c. (Note: Thin lines represent microcracks; and dots represent reference measuring points)

As in the case of indoor slabs, once microcracks became visible on the outdoor slabs (observed at a close distance from the slab surface, approximately 250 mm), an accurate mapping of the crack pattern was carried out starting at 92 days of exposure, measuring the crack development and crack width with the digital microscope. Figure 7 shows the final crack patterns determined by a visual inspection.

As shown in Fig. 7, three and one cracks were identified in slabs reinforced with No. 4 steel bars and No. 4 GFRP bars, respectively. Also, the slab reinforced with No. 4 steel bars had a larger number of microcracks (not visible to the naked eye), whereas the slab reinforced with

No. 3 GFRP bars exhibited no microcracks (Fig. 7(c)). Slabs reinforced with the same amount of No. 4 steel and No. 4 GFRP bars developed surface microcracks, with a higher number of cracks observed in the steel-reinforced slab (Fig. 7(a) and (b)).

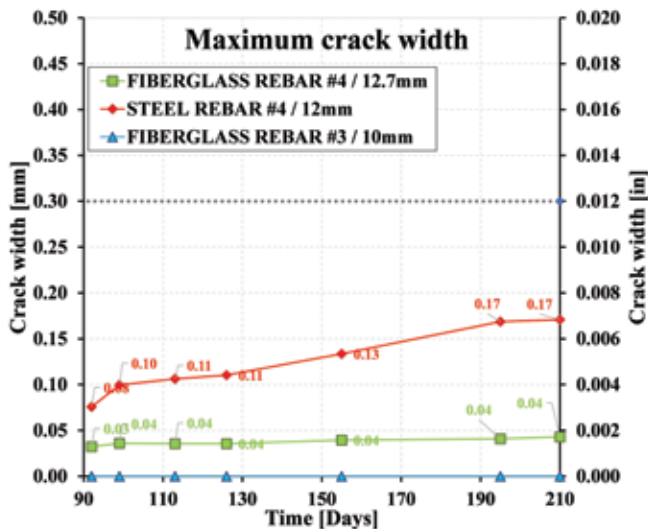
Fig. 8: Maximum crack width for outdoor slabs

Figure 8 shows the maximum crack widths observed for the outdoor slabs. It can be seen that slabs reinforced with No. 4 steel bars and No. 4 GFRP bars show a similar trend, with the steel-reinforced slab exhibiting larger crack widths. As a reference, Fig. 8 also includes the 0.3 mm reference line indicating a typical limit of acceptable crack widths in practice. It can be observed that the crack widths remain

below the “visible crack opening” of 0.3 mm in the three slabs.

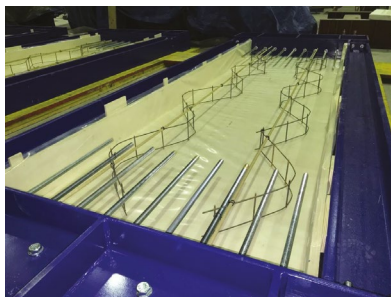
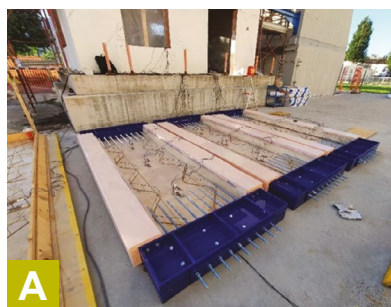
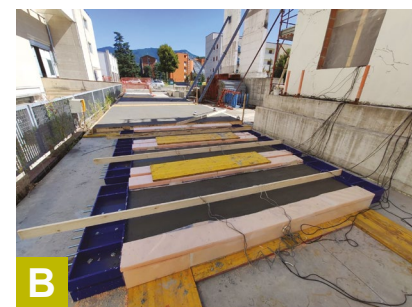
**Fig. 1:** Detalles del montaje de las losas: (a) cimbras de acero con película plástica antifricción, separadores o silletas tipo "serpiente" y varillas de anclaje roscadas (desde la izquierda, en exposición interior y exterior); y (b) especímenes después del colado (desde la izquierda, en exposición interior y exterior).

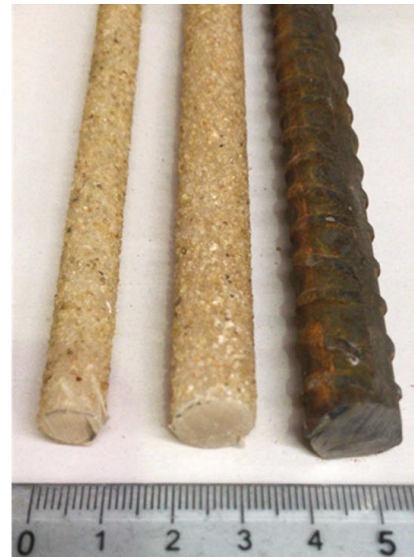
*Fig. 3: Tipos de varillas utilizadas en el estudio, de izquierda a derecha: Varillas de GFRP #3 y #4 y varilla de acero #4.*

La Figura 3 muestra las barras de acero y GFRP utilizadas en el estudio. Las barras de acero #4 eran de grado estándar B400S (Grado 60) con un límite elástico de 400 MPa (58 ksi) y un módulo de elasticidad de 210 MPa (30.5 ksi). Las barras de GFRP #3 y #4 (PINKBAR® de Owens Corning®) cumplían con ASTM D7957/ D7957M-17<sup>6</sup>, con una resistencia a la tensión de 981 y 910 MPa (142 y 132 ksi), respectivamente, y un módulo de elasticidad de 46.9 GPa (6.8 ksi).

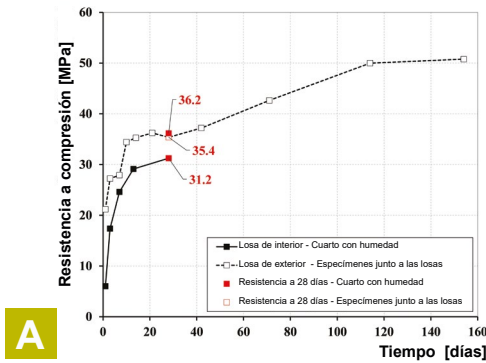
**Fig. 4: Resultados de las pruebas en losas de interior y exterior: (a) resistencia a compresión; y (b) contracción (Nota: 1 MPa = 145 psi).**

Las muestras de concreto para resistencia a compresión, los cubos de 150 mm, y los prismas de 75 x 75 x 250 mm (3 x 3 x 10 pulg.) para las mediciones de la contracción libre, se colaron al mismo tiempo que cada lote de losas. Exceptuando a los cubos de interior de resistencia a la compresión, todos los especímenes se mantuvieron en las mismas condiciones ambientales que las losas. Los cubos de interior se mantuvieron en el cuarto con humedad. La resistencia a la compresión del concreto se midió según EN 12390-3<sup>10</sup>. La contracción libre del concreto se midió según EN 12390-16<sup>11</sup>. La Figura 4(a) muestra el desarrollo de la resistencia a la compresión para losas en ambientes de interior y de exterior, respectivamente; la resistencia a compresión del concreto promedio a los 28 días fue de 31 y 35 MPa (4500 y 5130 psi) para los especímenes de interior y de exterior, respectivamente. La evolución de la contracción libre fue monitoreada durante aproximadamente 3 meses para las losas de interior y a lo largo de toda la duración de los ensayos para los especímenes de exterior. En la Fig. 4(b) se representan las mediciones de la contracción libre en condiciones de interior y de exterior. Para los especímenes de interior, se produjo un rápido aumento de la contracción durante los primeros 20 días después del colado, a partir de los cuales el índice de contracción disminuyó hasta alcanzar un comportamiento casi asintótico aproximadamente a los 60 días. Aproximadamente a los 90 días, la contracción promedio registrada fue de 665 microdeformaciones, que es un valor típico para la clase de concreto adoptada. En el caso de los

especímenes de exterior, se produjo un rápido aumento de la contracción durante unos 20 días después del colado, a partir del cual el índice de contracción disminuyó hasta alcanzar un comportamiento casi asintótico aproximadamente a los 48 días. A los 154 días, la contracción total promedio registrada fue de 457 microesfuerzos. Cabe señalar que los especímenes de exterior estuvieron sometidos a condiciones ambientales adversas, incluyendo el agua de lluvia.

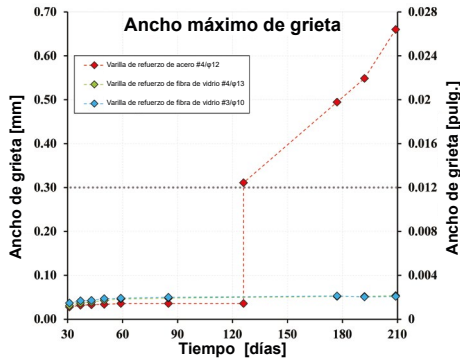
Fig. 6: Anchos máximos de grieta para losas de interior.

La Figura 6 muestra el ancho máximo de las grietas observadas en losas de interior; puede apreciarse que el ancho de las microgrietas aumentó lentamente hasta los 90 días en todas las losas, tras lo cual el índice de apertura disminuyó significativamente o se detuvo. Las aberturas de grietas en las losas reforzadas con GFRP fueron muy inferiores a 0.1 mm (0.004 pulg.). El mismo comportamiento se observó para las losas reforzadas con acero, hasta que apareció una macrogrieta en esta losa a los 126 días, alcanzando una abertura de más de 0.65 mm (0.025 pulg.) a los 209 días. La Figura 6 muestra también la línea de referencia de 0.3 mm (0.01 pulg.) de ancho de la grieta, ya que generalmente se aceptan microgrietas por debajo de ese valor en la construcción de pisos.
