“Reasonable Safety” of Existing Structures, Part 3

Reading the structure

by David G. Tepke, Liying Jiang, Keith E. Kesner, and Stephen S. Szoke

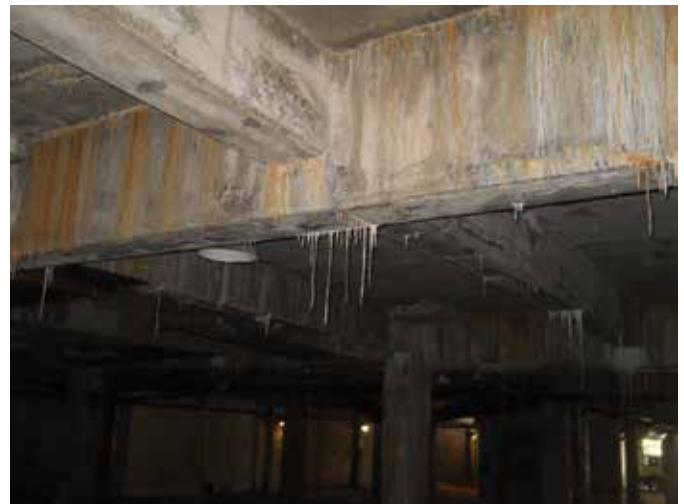
Fig. 1: Leakage with corrosion staining at an existing parking garage framing structure

Part 2 of this series focused on challenges associated with the availability of documentation, the evolution of the building codes and construction practices, and how these changes impact the assessment of structural safety.¹ The process of “reading” the structure typically starts with a visual survey to identify indicators of potential distress such as cracks, deterioration, excessive deformations, or signs of leakage (Fig. 1).

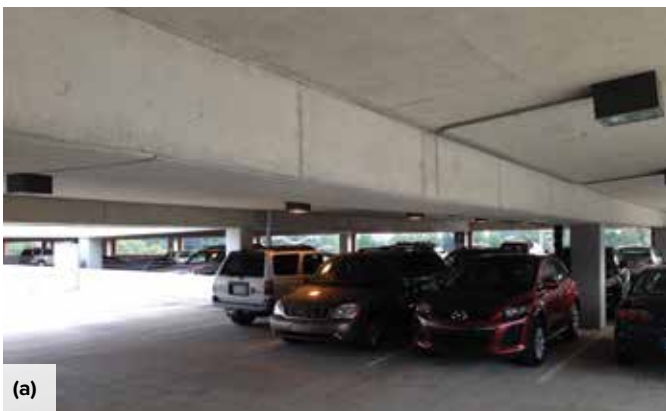
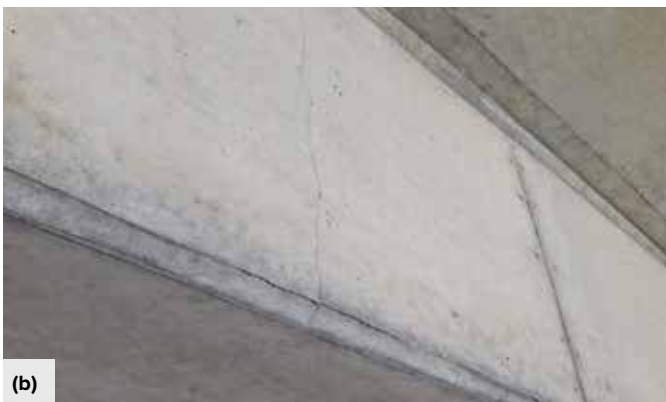
Fig. 2: A beam within a parking garage structure: (a) a general view; and (b) a close-up view of a crack on the beam face and soffit

design, or deterioration from longer-than-anticipated service in a given environment can lead to defects or damage that may be of concern. As described in ACI CODE-562-21, condition(s) observed during the visual survey perceived to be “potentially dangerous” or that give cause for the LDP to question the capacity of the structure or structural element—for example, the observed condition that is inconsistent with expectations of the design—must be further evaluated. This concept is illustrated in Fig. 2 and 3. Figure 2 shows a “typical” or “expected” crack on a concrete beam. This type of crack is common in concrete structures under “typical” service conditions. In contrast, Fig. 3 shows an example of atypical concrete cracking.

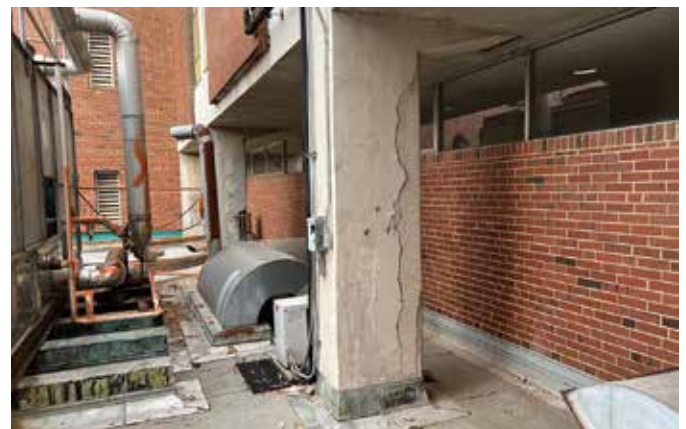
Fig. 3: Vertical cracks and concrete delamination in a column

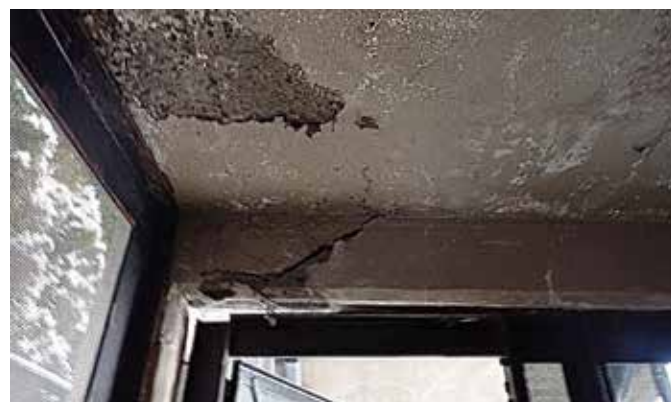
Fig. 4: This wide diagonal crack near a support indicates the need for shoring and additional investigation

- Cracks due to flexure or shear of structural elements may warrant further investigation, particularly wider cracks, cracks indicative of development failure, and cracks in members with limited redundancy. An example of a member with limited redundancy is a cantilever beam. Shear cracks, regardless of redundancy, require additional investigation due to the potential nature of the failure (Fig. 4);

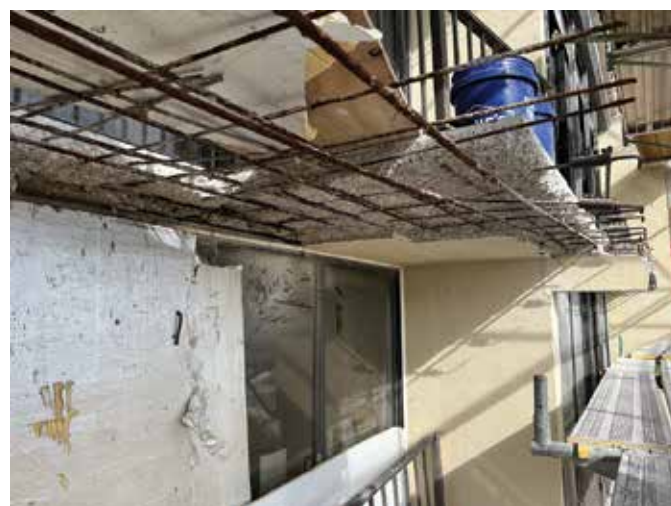
Fig. 5: Corroded reinforcing bars within a balcony (under repair)

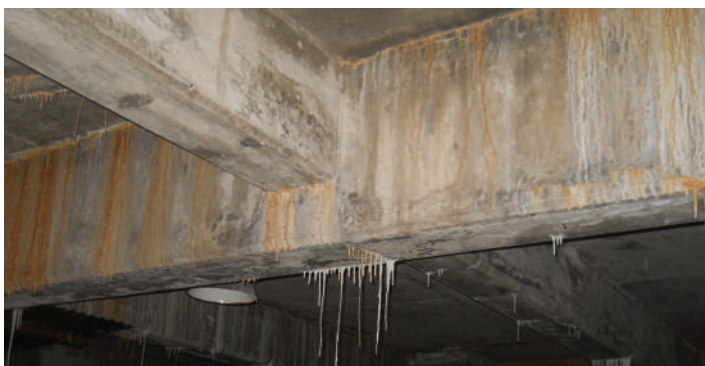
Fig. 1: Filtraciones con manchas de corrosión en una estructura de pórticos de un estacionamiento existente.

La Parte 2 de esta serie se centra en los retos asociados a la disponibilidad de documentación, la evolución de los códigos de construcción y las prácticas de construcción, y cómo afectan estos cambios a la evaluación de la seguridad estructural¹. El proceso de "lectura" de la estructura suele comenzar con una inspección visual para identificar indicadores de posibles problemas, como grietas, deterioro, deformaciones excesivas o signos de filtraciones (Fig. 1).

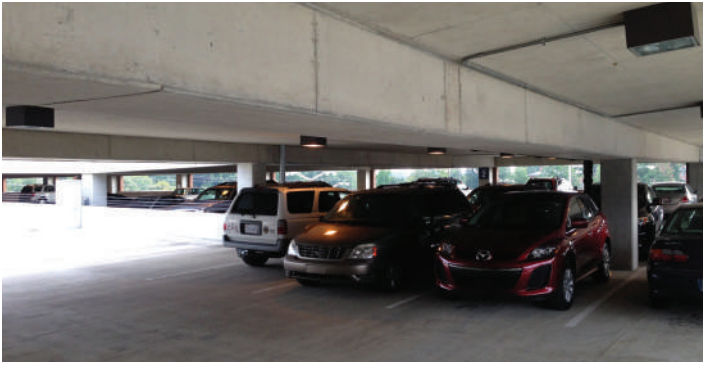
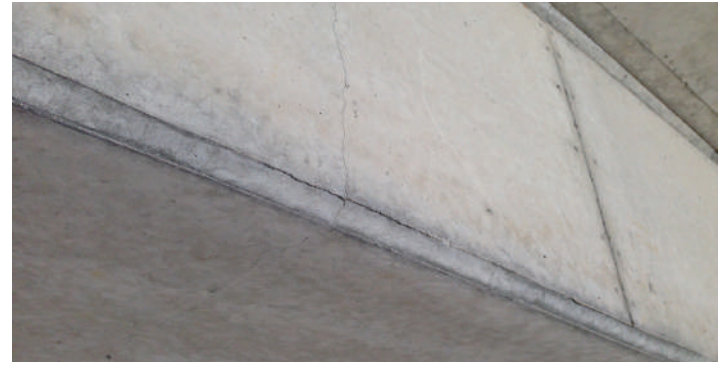
Fig. 2: Una viga dentro de la estructura de un estacionamiento: (a) una vista general; y (b) una vista en primer plano de una grieta en la cara de la viga y la losa.

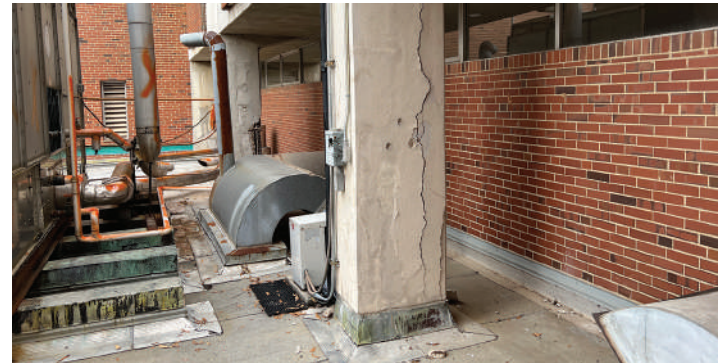
Fig. 3: Grietas verticales y delaminación del concreto en una columna.

Sin embargo, los errores de diseño o construcción fuera de las tolerancias estándar, el uso indebido o no previsto de la estructura, la exposición a cargas o condiciones no tenidas en cuenta en el diseño, o el deterioro debido a un servicio más prolongado de lo previsto en un entorno determinado pueden dar lugar a defectos o daños que pueden ser motivo de preocupación. Tal y como se describe en ACI CODE-562-21, la(s) condición(es) observada(s) durante la inspección visual percibida(s) como "potencialmente peligrosa(s)" o que dé(n) lugar a que el LDP cuestione la capacidad de la estructura o elemento estructural - por ejemplo, la condición observada que es inconsistente con las expectativas del diseño - debe(n) ser evaluada(s) más a fondo. Este concepto se ilustra en las figuras 2 y 3. La figura 2 muestra una grieta "típica" o "esperada" en una viga de concreto. Este tipo de grieta es común en estructuras de concreto bajo condiciones de servicio "típicas". Por el contrario, la Fig. 3 muestra un ejemplo de fisuración atípica del concreto.

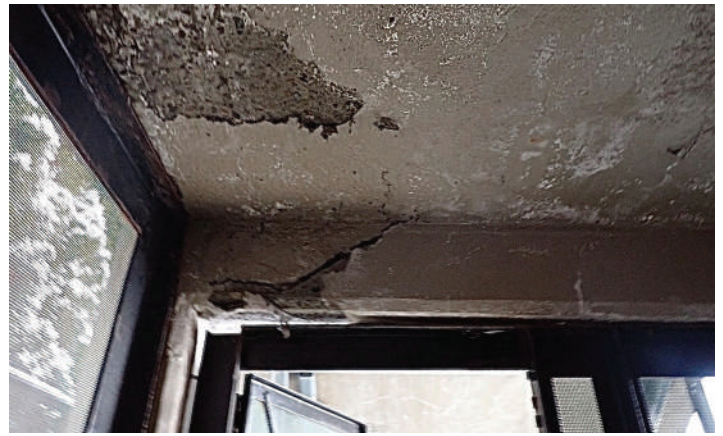
Fig. 4: Esta amplia grieta diagonal cerca de un soporte indica la necesidad de apuntalamiento e investigación adicional.

limitada. Un ejemplo de elemento con redundancia limitada es una viga en voladizo. Las grietas de corte, independientemente de la redundancia, requieren una investigación adicional debido a la naturaleza potencial de la falla (Fig. 4);

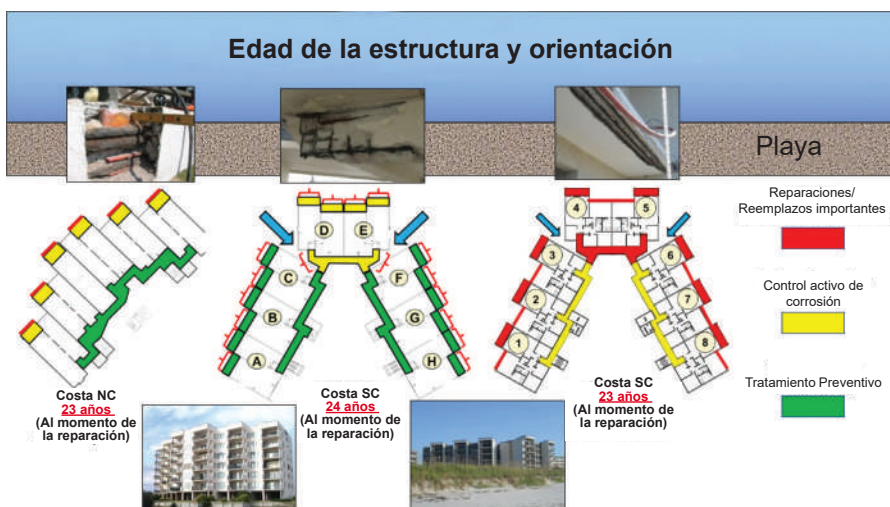
Fig. 6: Reparaciones/reemplazos importantes necesarias y control activo de la corrosión para estructuras en ambientes costeros después de aproximadamente 20 a 25 años de servicio.

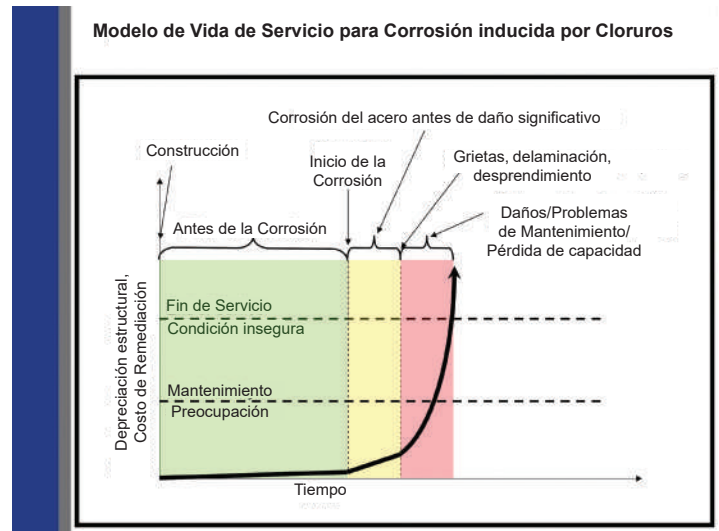
Fig. 7: Representación gráfica del deterioro de una estructura a lo largo del tiempo.

Muchos condominios y rascacielos costeros se construyeron en las décadas de 1970, 1980 y 1990, por lo que muchas de estas estructuras tienen 30, 40 y 50 años en la actualidad. Sin una evaluación y un mantenimiento adecuados, las cuestiones de seguridad asociadas a estas estructuras aumentarán a medida que se produzcan grietas, delaminación y desprendimientos. La figura 7 muestra una representación gráfica del deterioro

de una estructura con el paso del tiempo. La evaluación, el mantenimiento y la reparación de estas estructuras en el momento oportuno son fundamentales para prolongar la vida útil y mantener unas condiciones seguras.
