High-Performance Concrete Comprising Silica Fume: Evaluation of the
Decommissioned Salt Lake City Airport Parking Structure

A thesis submitted to the faculty of
Brigham Young University
in partial fulfillment of the requirements for the degree of
Master of Science

Department of Civil and Construction Engineering
Brigham Young University

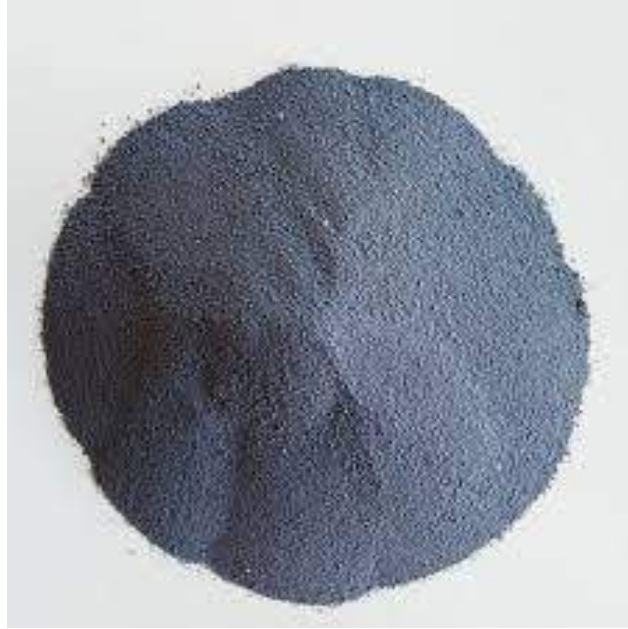
Figure 2-1: Silica fume powder (Henan Superior Abrasives 2024).

Silica fume is a co-product of silicon and ferrosilicon metals (Fidjestøl and Dåstøl 2008). As gaseous silicon oxide (SiO) is exiting the smelting furnace, it reacts with oxygen in the air to form solid silicon dioxide (SiO₂). The SiO₂ particles, which are more commonly referred to as silica fume, are less than 0.00004 in. in diameter, making it an extremely fine powder; the particles are approximately one hundredth of the size of an average cement particle (Silica Fume Association 2005). The significant size difference allows the silica fume to fill microstructural voids within the concrete matrix, which in turn reduces the permeability of the concrete. The small particle size of silica fume, however, also increases the likelihood of accidental inhalation because the particulate will linger in the air longer than larger particles, such as cement (Klemetti 2012). Silica fume powder is shown in Figure 2-1.

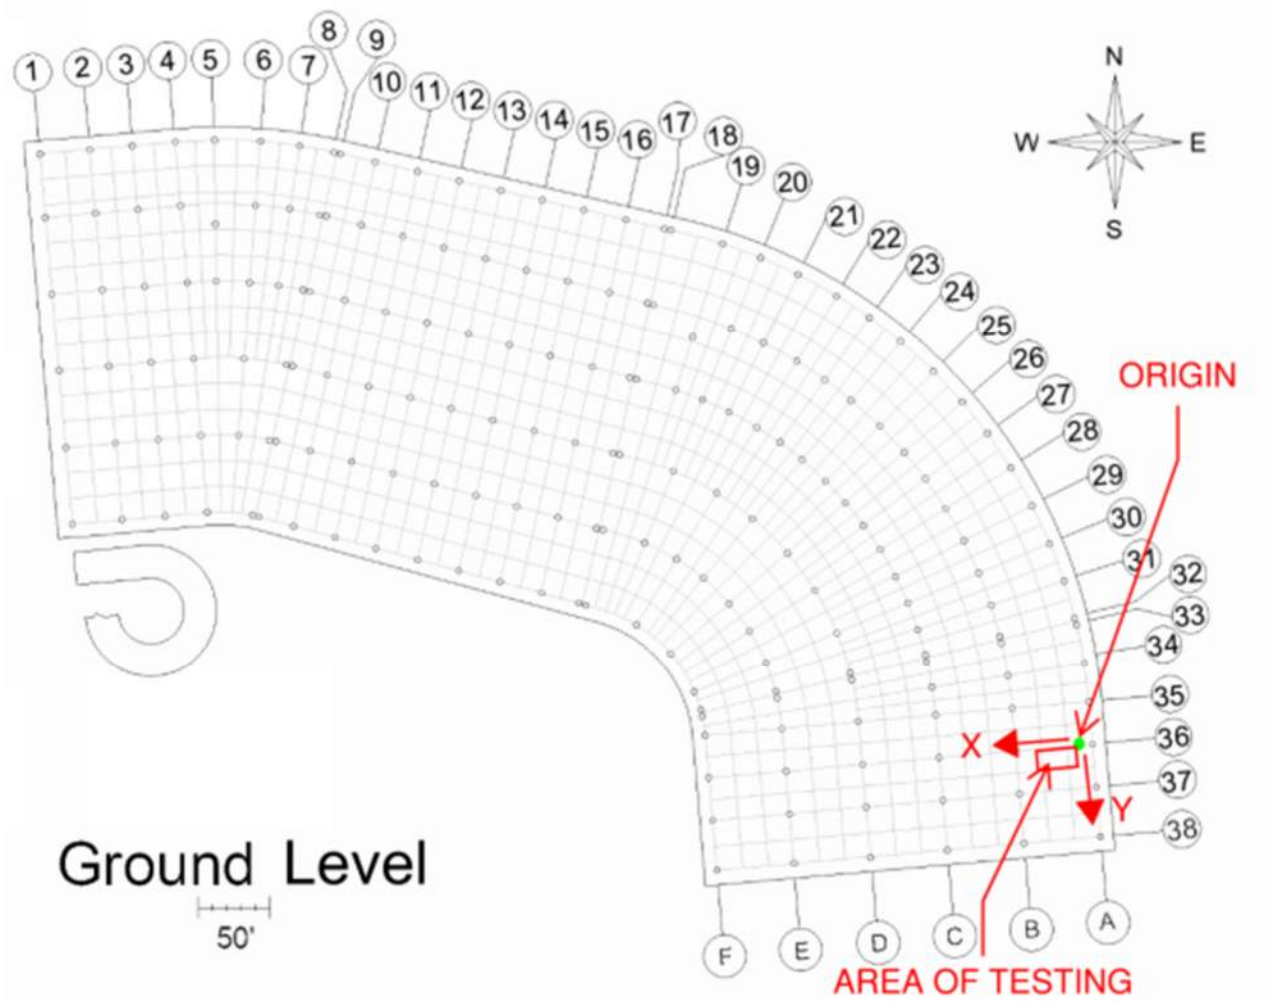
Figure 3-3: Schematic of ground-level area.

Figure 3-2: Aerial view of ground-level area.

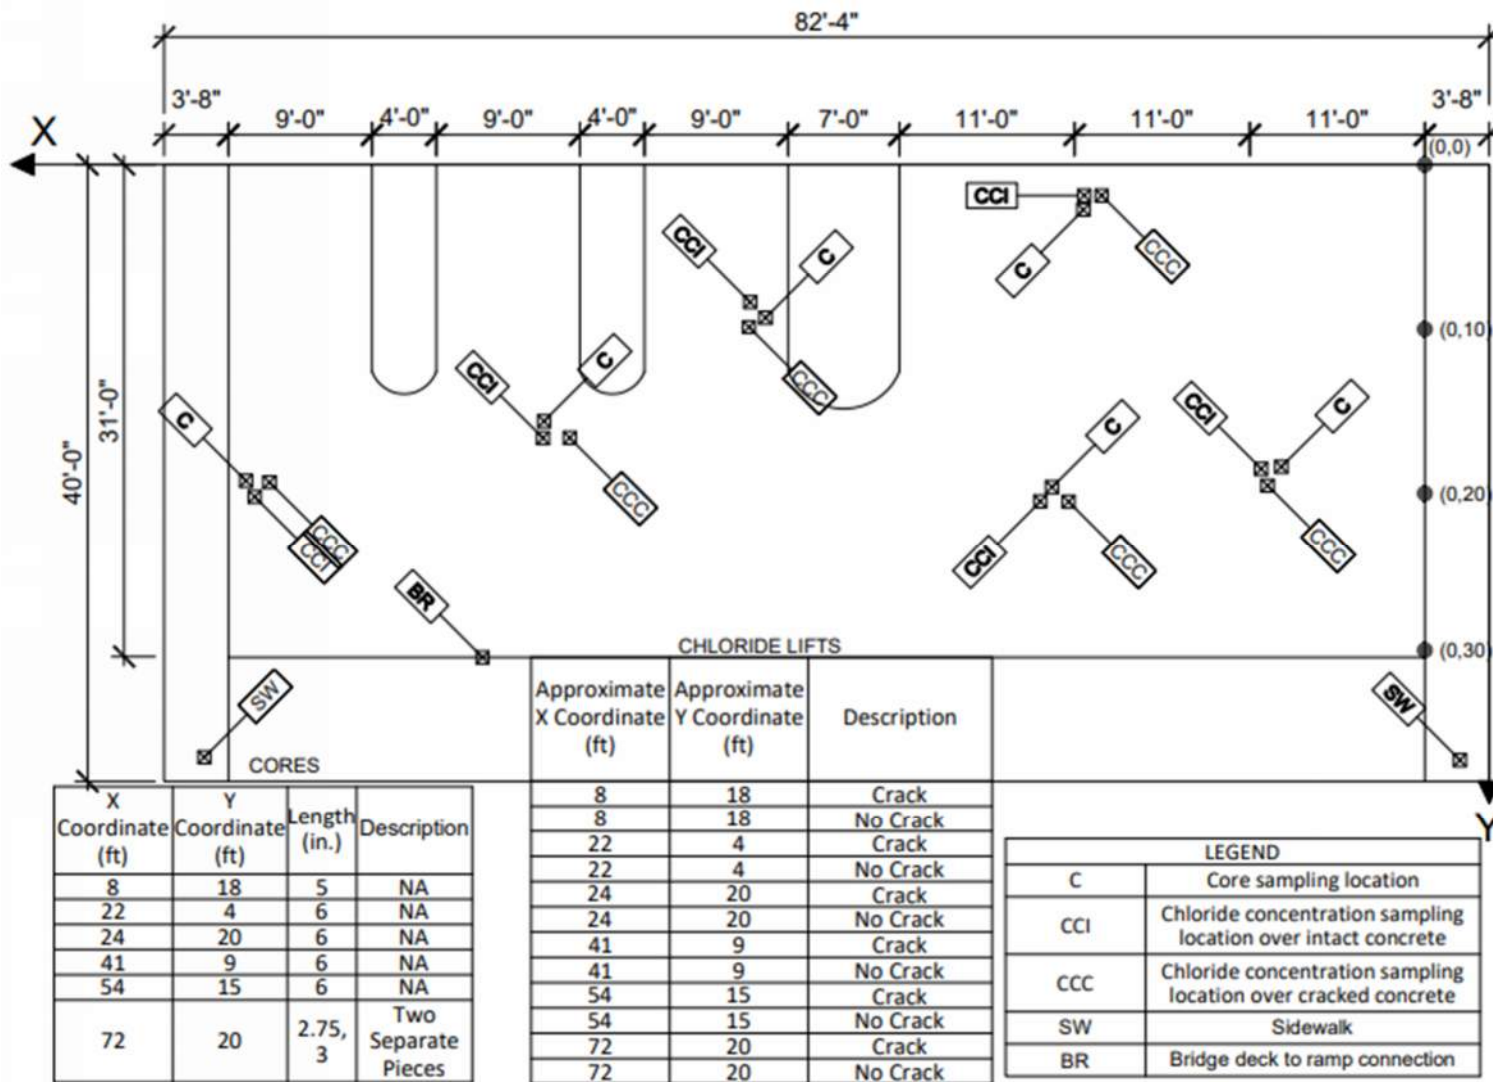
Figure 3-5: Schematic of entrance-ramp area.

Figure 3-4: Aerial view of entrance-ramp area.

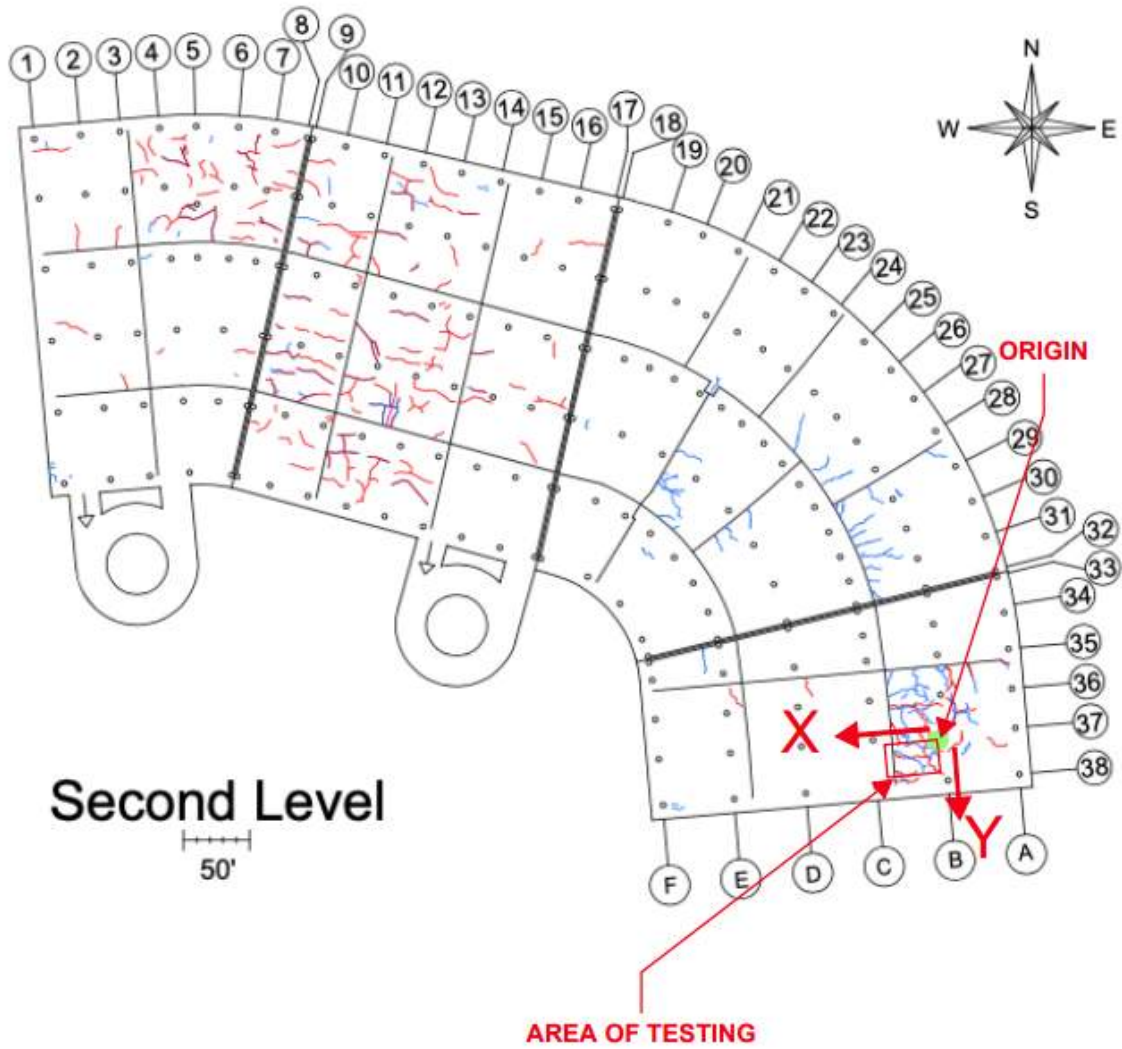
Figure 3-7: Schematic of second-level area.

Figure 3-6: Aerial view of second-level area.

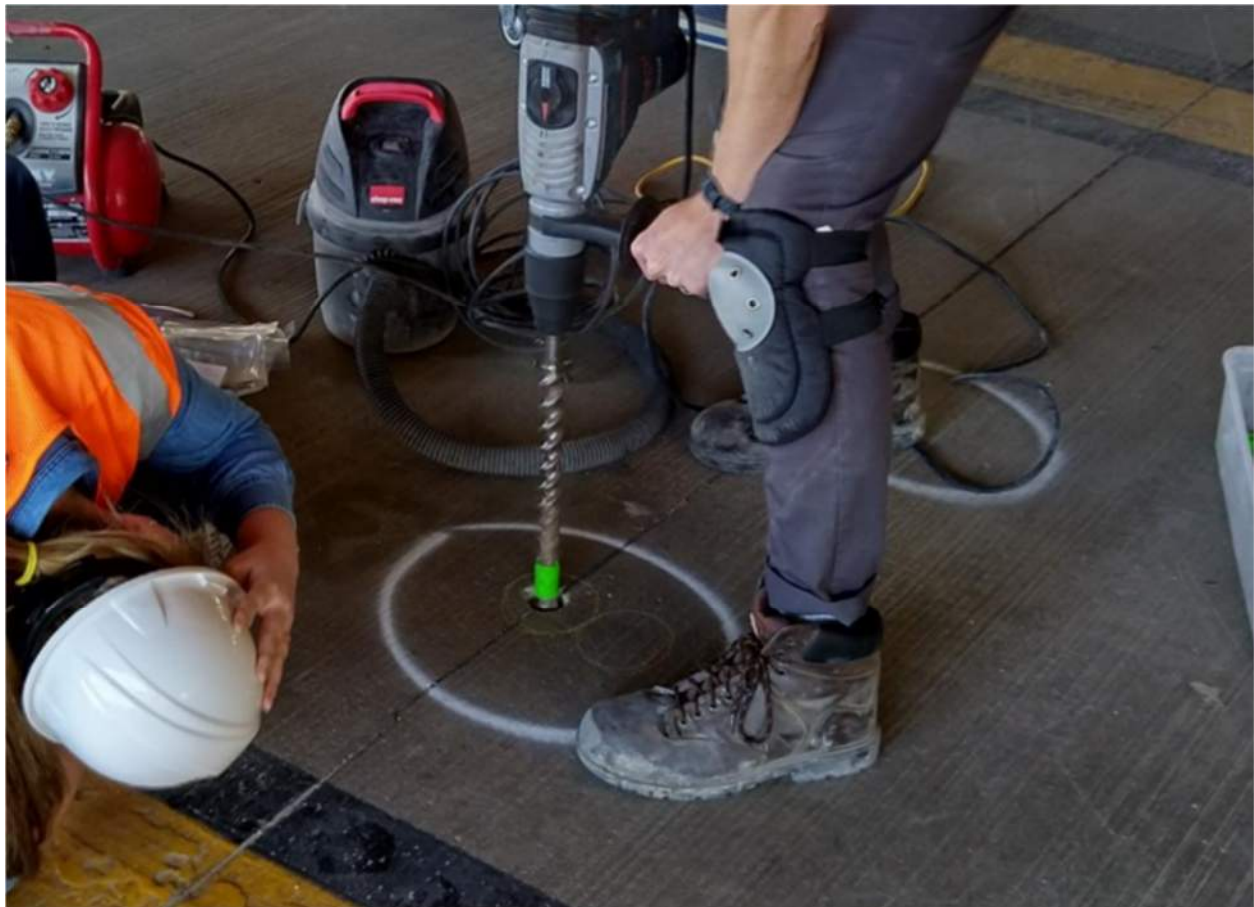
Chloride concentration sampling was performed within each test area to obtain concrete powder necessary for determining chloride concentration profiles within the concrete. As shown in Figure 3-14, a drill bit was consistently held perpendicular to the concrete, and six locations were sampled within each testing area except for the entrance ramp, where 12 locations were sampled.

Figure 3-14: Chloride concentration sampling.

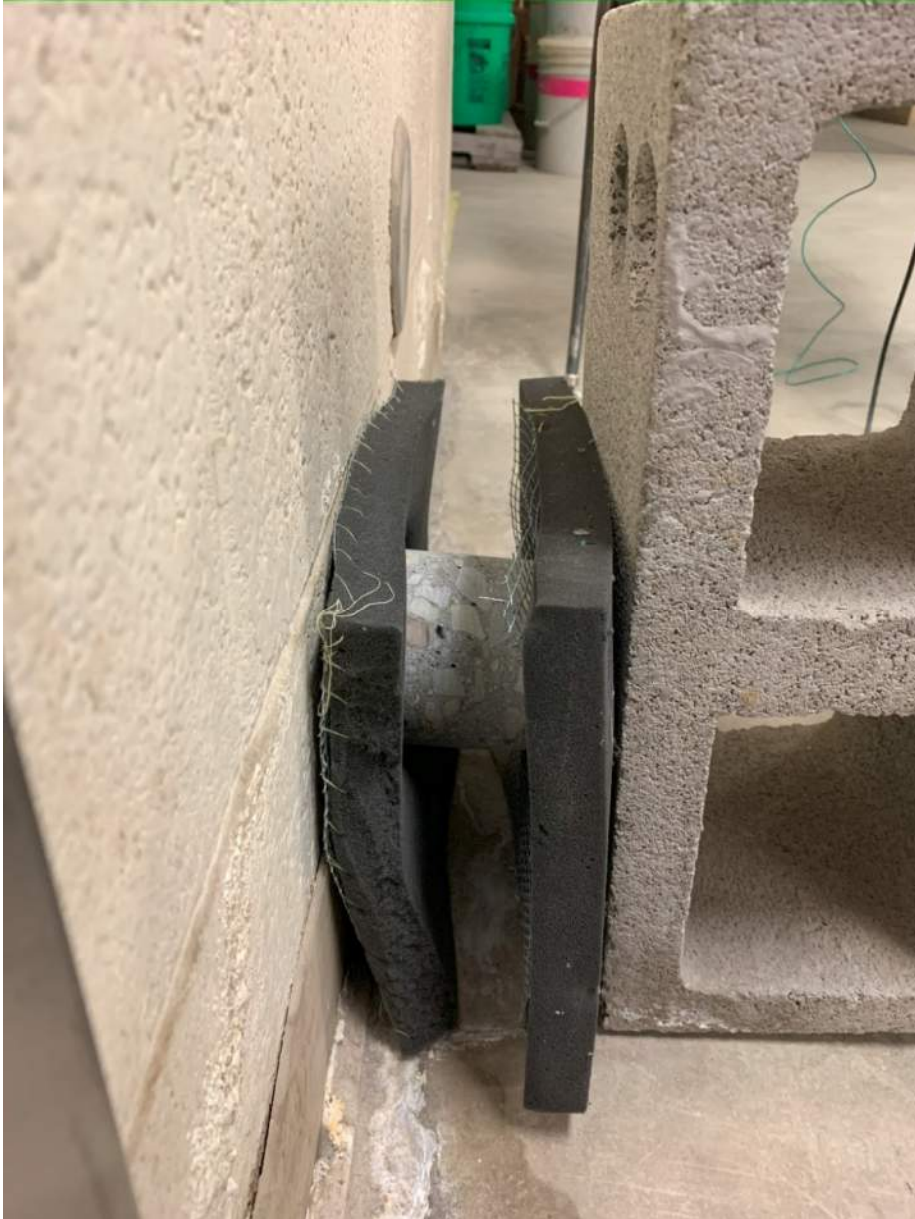
Figure 3-18: Electrical impedance testing.

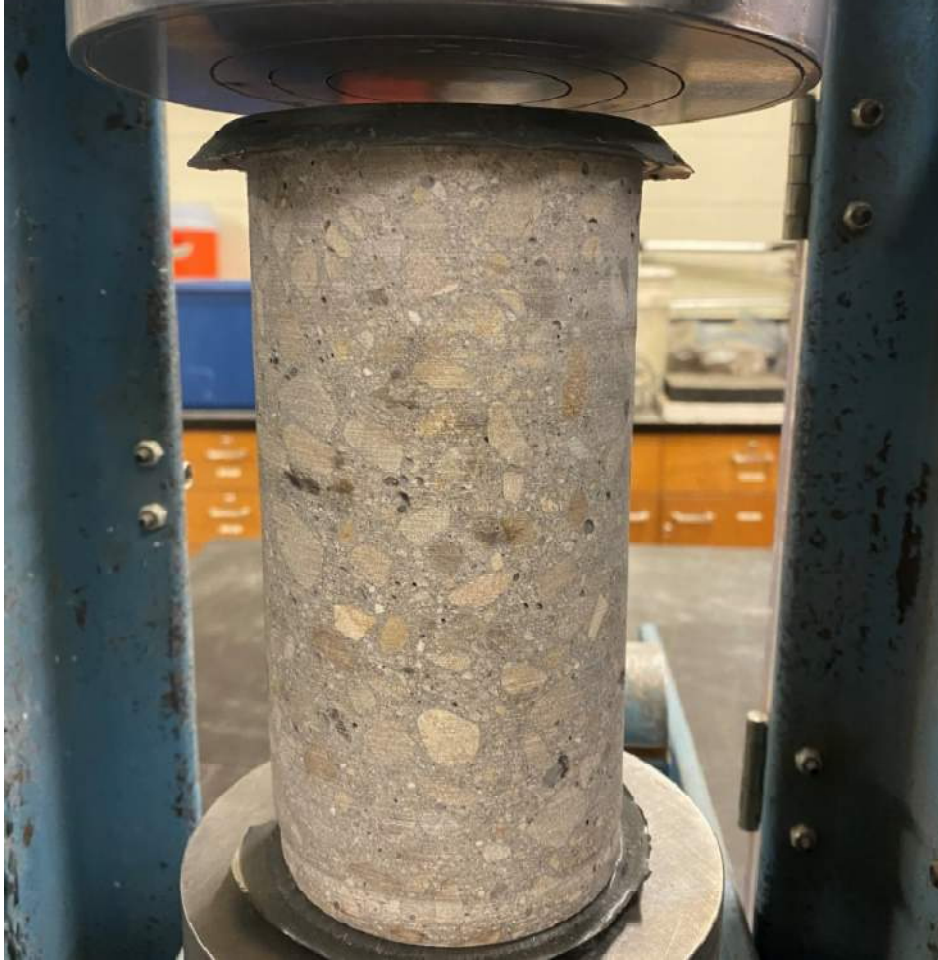
Figure 3-21: Compressive strength testing.

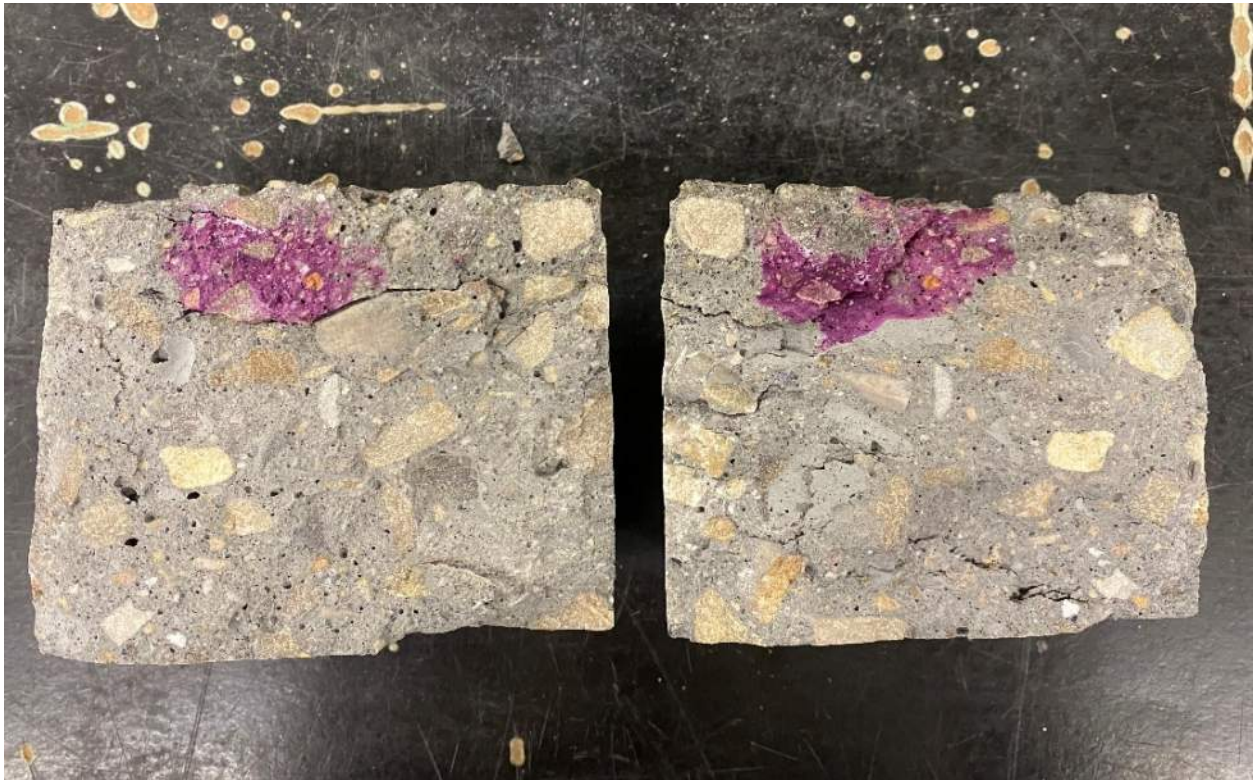
Carbonation depth testing was performed on each of the cores that were previously subjected to splitting tensile strength testing and compressive strength testing to estimate the depth of carbonation in the concrete. Immediately after failure in either the splitting tensile strength or compressive strength test, a solution of phenolphthalein indicator was sprayed onto a middle portion of both sides of a failure surface at the upper end of the core, corresponding to the top of the concrete deck, and the maximum depth of carbonation on each side was recorded. As shown in Figure 3-22, the concrete that did not experience carbonation turned pink, indicating a pH greater than about 9, while the concrete that did experience carbonation remained colorless, indicating a pH less than about 9. The maximum apparent depth of carbonation in inches was measured at these colorless sections.

Figure 3-22: Carbonation depth testing.

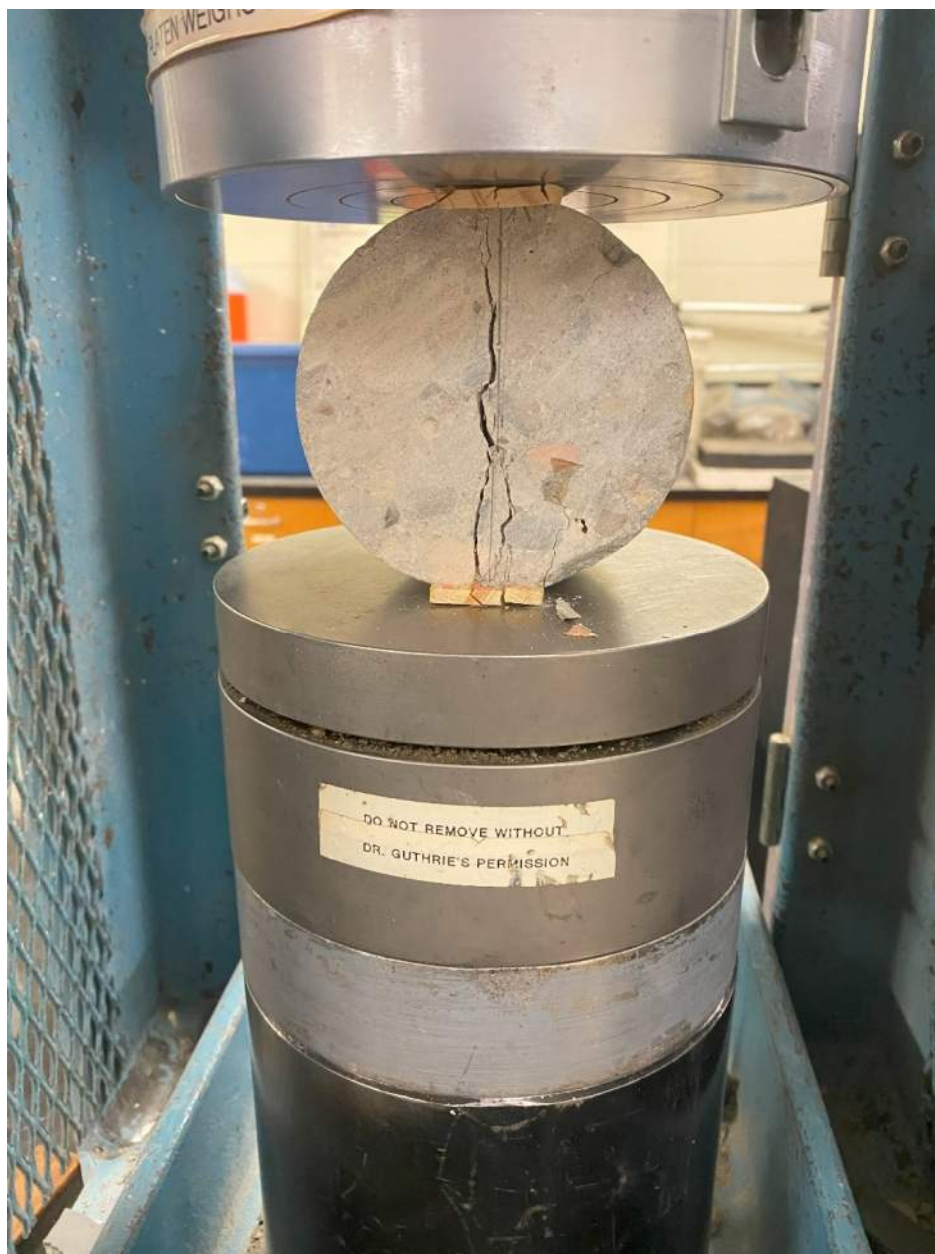
Splitting tensile strength data are provided in Table 4-21 for at least one concrete core sampled from each level and the helix. After reaching their peak loads, specimens broke suddenly in brittle failure, with the load immediately decreasing to zero. The average splitting tensile strength ranged from 732 psi to 1031 psi for the test areas, and the average splitting tensile strengths for concrete comprising silica fume and concrete without silica fume were 867 psi and 921 psi, respectively. Figure 4-1 shows a typical core after splitting tensile strength testing.

Figure 4-1: Typical core after splitting tensile strength testing.

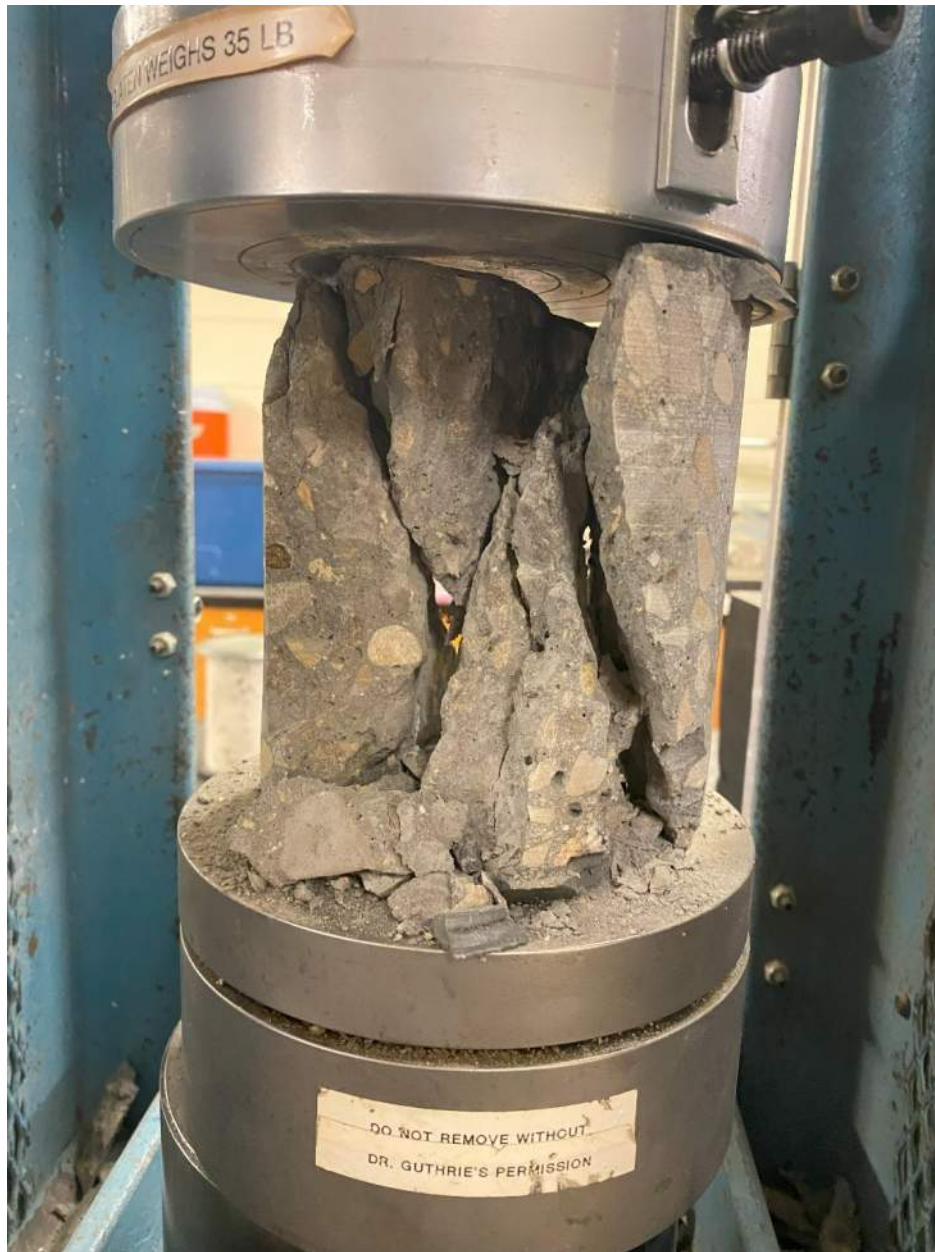
Compressive strength data are shown in Table 4-22 for at least one concrete core sampled from each level and the helix. As in splitting tensile strength testing, all specimens exhibited a brittle failure. The average compressive strength ranged from 6489 psi to 10611 psi for the test areas, and the average compressive strengths for concrete comprising silica fume and concrete without silica fume were 9049 psi and 6489 psi, respectively. Figure 4-2 shows a typical core after compressive strength testing.

Figure 4-2: Typical core after compressive strength testing.
