A Peak Construction Challenge on America's Mountain

The highest total precast building in the world tops the Colorado Rockies

by Deborah R. Huso

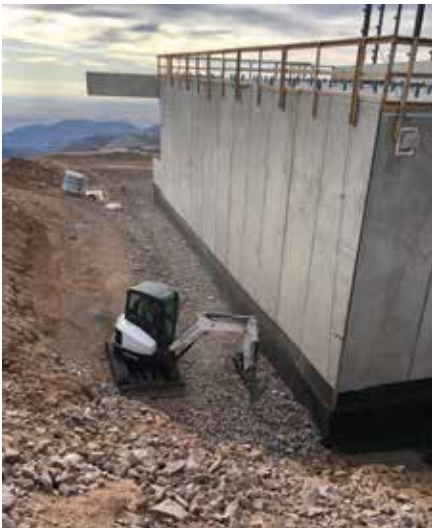
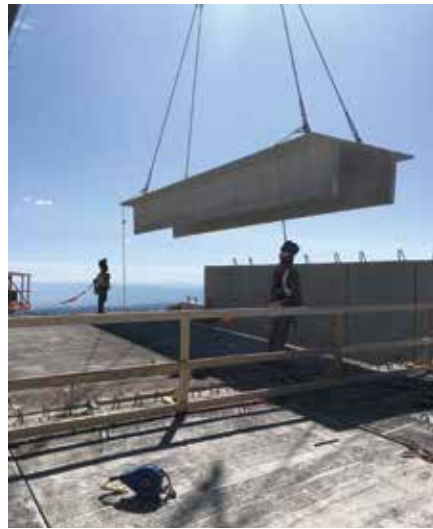
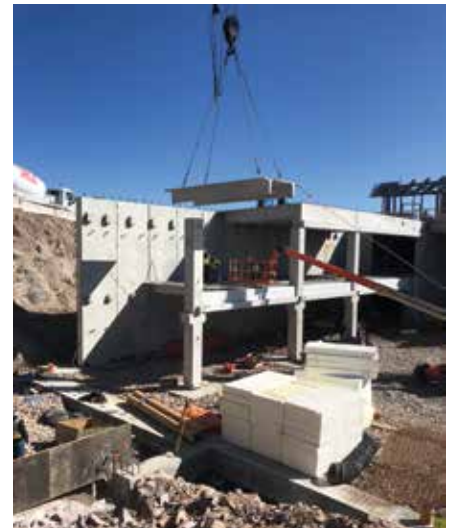
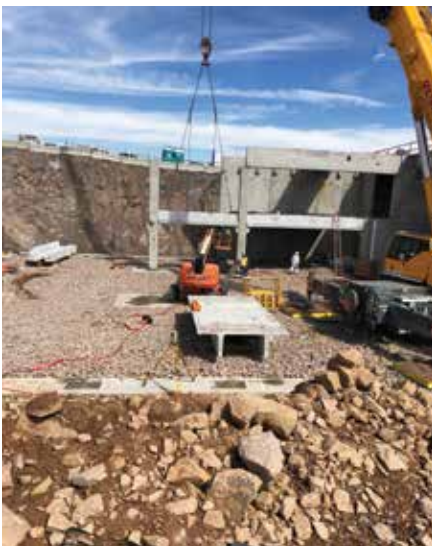
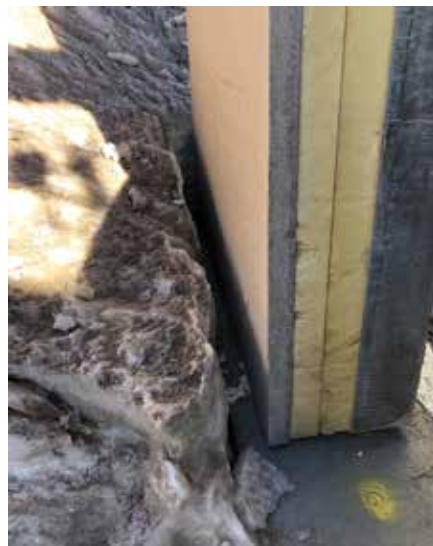
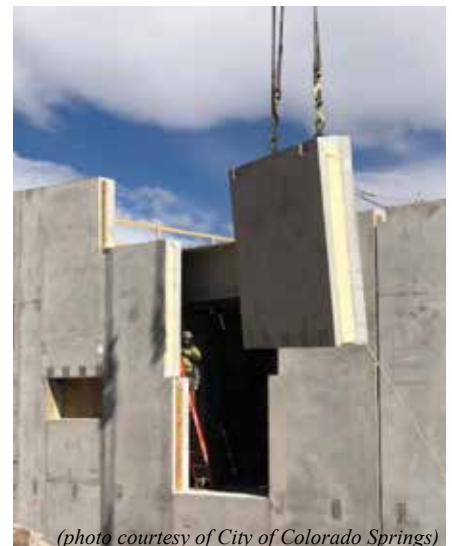
Pikes Peak Summit Visitor Center under construction *(photos courtesy of Stresscon)*
