The Urgent Need for Increased Robustness of Buildings in Highly Seismic Regions

by Santiago Pujol, Rémy D. Lequesne, and Chungwook Sim

ACI Committee 133, Disaster Reconnaissance, was established to report on the effects of major disasters on concrete construction worldwide and to identify potential design issues requiring code changes. The committee's work has been described by Laughery et al.¹ Previous reconnaissance completed or supported by the committee includes Shah et al.,² Abrahameczyk et al.,³ Sim et al.,⁴ Villalobos et al.,⁵ Alcocer et al.,⁶ and Pujol et al.⁷ The latest reconnaissance effort was completed after the Pazarcik and Elbistan Turkey Earthquake Sequence of 2023.⁸ The implications of the latest field observations, as informed by previous data, are discussed in relation to the future of reinforced concrete (RC) practice. A historical background is provided first to support the discussion that follows.

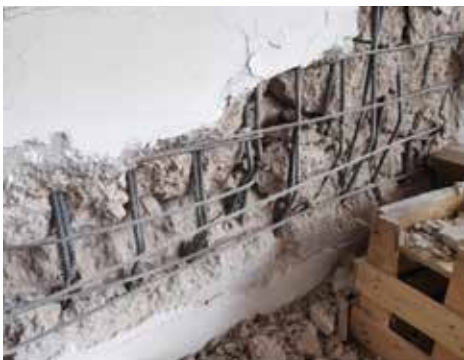
Fig. 3: Failure of wall with light lap-spliced vertical reinforcement and no boundary-element confinement, Turkey, 2023

- Ordinary walls (walls not classified as “special walls”), which can be used in regions believed to have moderate seismicity and may undergo longitudinal bar yielding, are not required to have confined wall edges (boundary elements). These walls can also have small reinforcement ratios ($\leq 0.25\%$) and lap splices near critical sections. Figure 3 shows damage to a wall with ordinary detailing. Ordinary walls should either be prohibited in regions with moderate seismicity or required to have reinforcement details capable of limiting damage;

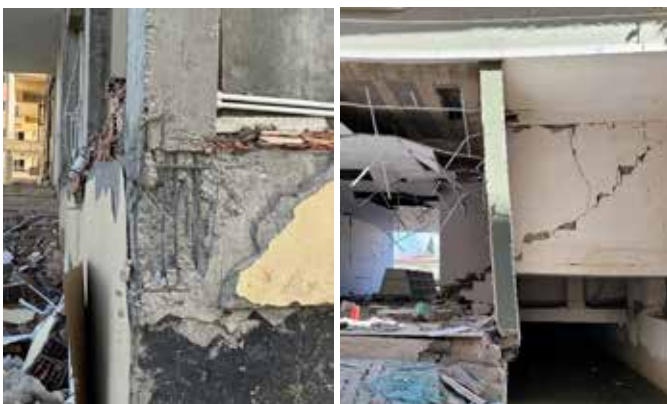
Fig. 4: Failure of column (left) and structural wall (right) without adequate confinement within the foundation near an edge, Turkey, 2023

- Longitudinal reinforcement in columns and wall boundary elements must be confined within the foundation when located near an edge of the foundation if the bars are expected to yield. If not confined, bars can buckle (Fig. 4), causing spalling and undermining support for the column or wall. ACI CODE-318-19(22)²⁶ requires such confinement in structures assigned to seismic design categories (SDC) D, E, and F, but the requirement should be extended to SDC C because bar yielding is expected;

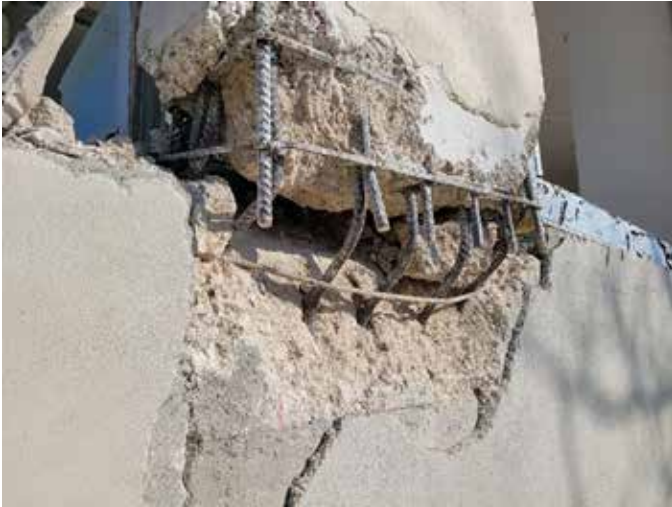
Fig. 5: Failure of a column without adequate confinement within the foundation near an edge and lap spliced bars immediately above the foundation, Turkey, 2023

- The risks of spalling and bar buckling are exacerbated when longitudinal bars are lap spliced immediately above the foundation (Fig. 5), because the stiffer splice region forces rotations to concentrate at the base of the column or wall. Lap splices are also likely to fail when subjected to cyclic inelastic strain demands. Lap splices should not be permitted at the base of intermediate moment-frame columns; and

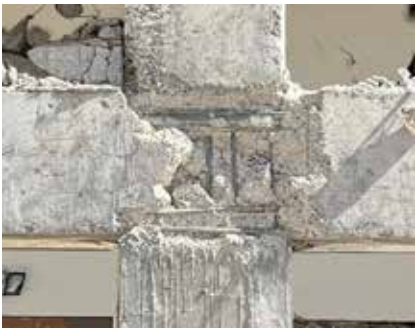
Fig. 6: Beam-column joint with unconfined beam reinforcement, Turkey, 2023

- Beam longitudinal bars that pass outside the column reinforcement need to be confined to limit spalling damage (Fig. 6) and stiffness loss. ACI CODE-318-19(22) requires this confinement in special moment frame joints, but this requirement should apply to other joints subjected to bar yielding in earthquakes, including “nonparticipating” frames in SDC D, E, and F, and in intermediate moment frames.

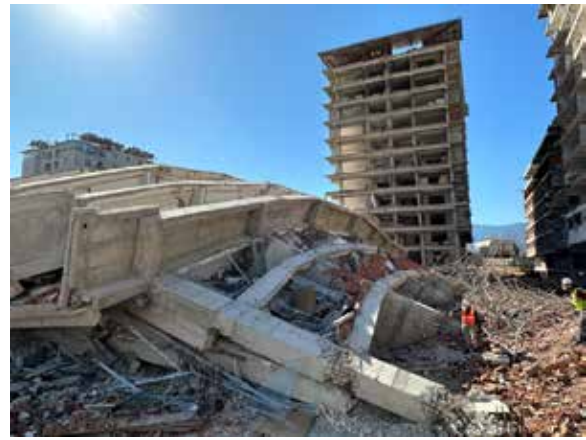
In Antakya, after the 2023 Pazarcik and Elbistan earthquake in Turkey, flexible buildings were observed to have excessive residual drifts. The buildings in Fig. 7 were built by one contractor using the same set of drawings. The reinforcement detailing observed in these buildings was better than what was observed in most other buildings in the area. Despite the relatively good detailing, the building in the background that did not collapse had a residual ground-story drift ratio of approximately 6%, and the building in the foreground overturned, likely because of second-order (P-delta) effects.

Fig. 7: Building that overturned with “better” reinforcement details (foreground), and a building with 6% residual drift ratio (background), Turkey, 2023

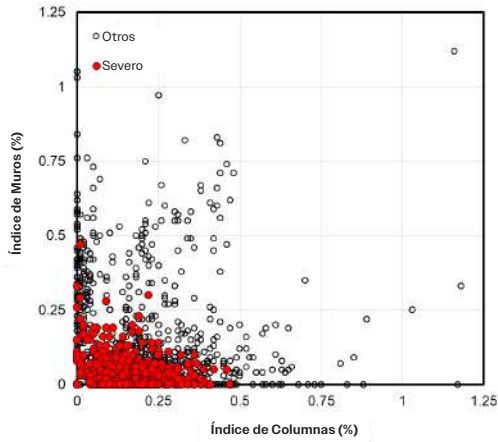
Fig. 1: Datos de Índice de muros (WI) e Índice de columnas (CI) de más de 1600 edificios medidos después de 15 sismos. Edificios calificados con daño “severo” presentaban daños como fallas por cortante en columnas o colapso

La gráfica muestra que los edificios con daños severos están concentrados en el cuadrante definido por $WI < 0.25\%$ e $IC < 0.25\%$. Otra forma de separar edificios con daños graves del resto es con una línea en $WI = 0.2\%$. Sólo nueve de los edificios con $WI > 0.2\%$ sufrieron daños graves, independientemente del CI, detallado del refuerzo o la intensidad del sismo. Separar los datos por sitio del terremoto no cambia las conclusiones, lo cual es notable dada la variedad de escenarios que se están considerando.

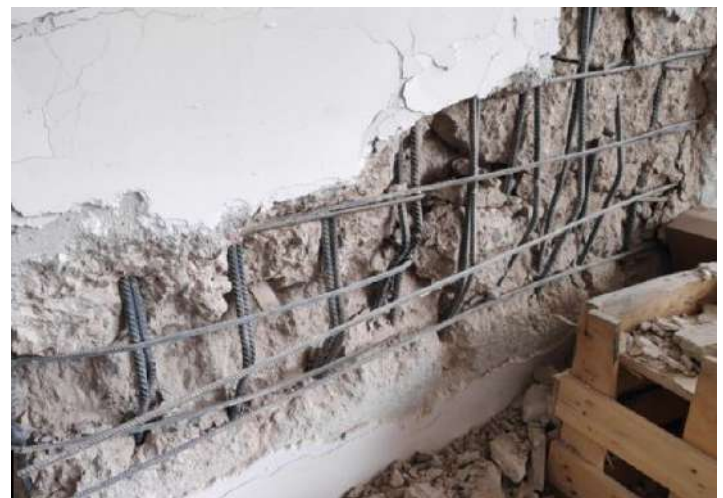
Fig. 3: Falla de un muro con empalmes por traslape del refuerzo vertical corto y sin confinamiento del elemento de borde, Turquía, 2023

- No se requiere que los muros ordinarios (muros no clasificados como “muros especiales”), que se pueden utilizar en regiones que se cree que tienen moderada sismicidad y pueden sufrir fluencia de barras longitudinales, tengan bordes confinados (elementos de borde). Estos muros también pueden tener bajas cuantías de refuerzo ($\leq 0.25\%$) y empalmes por traslape cerca de secciones críticas. La Fig. 3 muestra daños de un muro con detallado común. Los muros ordinarios deberían prohibirse en regiones con sismicidad moderada o deberían tener detalles de refuerzo capaces de limitar los daños;

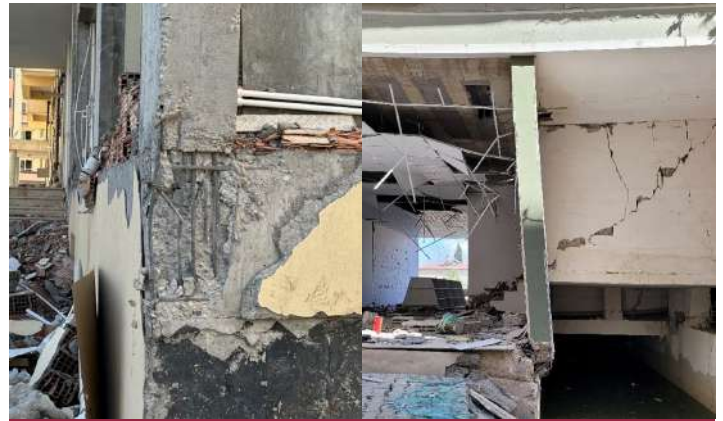
Fig. 4: Falla de una columna (izquierda) y de un muro estructural (derecha) sin confinamiento adecuado dentro de la cimentación cerca de un borde, Turquía, 2023

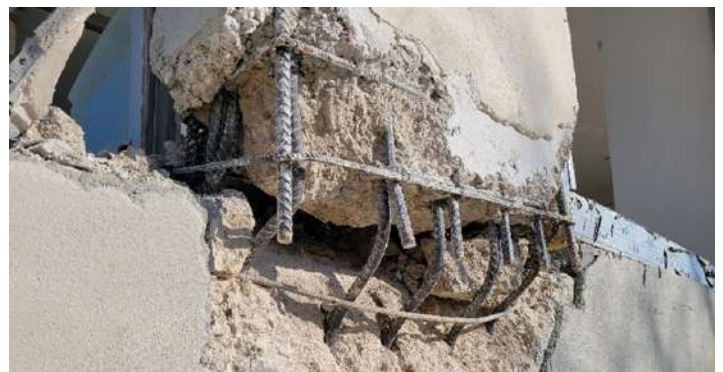
Fig. 5: Falla de una columna sin confinamiento adecuado dentro de la cimentación cerca de un borde y empalmes por traslape inmediatamente arriba de la cimentación, Turquía, 2023

- Los riesgos de descascaramiento y de pandeo de las barras se exageran cuando las barras longitudinales se empalman inmediatamente encima de la cimentación (Fig. 5), porque la región de empalme más rígida fuerza la concentración de rotación en la base de la columna o muro. También es probable que los empalmes por traslape fallen cuando se los somete a demandas de deformación inelásticas cíclicas. No se deben permitir empalmes por traslape en la base de columnas de pórticos intermedios resistentes a momento; y

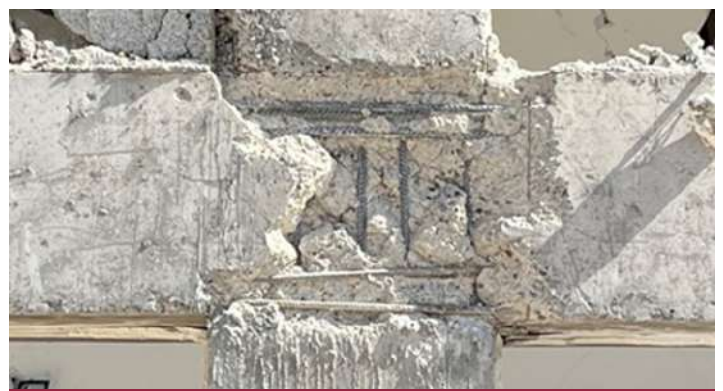
Fig. 6: Nudo viga-columna con el refuerzo de la viga no confinado, Turquía, 2023

- Las barras longitudinales de viga que pasan fuera de la columna deben confinarse para limitar el daño por descascaramiento (Fig. 6) y la pérdida de rigidez. El Código ACI-318-19(22)²⁶ requiere este confinamiento en nudos de pórticos especiales resistentes a momento, pero este requisito debería aplicarse a otros nudos sujetos a fluencia de las barras en caso de sismo incluyendo los pórticos “no participantes” en categorías (SDC) D, E y F, y en pórticos intermedios resistentes a momento.

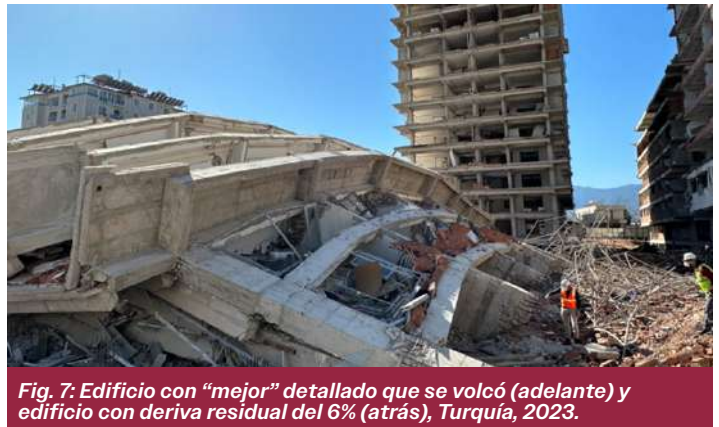
En Antakya, tras el terremoto de Pazarcik y Elbistan de 2023 en Turquía, se observó que los edificios flexibles tenían derivas residuales excesivas. Los edificios de la Fig. 7 fueron construidos por un contratista utilizando el mismo conjunto de planos. Los detalles de refuerzo observados en estos edificios eran mejores que los observados en la mayoría de los demás edificios de la zona. A pesar del relativamente buen detallado, el primer piso del edificio en el fondo, que no se derrumbó, tenía una deriva residual de aproximadamente 6%, mientras que el edificio en primer plano colapsó, probablemente debido a efectos de segundo orden (P-delta).

Fig. 7: Edificio con “mejor” detallado que se volcó (adelante) y edificio con deriva residual del 6% (atrás), Turquía, 2023.
