ASCE 41 versus TEASPA*:

Comparison of Seismic Evaluation Results of RC Frame Buildings Damaged during 2016 Meinong Earthquake, Taiwan

Jiun-Wei Lai, Insung Kim , Garrett Hagen, Kirk Johnston, Daniel
Zepeda, Shyh-Jiann Hwang

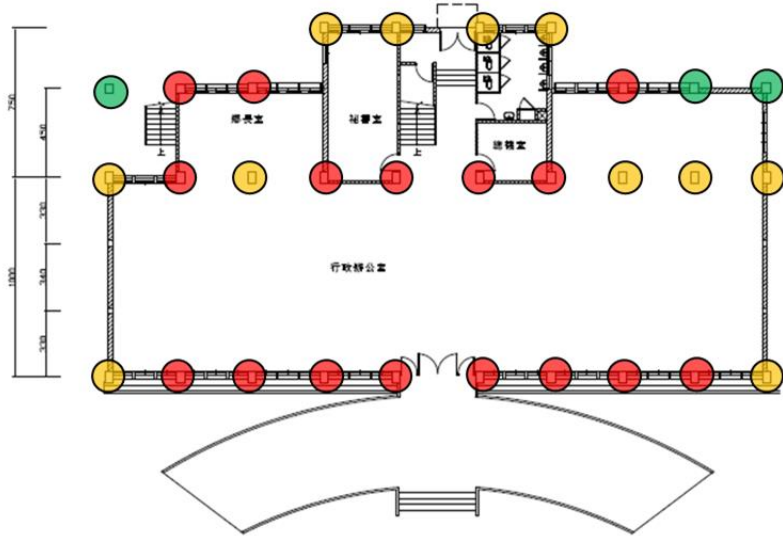
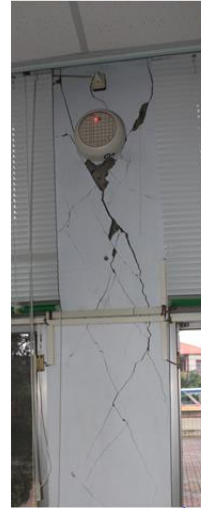
Column Evaluation Results vs Actual Damage Observed (Jho-Jhen District Office)

LDP, column shear DCRs (1st floor),
LS performance level

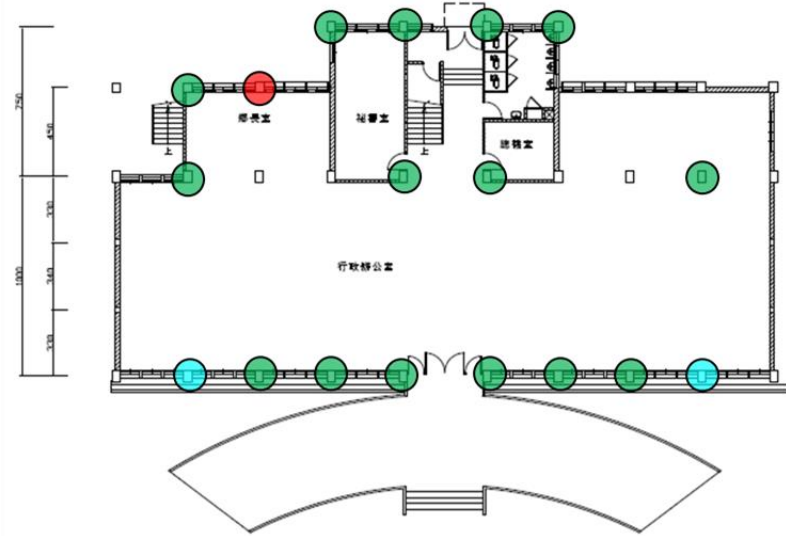
NSP, column hinge distribution (1st floor),
82% of target roof displacement

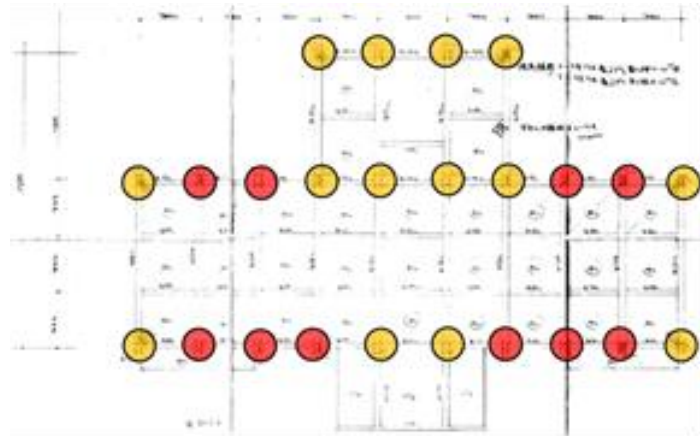
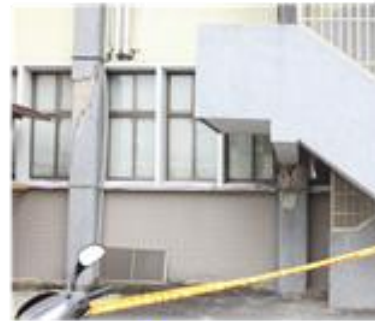
Column Evaluation Results vs Actual Damage Observed (Shan-Shang District Office)

LDP, column shear DCRs (1st floor),
LS performance level

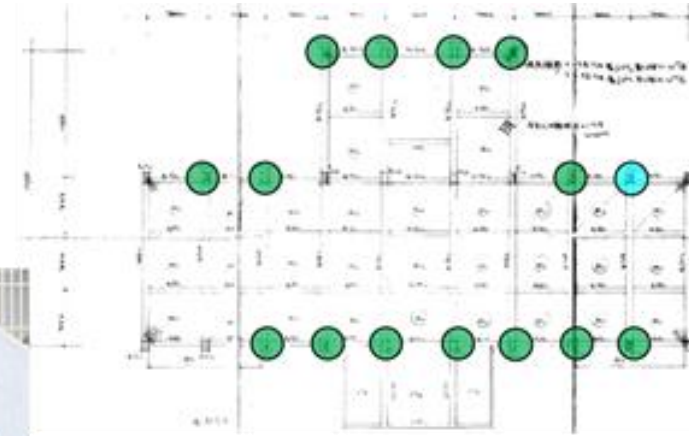
NSP, column hinge distribution (1st floor),
100% of target roof displacement

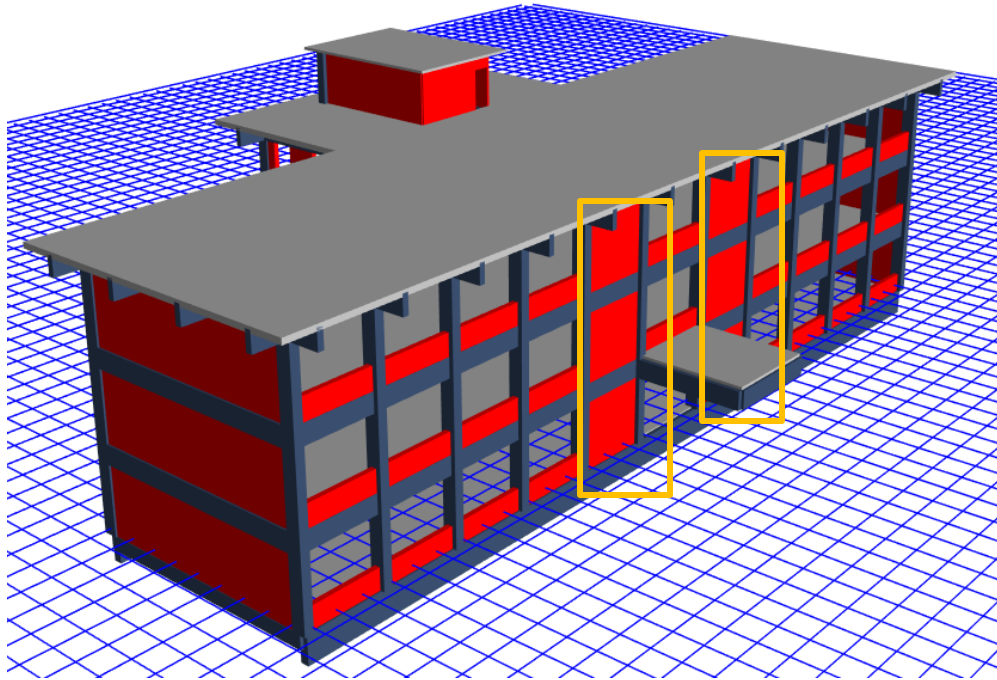
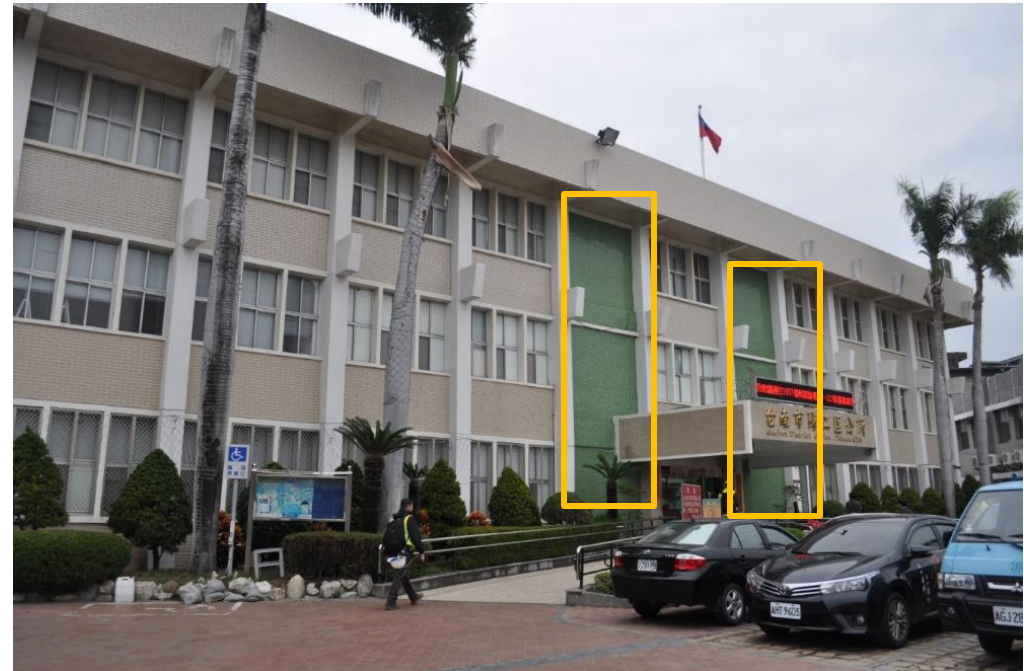
Guei-Ren District Office Building (Retrofitted)

ASCE 41-13 LDP

DCR = 0.67 (LS)

DCR = 0.74 (IO)

ASCE 41-13 NSP

DCR = 0.19 (LS)

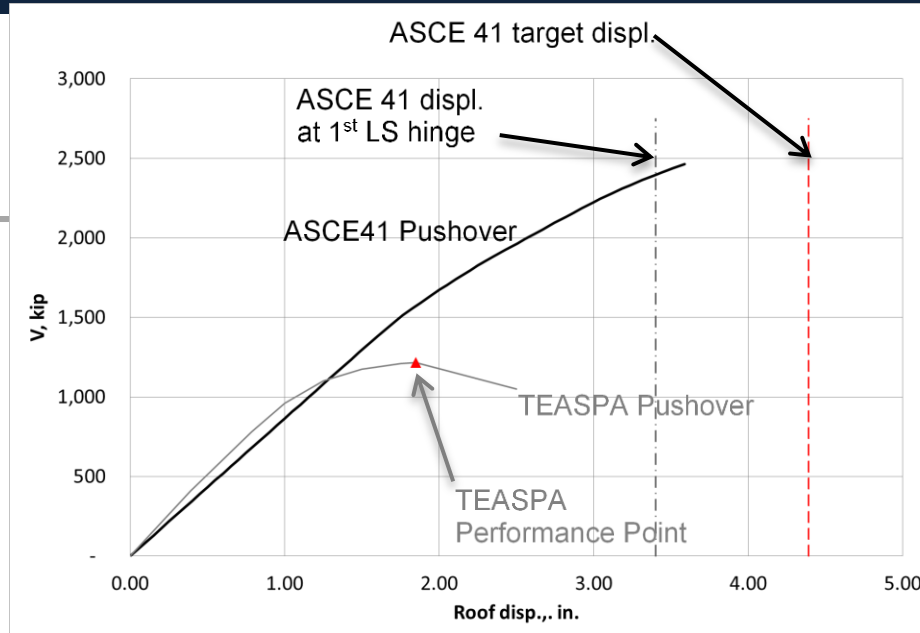
Jho-Jhen

District Office Building	TEASPA DCR	ASCE 41 Life Safety NSP DCR
Juo-Jhen	1.54	1.29
Shan-Shang	1.52	1.05
Guei-Ren (retrofitted)	0.40	0.19

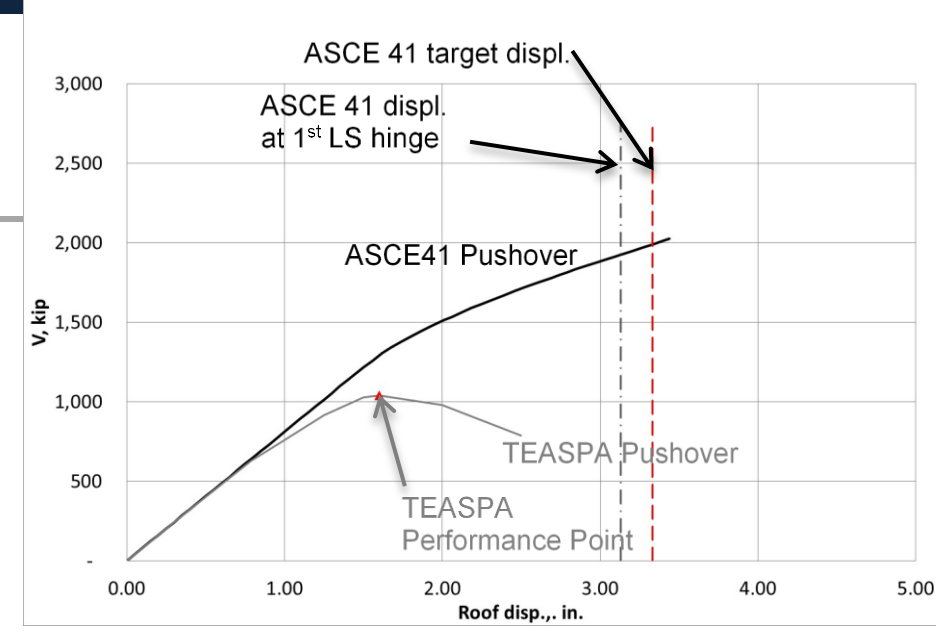
Shan-Shang District Office Building	X direction
Base Shear (tonf)	462
Roof Displacement (cm)	4.05
Seismic Capacity A_p (g)	0.26
Ground Motion Record A_{EQ} (g)	0.40
Capacity-Demand Ratio (CDR)	0.66 (DCR= 1.52)

Retrofit required
