Seismic Performance of Repaired Lightly Reinforced Concrete Walls

Christopher Motter, Aaron Clauson, James Petch,
Matias Hube, Richard Henry, Kenneth Elwood

October 17, 2018

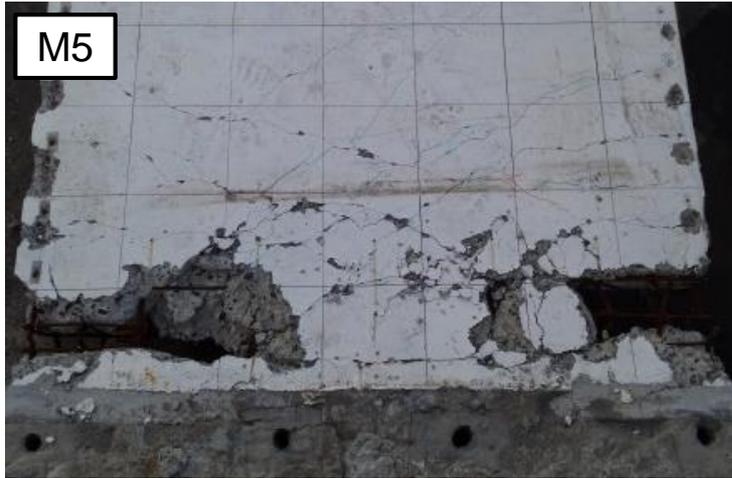
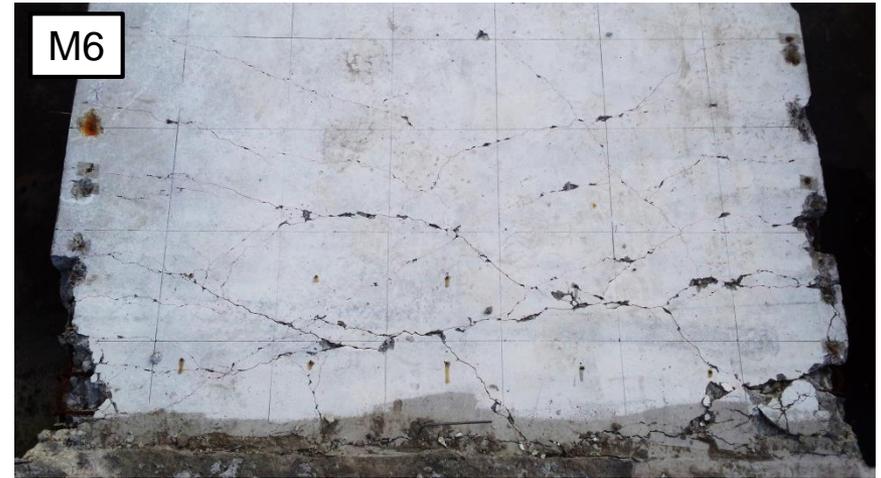
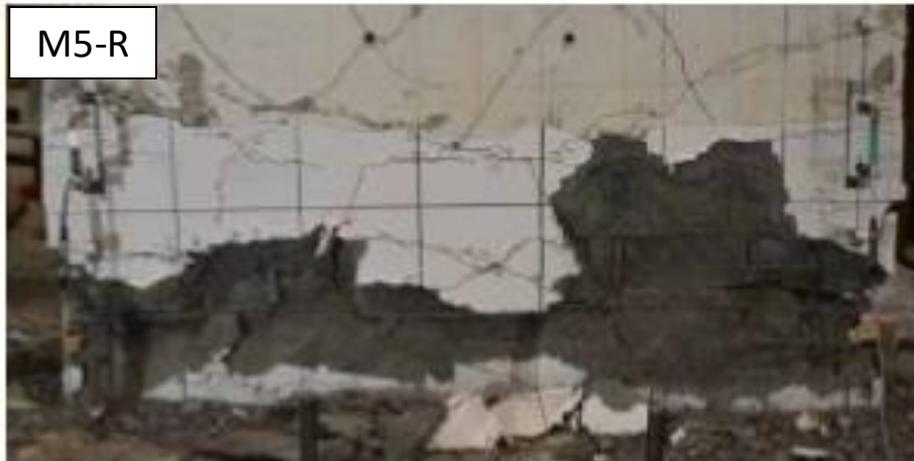
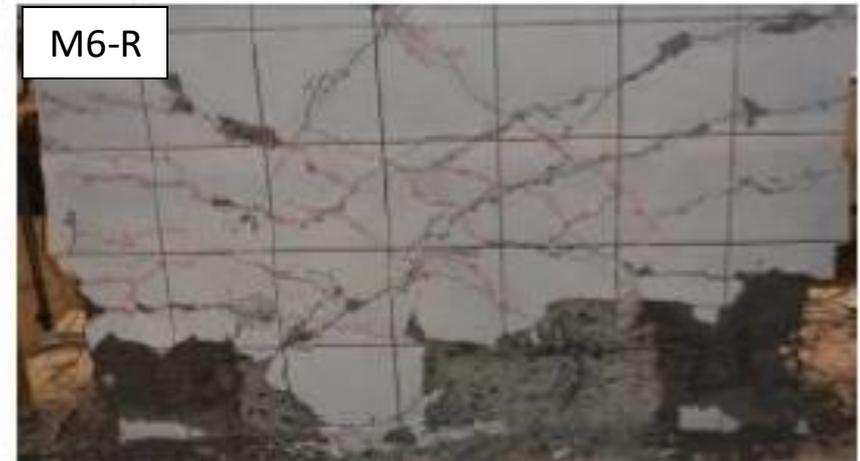
Damage at Completion of Test

Spec.	Dir.	Cracking	Spalling	Reinf. Buckling	Reinf. Fracture
M5	+	0.2% (1st) ¹	2.0% (1st)	2.0% (3rd)	2.0% (3rd)
	-	0.2% (1st) ²	1.5% (1st)	1.5% (3rd)	2.5% (2nd)
M5-R	+	100 kN (1st)	2.0% (1st)	2.0% (1st)	2.0% (3rd)
	-	100 kN (1st)	2.0% (1st)	2.0% (1st)	2.5% (1st)
M6-R	+	100 kN (1st)	2.0% (1st)	2.0% (1st)	2.5% (1st)
	-	75 kN (1st)	2.0% (1st)	2.0% (1st)	2.5% (1st)
