Quality Control of Silica Fume Bridge Decks

Quality Control of Silica Fume Concrete Bridge Decks

KOSCIUSZKO BRIDGE

Brooklyn – Queens Expressway, Brooklyn, NY

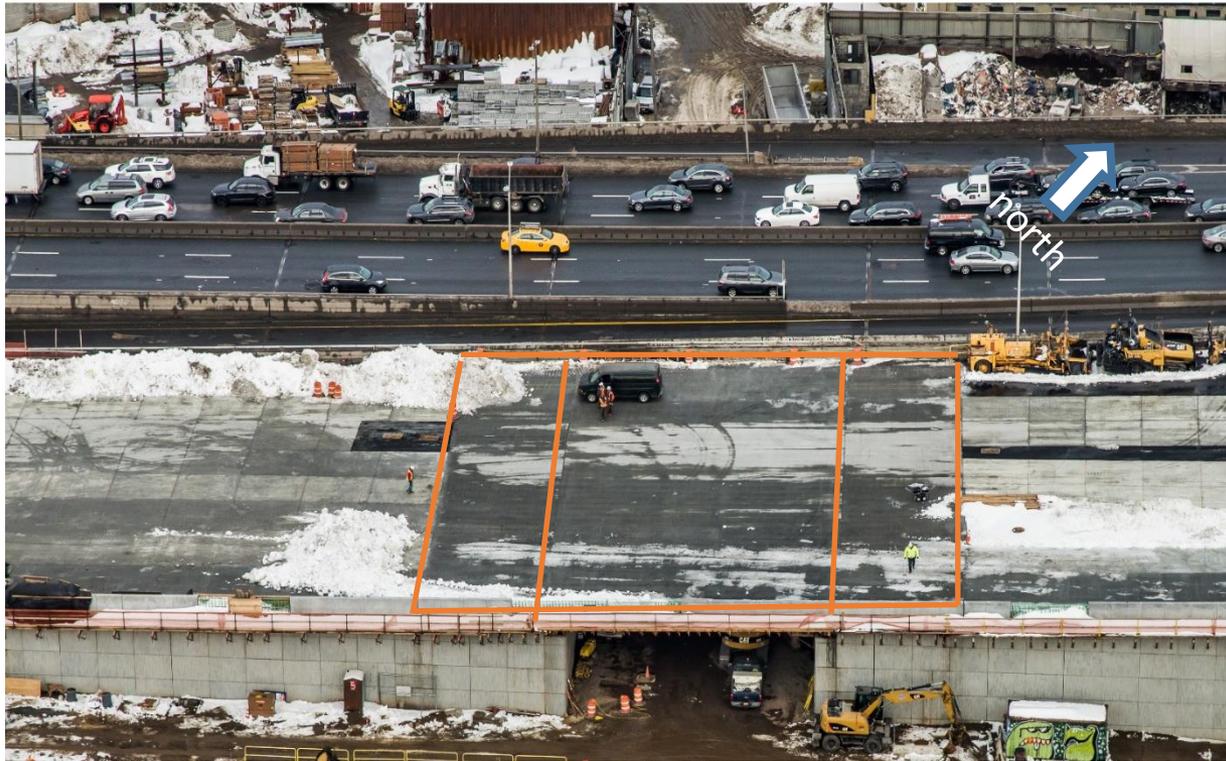
Connector - Varick Bridge Deck and App. Slabs

- Used one Bidwell to travel the 100' transversely
- Winter conditions
 - glycol hoses top
 - burners underside -
 - avg. cure temp 75F at 18 hour mark
- Scrimped on water - mix too stiff – surface overworked
- Late in applying burlap cure – followed with blankets

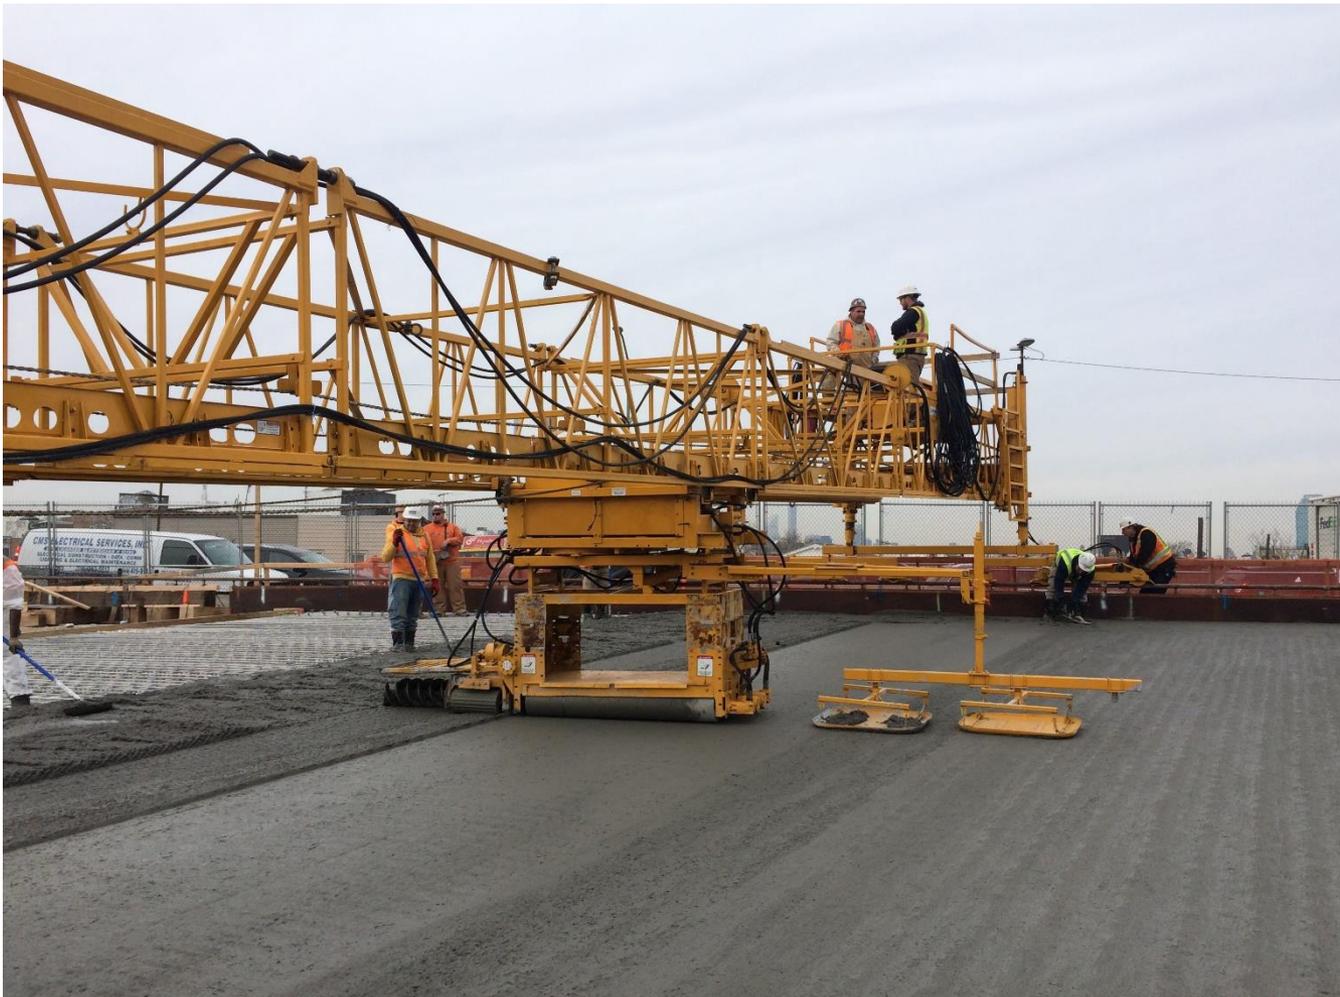
Vandervoort Deck Placement

- Used one Bidwell to travel the 45' transversely
- Slump was workable
- Late in applying wet burlap cure
- Winter conditions
 - Glycol hoses top
 - Burners under and thru stringer bays
 - Avg. cure temp 94F at 24 hour mark

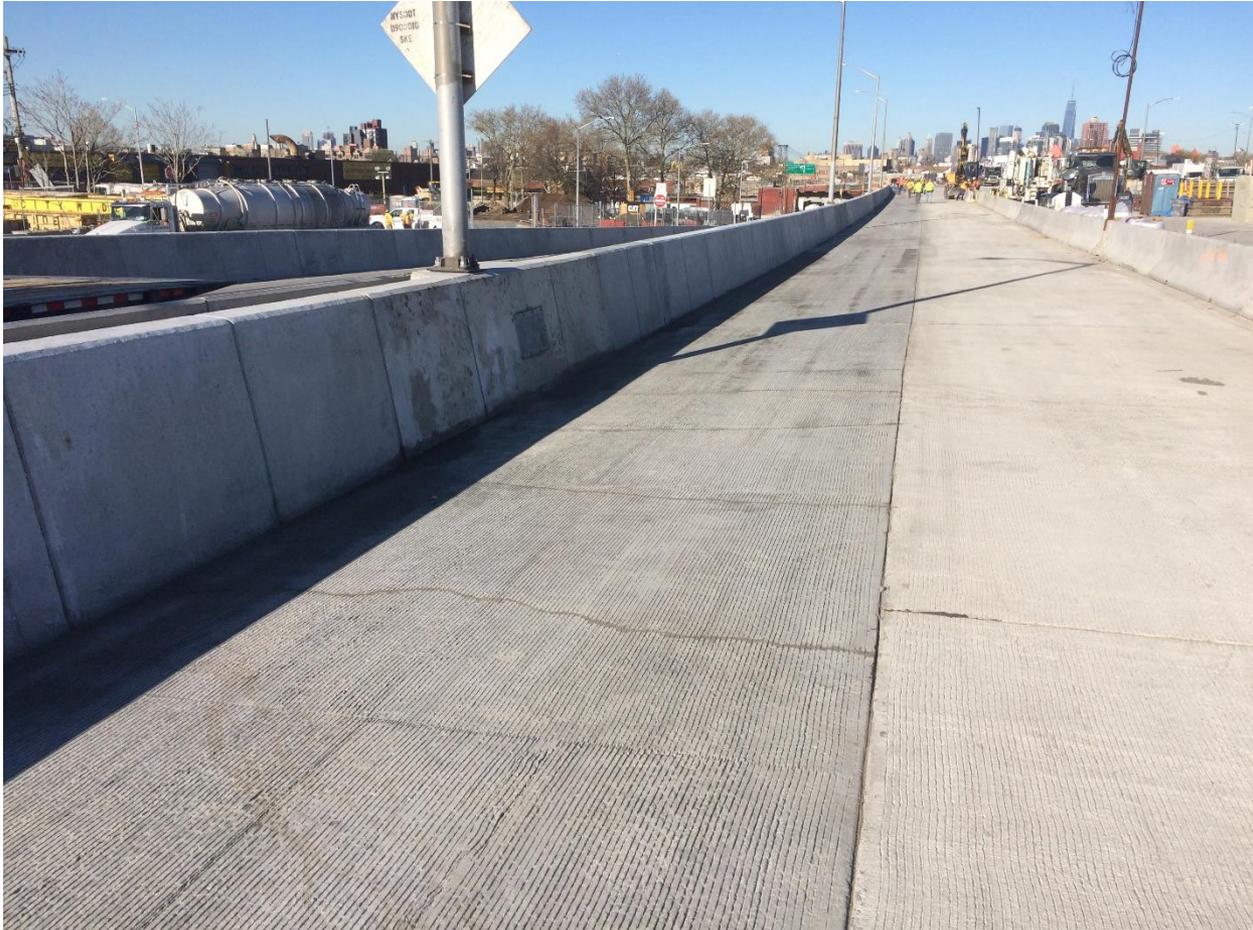
Moment Slab w/o Overhang

To evaluate cracks

- Seal all cracks over .007”
- Full dose of water
- Fogging and quickly placed curing covers
- Minimize placement temperatures
