Report No. UT-20.103

# SALT LAKE CITY AIRPORT PARKING GARAGE VISUAL INSPECTION REPORT

Utah Department of Transportation  
Research Division

Utah Valley University  
Department of Engineering

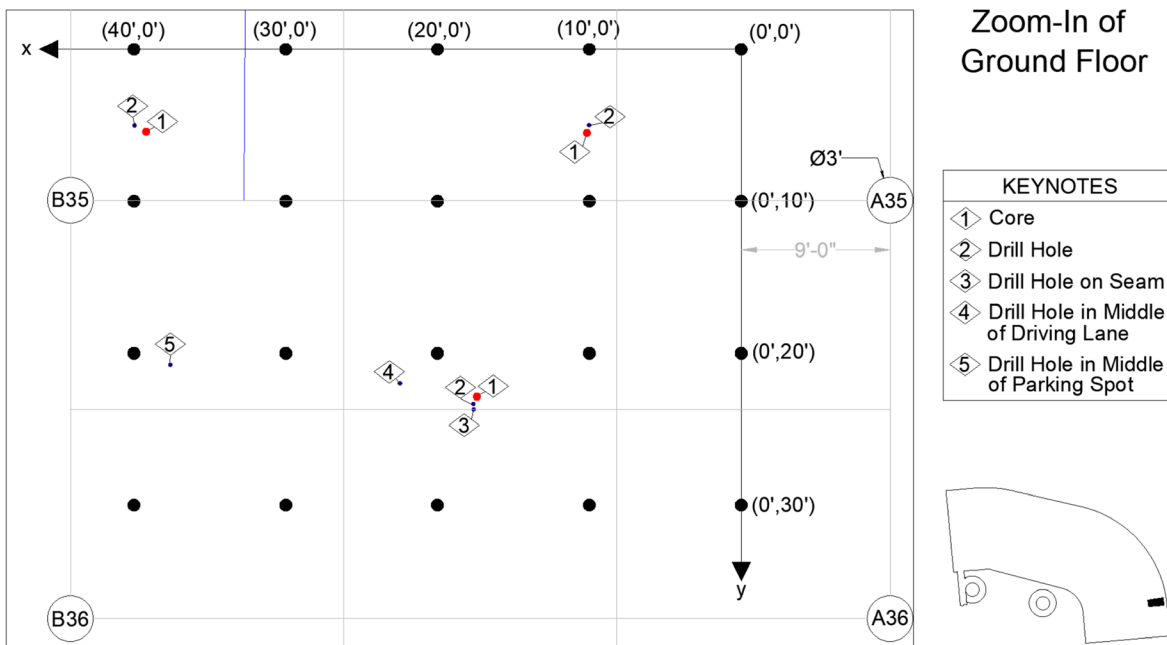
**Figure 2-2 Zoomed-in view of data sampling area taken on the plain unreinforced concrete on the ground floor. The black dots were for Schmidt hammer readings; red dots for core sample locations; blue dots for chloride drilled sample locations; grey lines were saw-cut joints; and top-down cracking (blue line).**

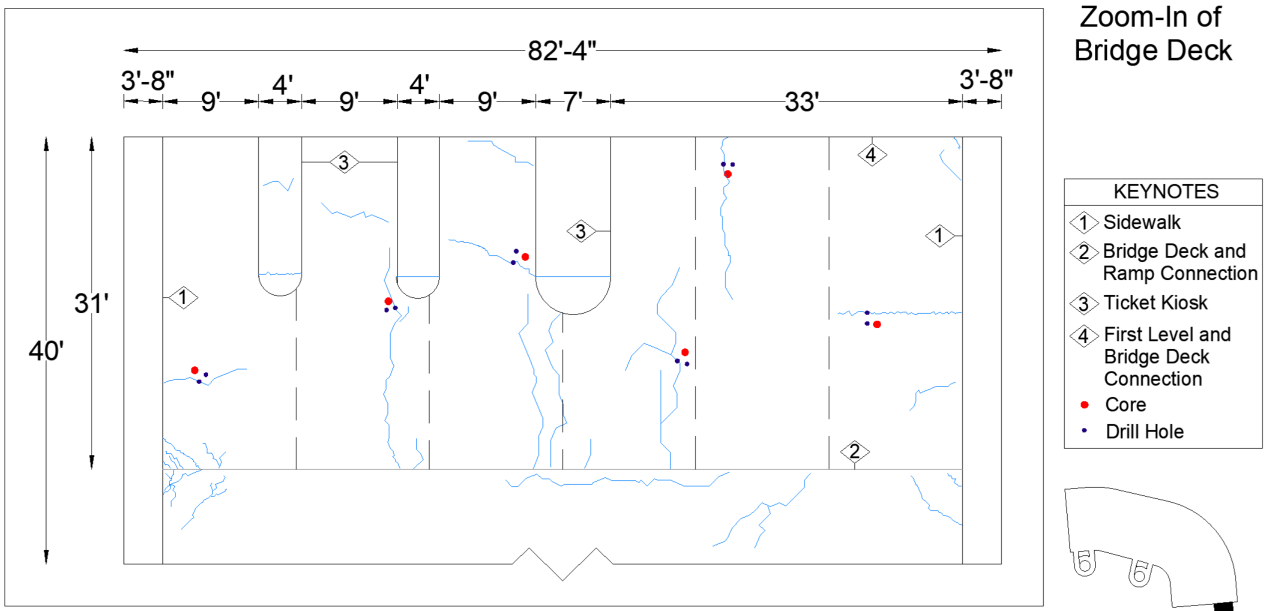
**Figure 3-11 First floor entrance bridge detailed analysis site showing black dashed lines for the lane grid setup, red dots for core sample locations, blue dots for chloride drilled sample locations, and to top-down cracking (blue lines).**

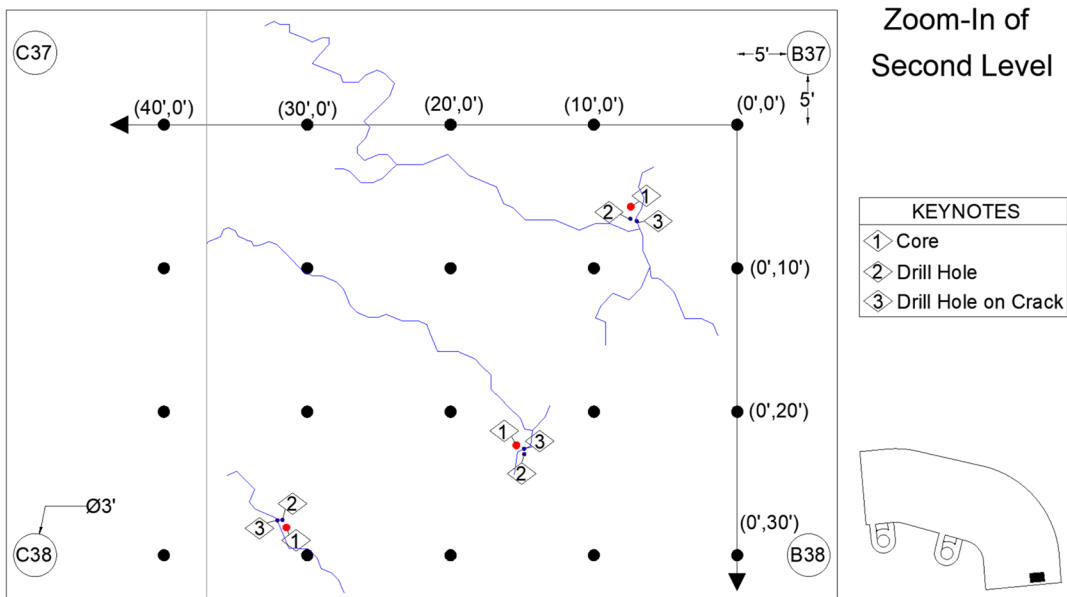
**Figure 3-12 Second floor detailed analysis site showing the black dots for Schmidt hammer, cover depth, and VEI readings; red dots for core sample locations; and blue dots for chloride drilled sample locations; and top-down cracking (blue lines).**

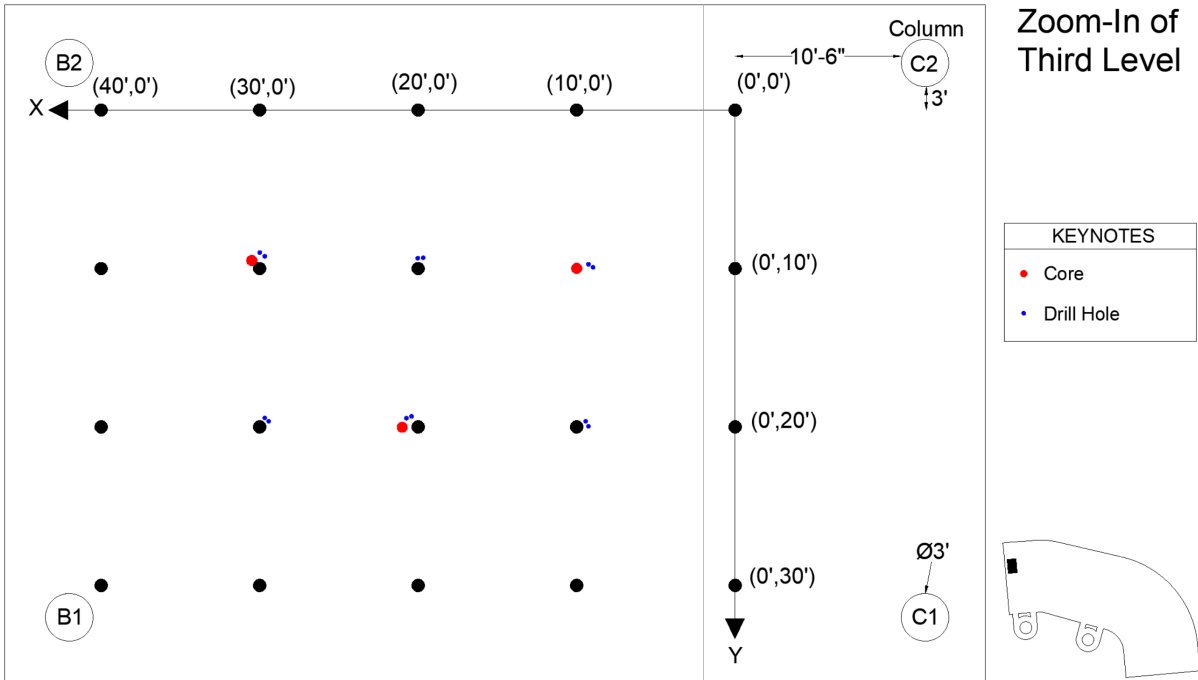
**Figure 3-13 Third (top, covered) floor detailed analysis site showing black dots for Schmidt and cover depth readings, red dots for core sample locations, and blue dots for chloride drilled sample locations. There were no cracks found in this site.**

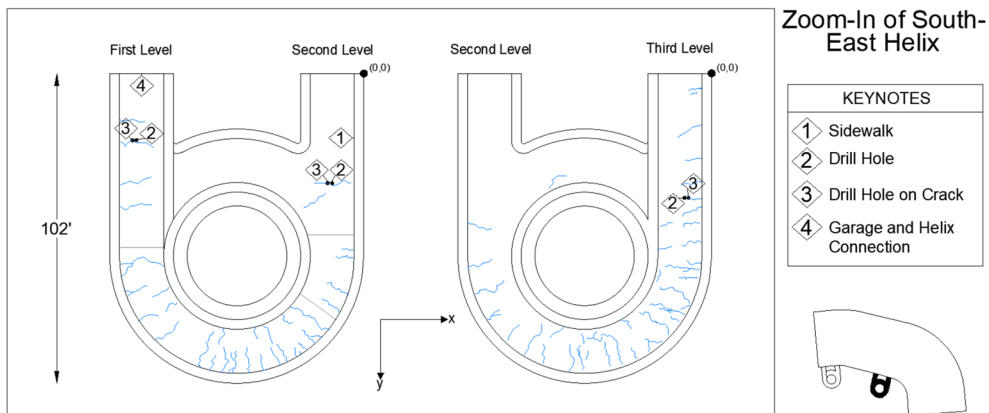
**Figure 3-14 Helix (upward traffic, covered) floor detailed analysis site showing blue dots for chloride drilled sample locations, and top-down cracking (blue lines). No cores were taken on the helix because of the inclined surface.**

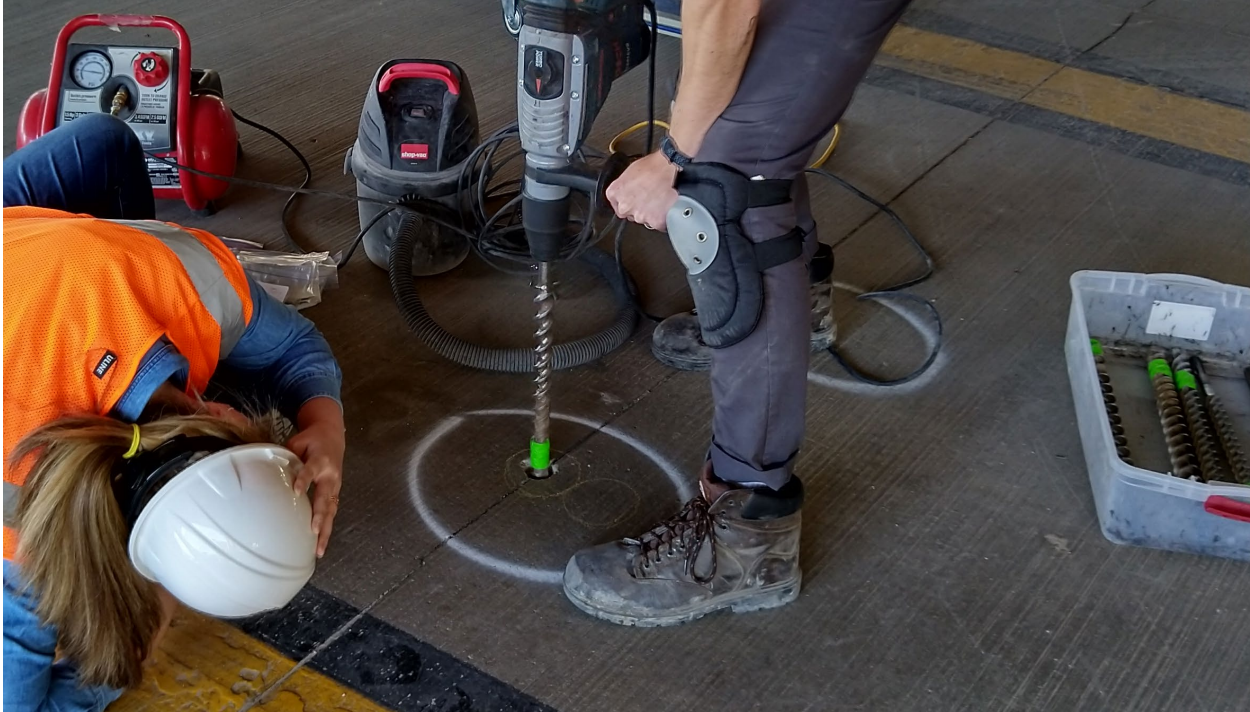
**Figure 3-15 Photograph showing the drilling of the chloride penetration sample collection on the ground floor. Current image is of drilling the sample in the wheel-path (according to the paint) and at the epoxy-filled joint.**
