**Fabrication and  
Shipment Cracks in  
Precast or Prestressed  
Beams and Columns**

Reprinted from the copyrighted  
JOURNAL of the Prestressed Concrete Institute,  
Vol. 30, No. 3, May-June 1985.

**PCI Committee on Quality Control  
Performance Criteria**

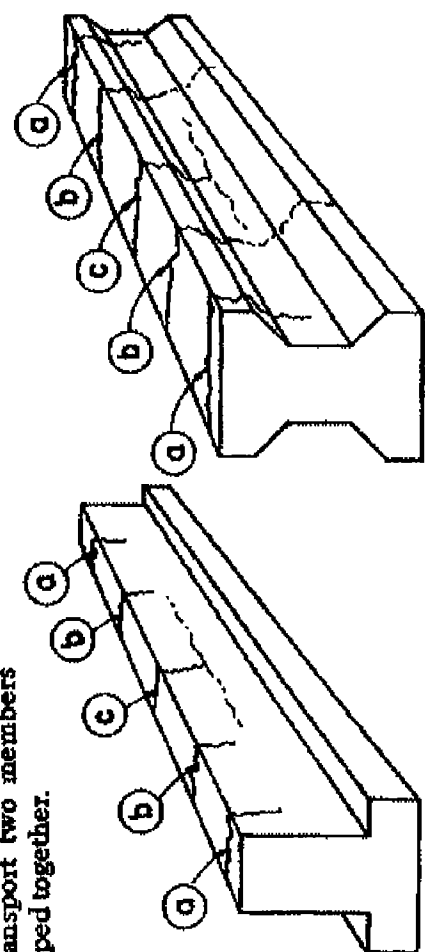
**Description** — These cracks are typically perpendicular to the longitudinal axis of the beam and they may extend across the top of the beam and be visible on both sides. In severe cases, they may extend to the full depth of the beam as shown in the figure for Crack 1b, or they may propagate parallel to the longitudinal axis near the centroid of the beam as shown in the figure for Crack 1c.

<p>1a Located near end of beam</p> <p>1b Located between end and center of beam</p> <p>1c Located near center of beam</p>

CAUSE	PREVENTION	EFFECT	REPAIR
<p>A. (cont.)</p> <p>5. Improper location of lifting or dunnage points (Cracks 1b and 1c).</p> <p>6. Prestress uplift at midspan exceeds weight of member or exceeds beam's top fiber tensile capacity (Crack 1c).</p> <p>B. Shrinkage.</p> <p>C. Delayed detensioning of heat cured products.</p>	<p>A. (cont.)</p> <p>5. Maintain proper lifting and dunnage locations. Avoid use of more than two dunnage points. If more than two dunnage points must be used, assure that full bearing is achieved at all points.</p> <p>6. Add weight to midspan before release to offset uplift, or add reinforcement to minimize cracks. (Even when reinforcement is provided, section may crack as reinforcement takes on tensile load.)</p> <p>B. Apply covers rapidly and/or mist spray with water.</p> <p>C. Detension as covers are removed and do not allow section to cool rapidly.</p>	<p>If the crack extends horizontally (as shown by the dashed line in the figure for Crack 1c) the condition may be severe, and evaluation by an engineer is mandatory.</p>

CAUSE	PREVENTION	EFFECT	REPAIR
<p>D. Form expansion with curing temperature rise if preset time is inadequate (Crack 1a).</p> <p>E. Excessive side fiber tension (Crack 1b).</p> <p>1. Excessive lateral displacement during transportation. This crack usually extends the full height of the section in I girders, as shown by the dashed line in the figure.</p>	<p>D. Lengthen preset time — Determine in accordance with ASTM C403.</p> <p>E. Reduce side fiber tension.</p> <p>1. Provide lateral strongbacks or transport two members strapped together.</p>

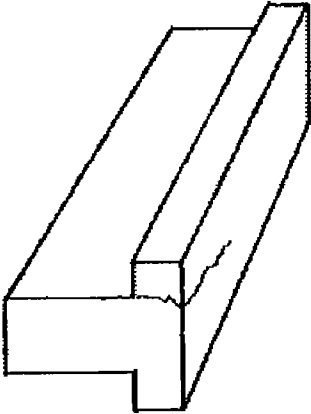
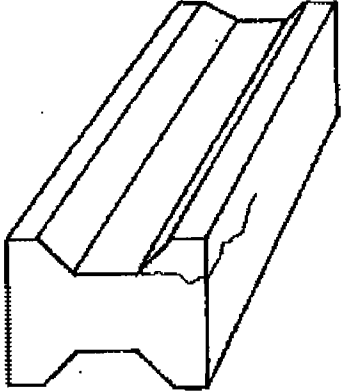
## 5. Ledge Crack

**Description** — Crack originates at the intersection of the web and flange and extends toward the bottom of the member. The crack is located at the end of the beam.

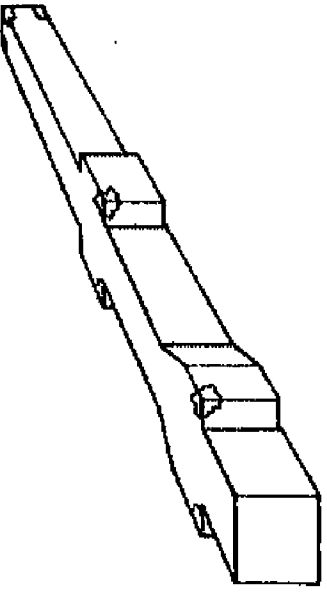
## 2. Exterior Corner Crack or Spall in Corbel

Description — Crack is located at the exterior corner of the corbel and usually occurs just beyond the principal tensile reinforcement.

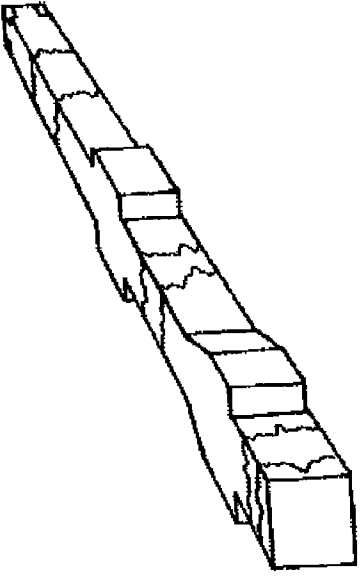
### 3. Horizontal Crack

Description — Crack is horizontal often lining up with stirrups. May extend completely around member.

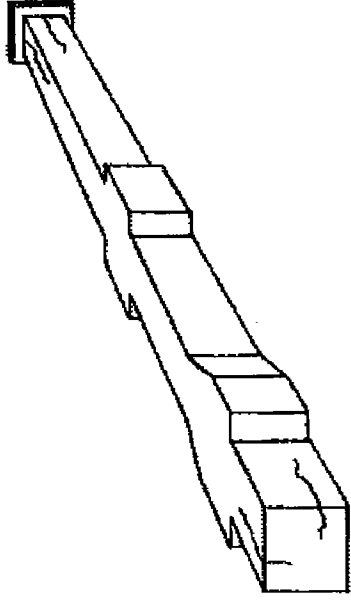
#### 4. Vertical Crack at Ends

**Description** — This crack begins at the end of the column and extends longitudinally from several inches up to a few feet. It is usually located in the plane of a strand.

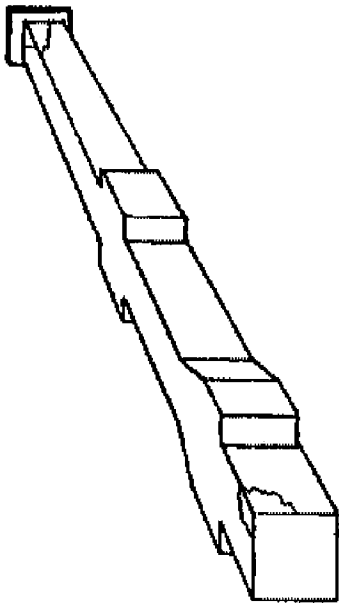
## 5. Diagonal Crack at Ends

Description — Diagonal crack extending from one face to the other.

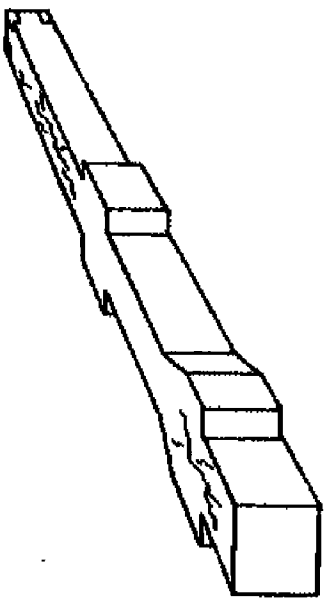
## 6. Miscellaneous Cracks

Description — Fine, shallow cracks; also coarse cracks with adjacent surfaces sloping into cracks.
